95% Draft Preliminary Engineering Report
Water Treatment Plant and Washeteria
Tununak, Alaska

March 13, 2020

95% DRAFT PER (r1)

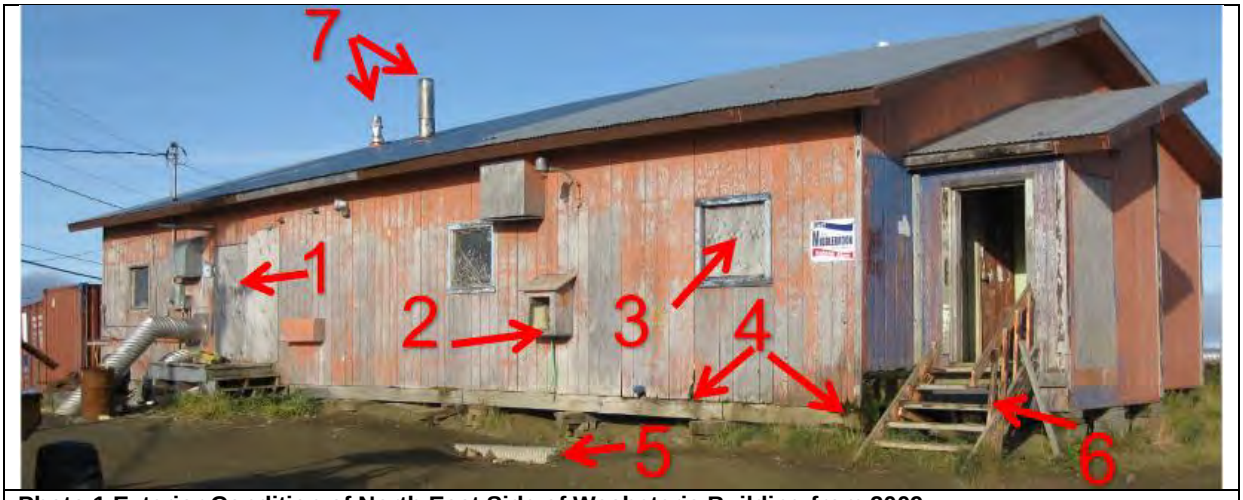
1. Sealed/boarded over egress door on Water Treatment half of building.
2. Abandoned Watering Point
3. Board up window
4. Decaying, damaged, and missing siding. Siding needs to be sealed/painted. Foundation lower at corner than center of building.
5. Soil under foundation washing out under foundation cribbing.
6. Handrail unstable and requiring repair/replacement.
7. Missing Chimney Caps.

Photo 1 Exterior Condition of North East Side of Washeteria Building from 2009
Visual inspection of building finds a minimum of 7 items that need to be addressed. (File photo 9/24/2009)

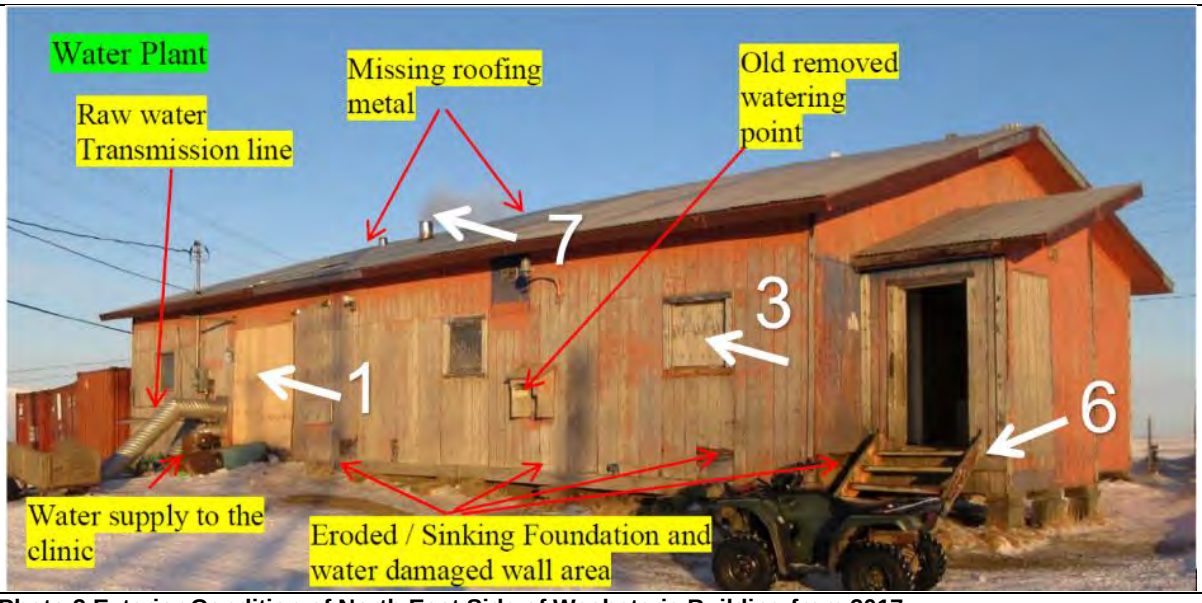
Photo 2 is the same view of the Washeteria taken almost 8 years later as part of the Rural Alaska Village Grant (RAVG) assessment in March of 2017. All of the deficiencies present in 2009 are present in the 2017 photo. White arrows and numbers matching the callouts of the items identified in photo 1 that were not identified by the RAVG assessment. One chimney stack is shorter, the handrail at entrance of the washeteria is gone, more siding is missing and there are no longer stairs leading up to the boarded up mechanical room entrance on the east side of the building.

Photo 2 Exterior Condition of North East Side of Washeteria Building from 2017
Visual inspection of building finds a that the 7 items identified in the 2009 Photo were not addressed and the building condition continued to deteriorate further. (RAVG 3/21/2017)

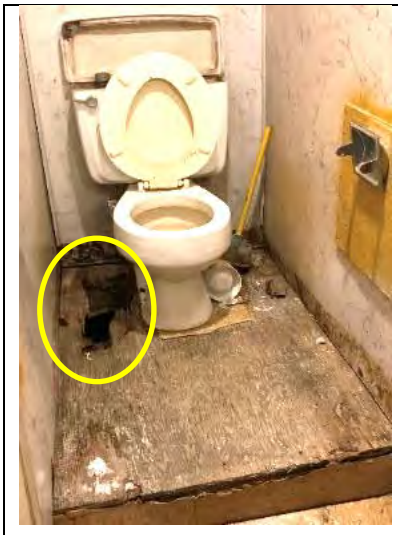
Photo 3 Rotting Floors
Plywood floor is rotting out next to toilet, hole circled in yellow. (Stantec 6/2018)

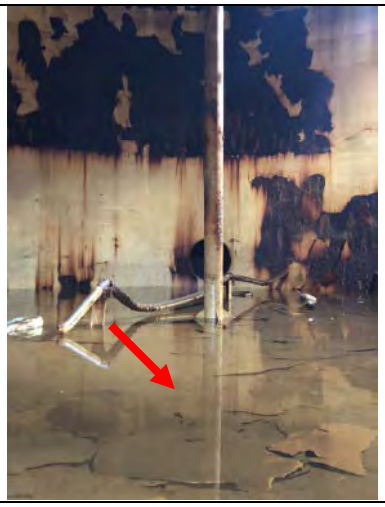
Photo 8 Damaged Siding on Water Tank Missing access ladder and siding with exposed insulation circled in red. (Stantec 6/2018)	**Photo 9 Damaged Insulation** Roof insulation showing sun damage where missing protective paint has left it exposed. Insulation missing from hatch. (Stantec 6/2018)	**Photo 10 Missing Tank Lining** Interior condition prior tank cleaning. Tank lining is floating in water, outflow assemble is bent. (RMW 10/2018)

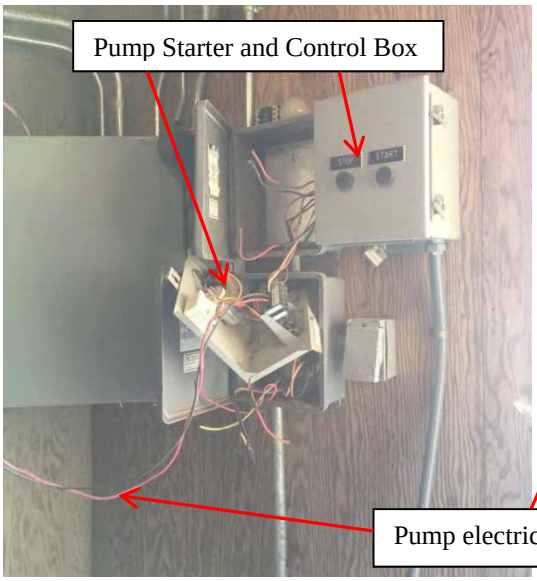
Tununak WTP's water source comes from a small Well house (8 X 8 foot) building approximately 500 feet east of the WTP. Well house is built directly over the middle of a small creek steam and surface water is pumped from a shallow infiltration gallery placed in the creek bed. Upon arrival we discovered the well house door was blocked from the inside by snow and ice blown in through the roof. We were able to enter the building through a small roof originally designed to lift and remove well pump. We removed the snow blocking the entrance door and opened to daylight so we could inspect inside.

The water is pumped by a submersible well pump set inside a vertically set, 24 inch diameter, galvanized culvert buried into the creek bed as the infiltration gallery. We could not inspect inside gallery as it was frozen over. It appeared the submersible pump when is not in use is removed from the gallery and was observed stored inside the corner of the building. The well pump's discharge stand pipe manifold was about 6 feet tall and or the depth it was set below the well house floor. Mr. Billy stated he has problems with the pump plugging with silt and required him to routinely lift it out and clean inside the culvert area and the inlet of the pump. The observed well pump was a GOULDS model # 35GS15 fitted to a 1.5 horse power, 230 Volt, 1 phase pump motor. The operator Mr. Billy stated he only pumps periodically (4-5 times a year) to fill his 50,000 gallon water storage tank (WST).. During the winter months the gallery and

well house is allowed to freeze. He said he uses a cold water jetter to thaw the transfer line and intake gallery in order to re-establish pumping operation during the winter.

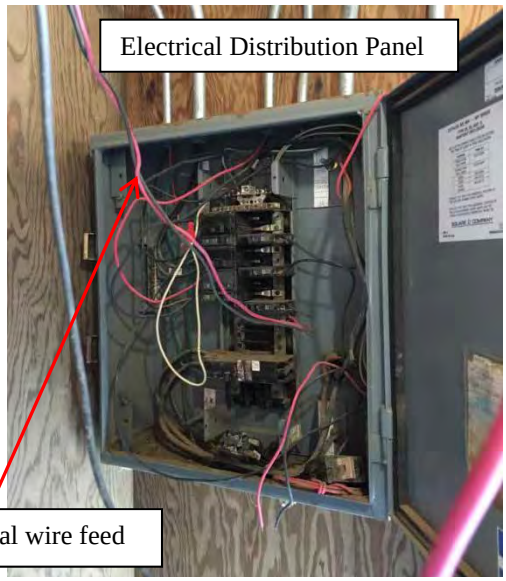
The well house building structure was observed in rough condition. The metal roof has started to rust and the roof hatch penetration frame was weathered and covered with a loose piece of nailed plywood. The pump control panels were bypassed. The pump starter control box and distribution panel were left open, covers removed and the electrical wires run openly exposed with no conduit and potentially easy to damage. No operational lighting.

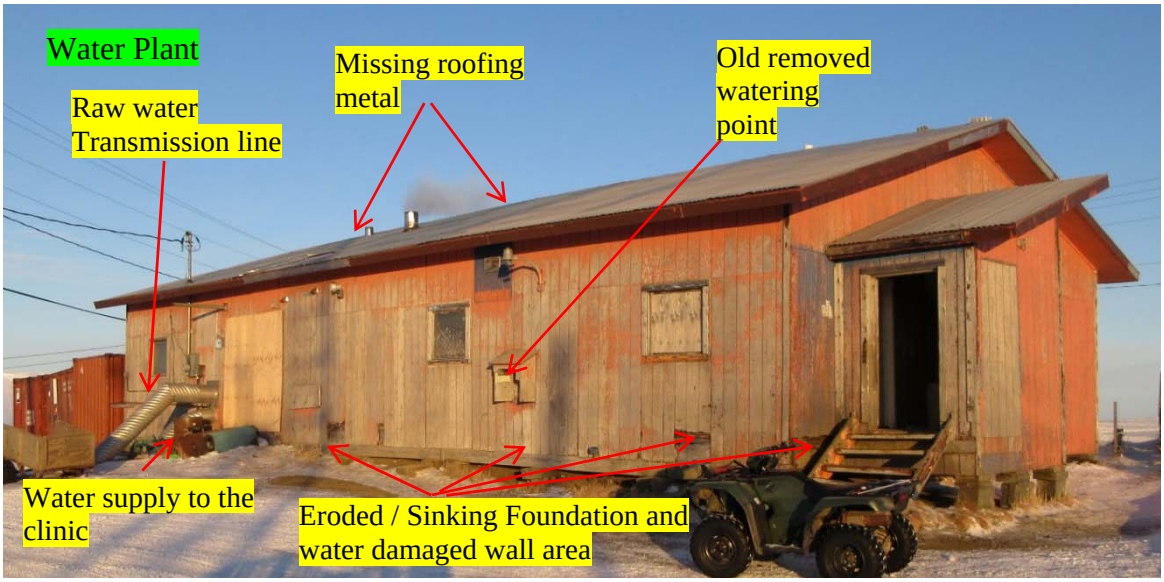
Portion of the community homes apparently had been served with water and sewer in the late 1980s and reminisces of a heated circulating water distribution system was observed installed in the WTP but is currently not operational. Parts of the circulation pumps and the manifold piping still exist. Operator Mr. Billie stated the system has not operated in years. We did not investigate or research any further details to this distribution system outside the building envelope.

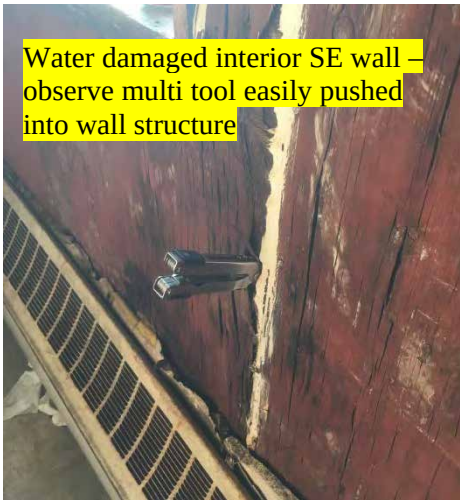
The WTP / Washeteria building structure is in very poor condition. The original metal roofing is damaged and missing in areas. Repairs to the metal roofing appeared to have been made in the past however some of the roofing has currently torn off and damaged by the wind with sections missing from the roof. Water damaged was observed and visible from inside and outside of the structure. The public bathrooms and hallway and access to mechanical room appeared the worst area. The ceiling over the public hallway area has fallen down exposing electrical and mechanical piping components. Water damage along the south east (SE) long wall can be seen at interior plywood sheathing and exterior T1-11 siding along the lower wall section with exposed foam building panel insulation, rotten wall plate and floor rim joist. Bathroom raised floor area is soft and suspect water damage. The pad under the SE long wall's wood foundation has eroded and the foundation and floor is sloping towards the damaged exterior wall and west corner towards the washeteria. Four of the windows are broken and plywood boarded over. The two remaining windows are in very poor condition.

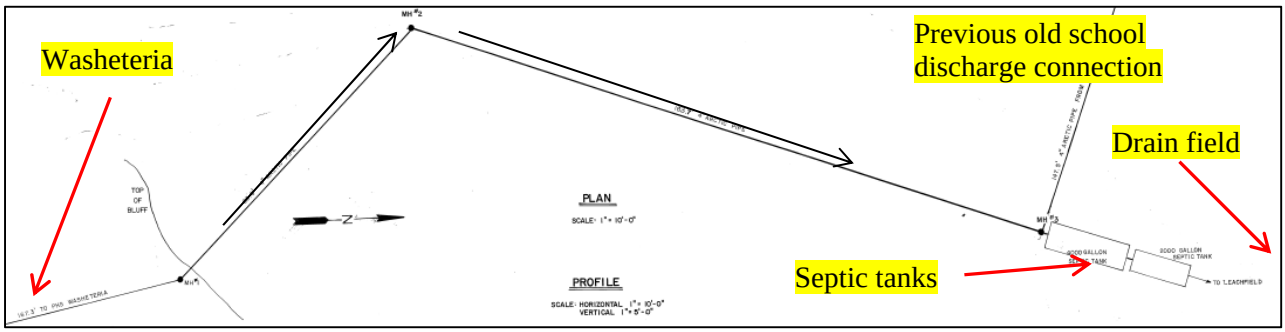
Sewer System

Per record plan as-builts; the sewer and waste water from the WTP / Washeteria gravity feeds through a 4 inch arctic pipe and sewer manholes and finally discharge into a 4000 and a 2000 gallon septic tanks connected in series. Effluent from septic tanks discharges into a buried drain field. According to Mr. Billie the septic tanks have been cleaned once every ten years or so. Due to the winter weather conditions and temperature we did not open or inspect the manholes, septic tanks or monitor ports at the drain field to verify or confirm condition or operation.

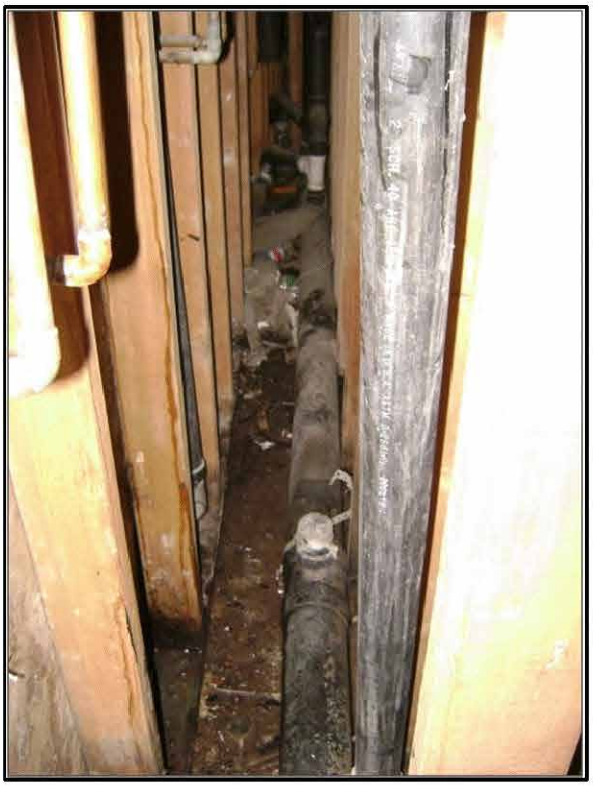
Photo 9: Rotted window frames and replaced glass with single pane Plexiglas or plywood.

Photo 10: Showing disconnected drainage piping improperly sealed.

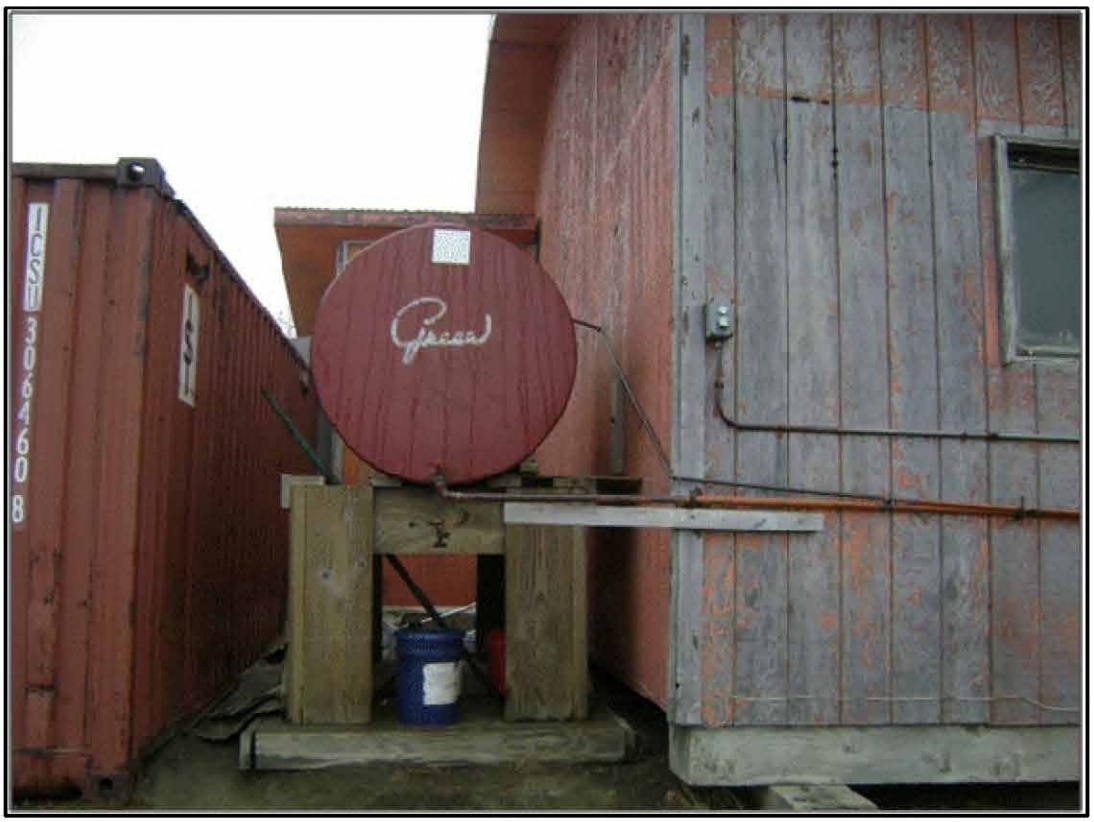
Photo 11: Boiler 2 burner showing firebox leakage and melting of combustion air inlet piping.

Photo 12: Building fuel supply tank located too close to building. Piping is not properly connected. Fill access is at rear contributes to fuel spill potential.

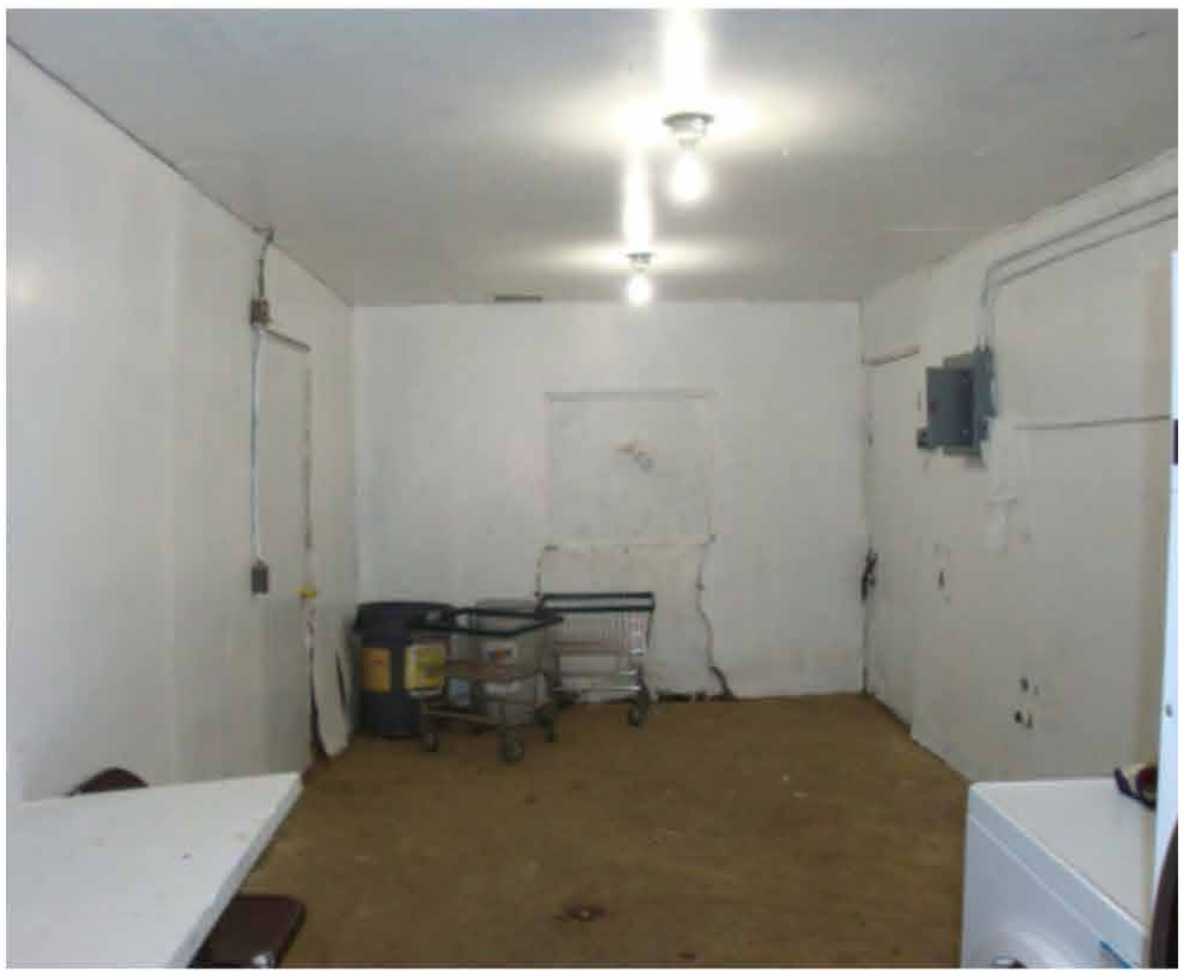
Tununak Washeteria. Photo shows decay of the door and flooring, and peeling of the wall.

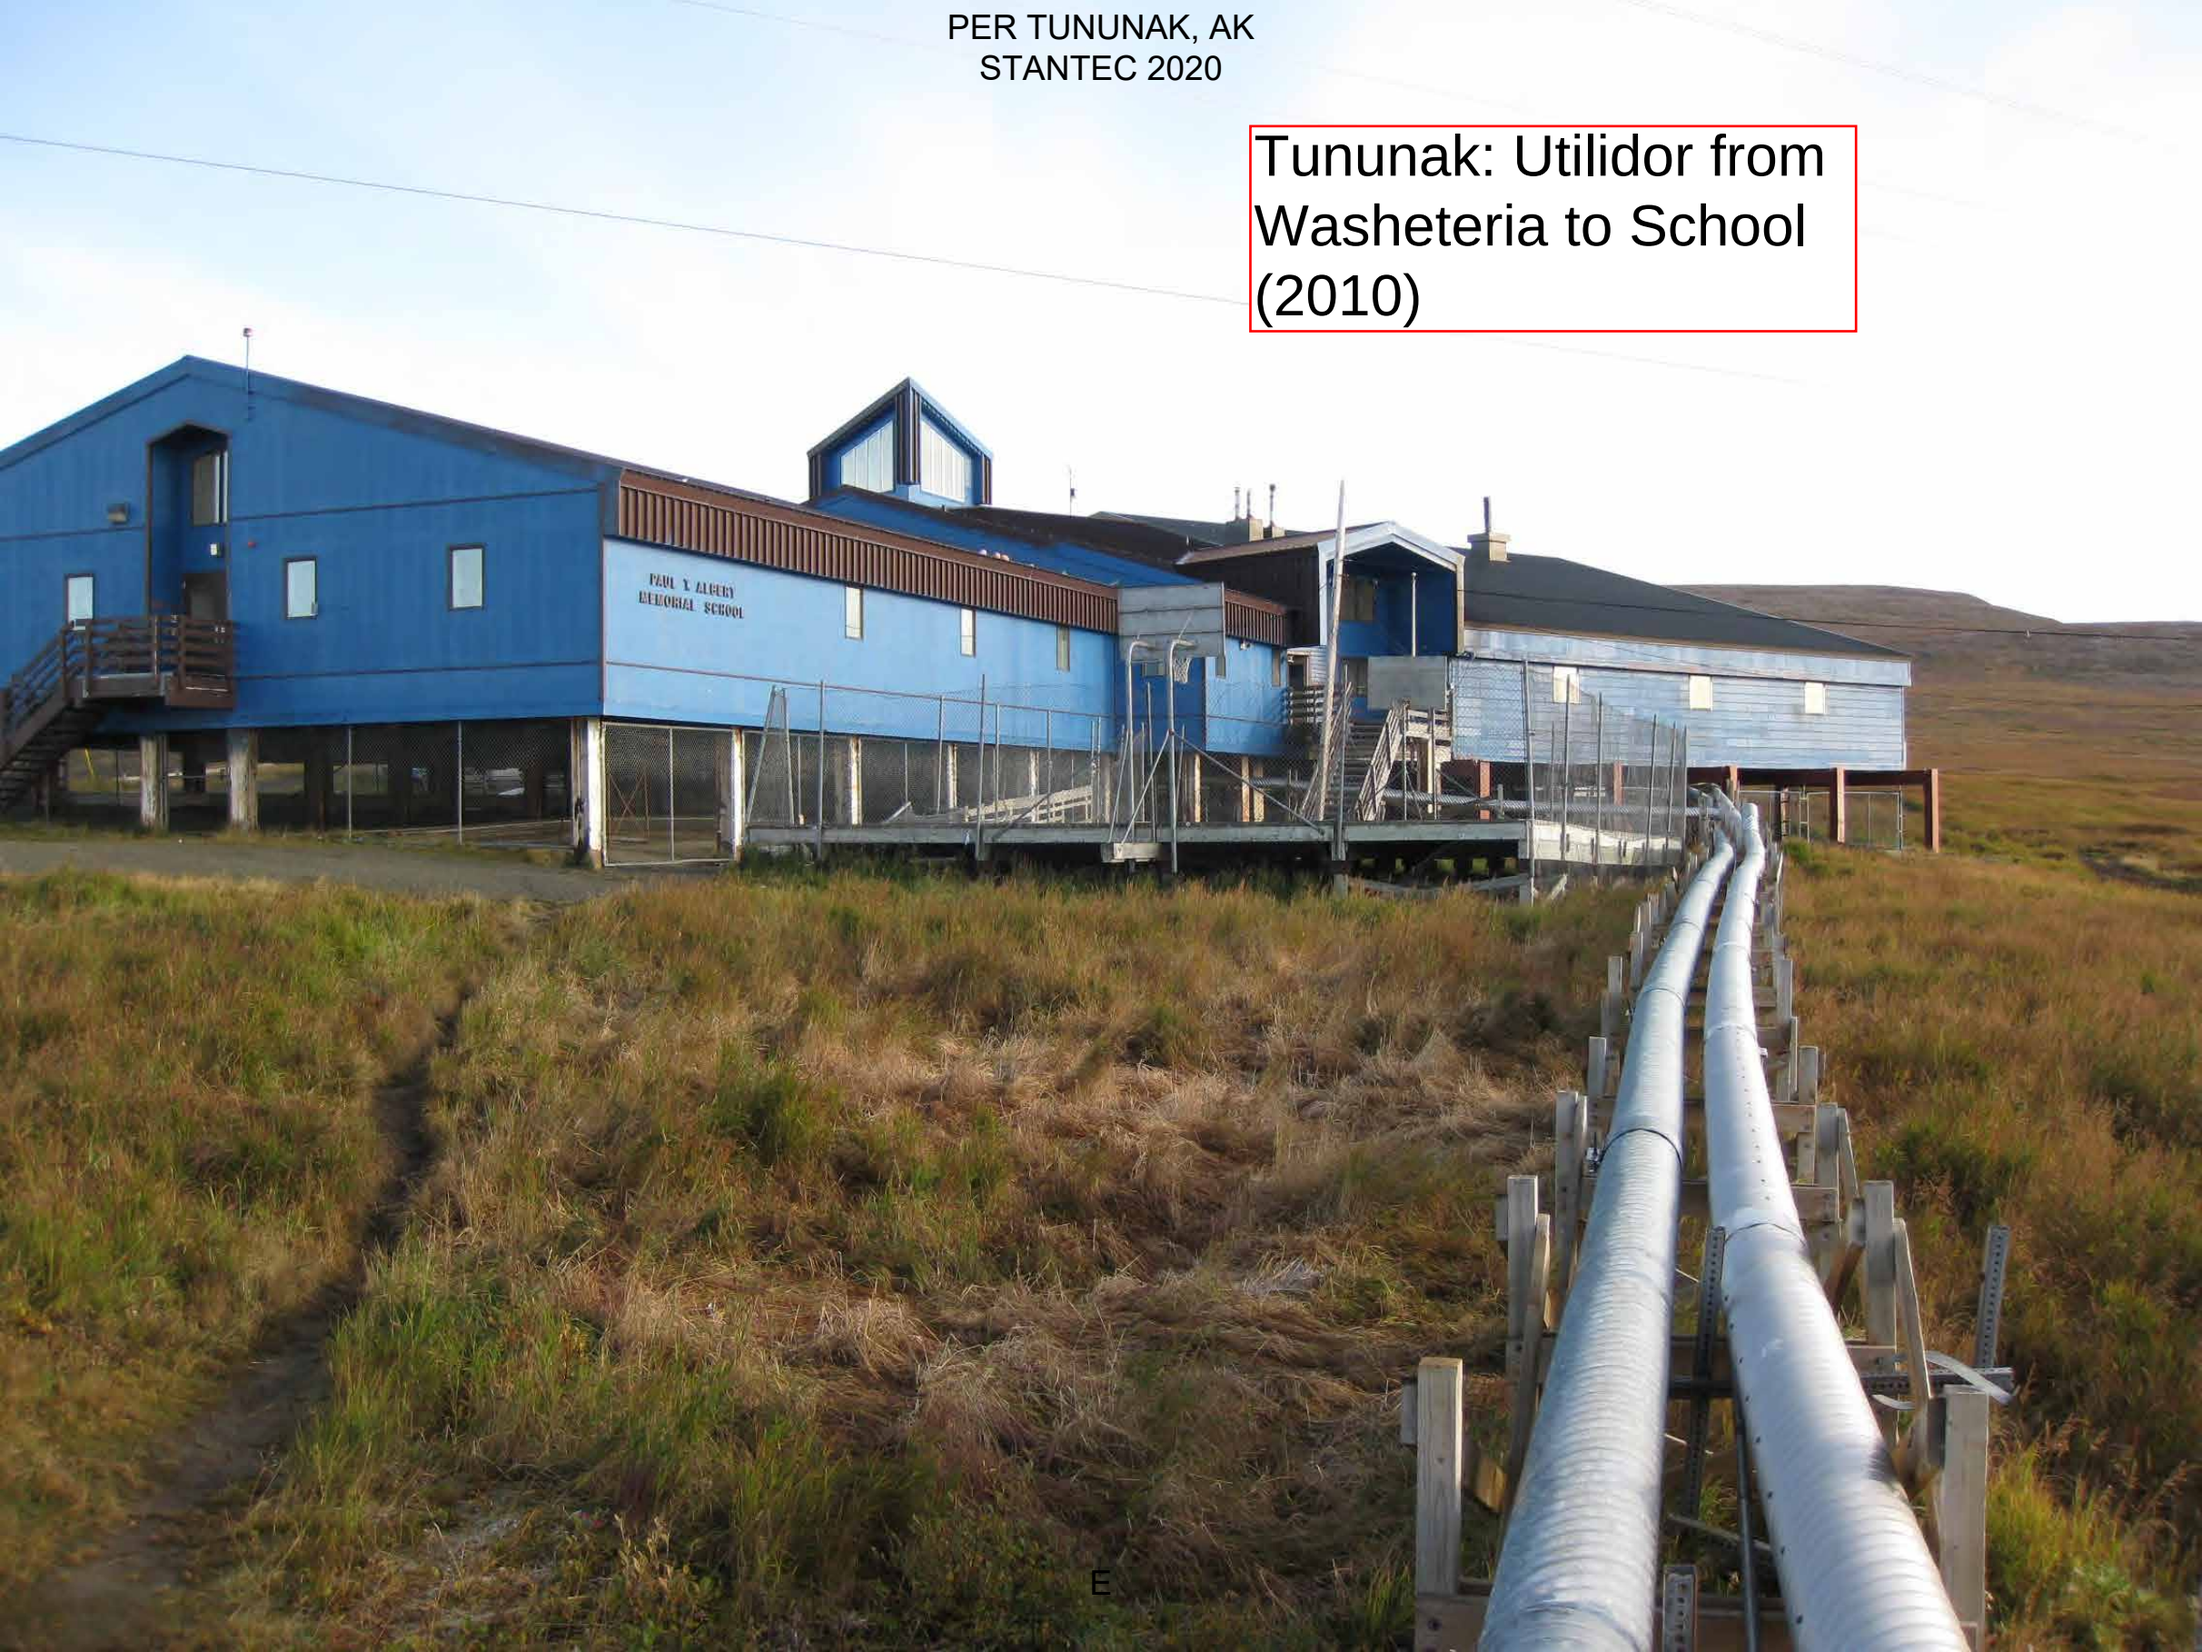
Tununak: View of Washeteria, WST, and School from West (2010)

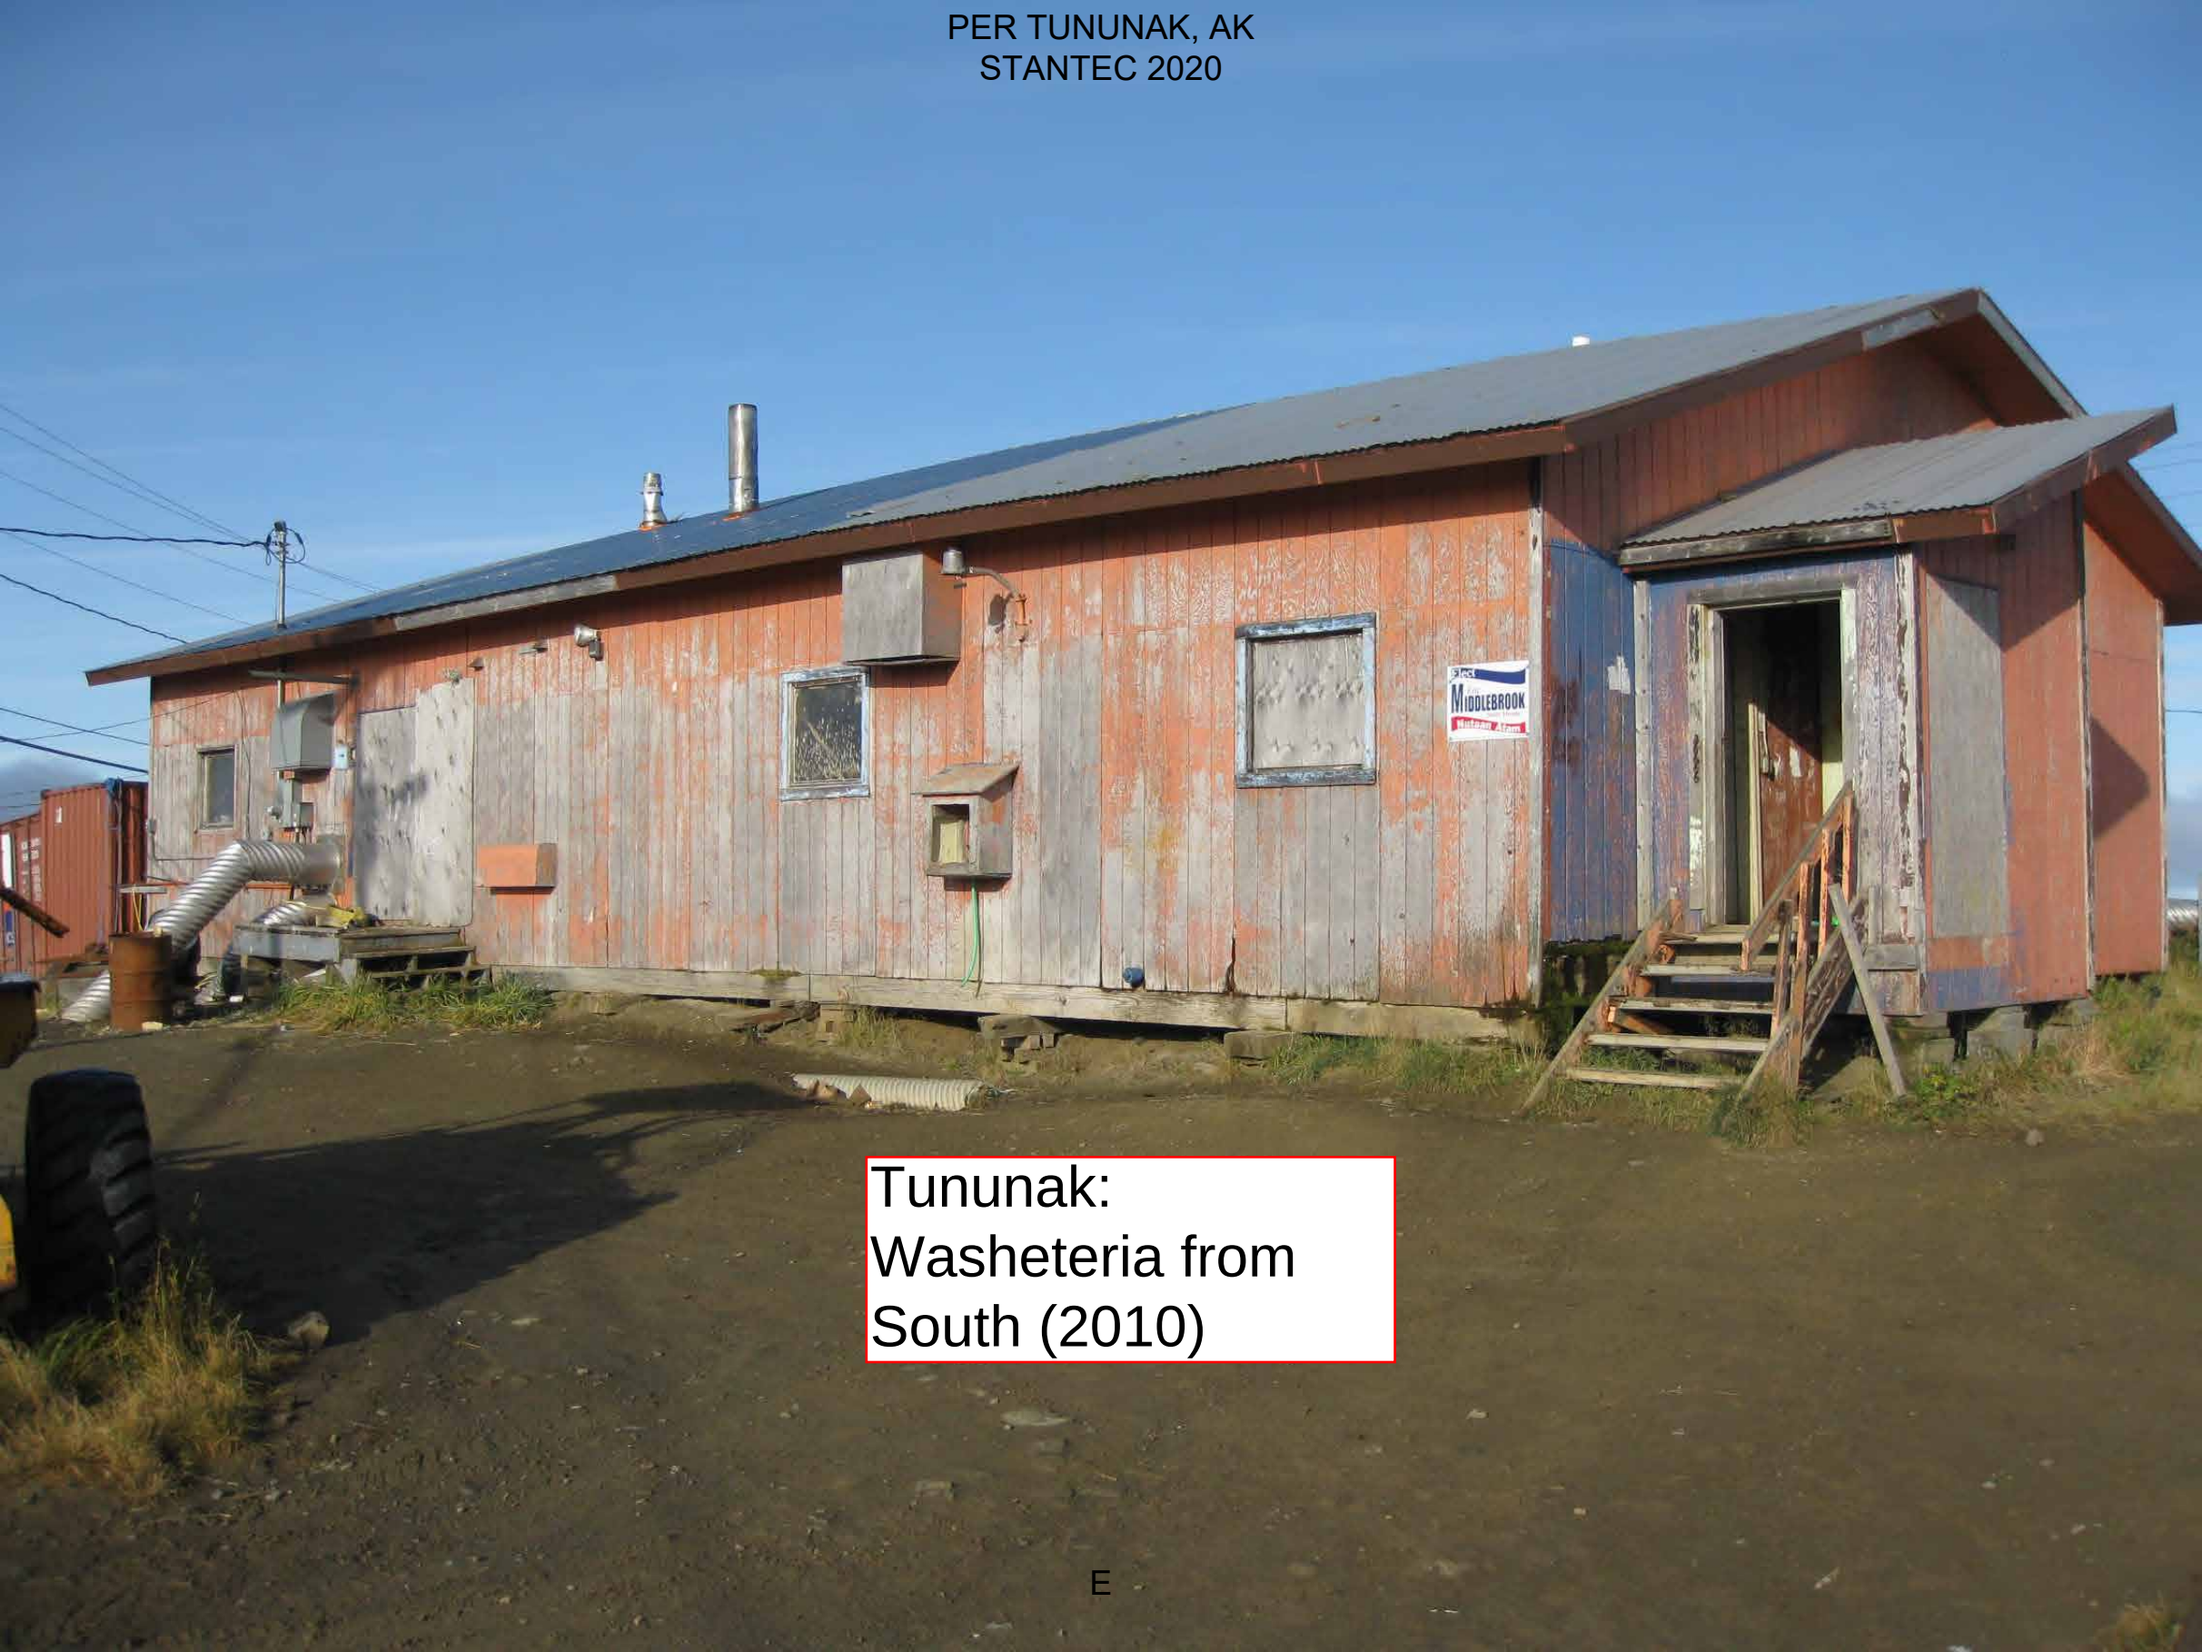
Tununak: Aerial from West (2010)

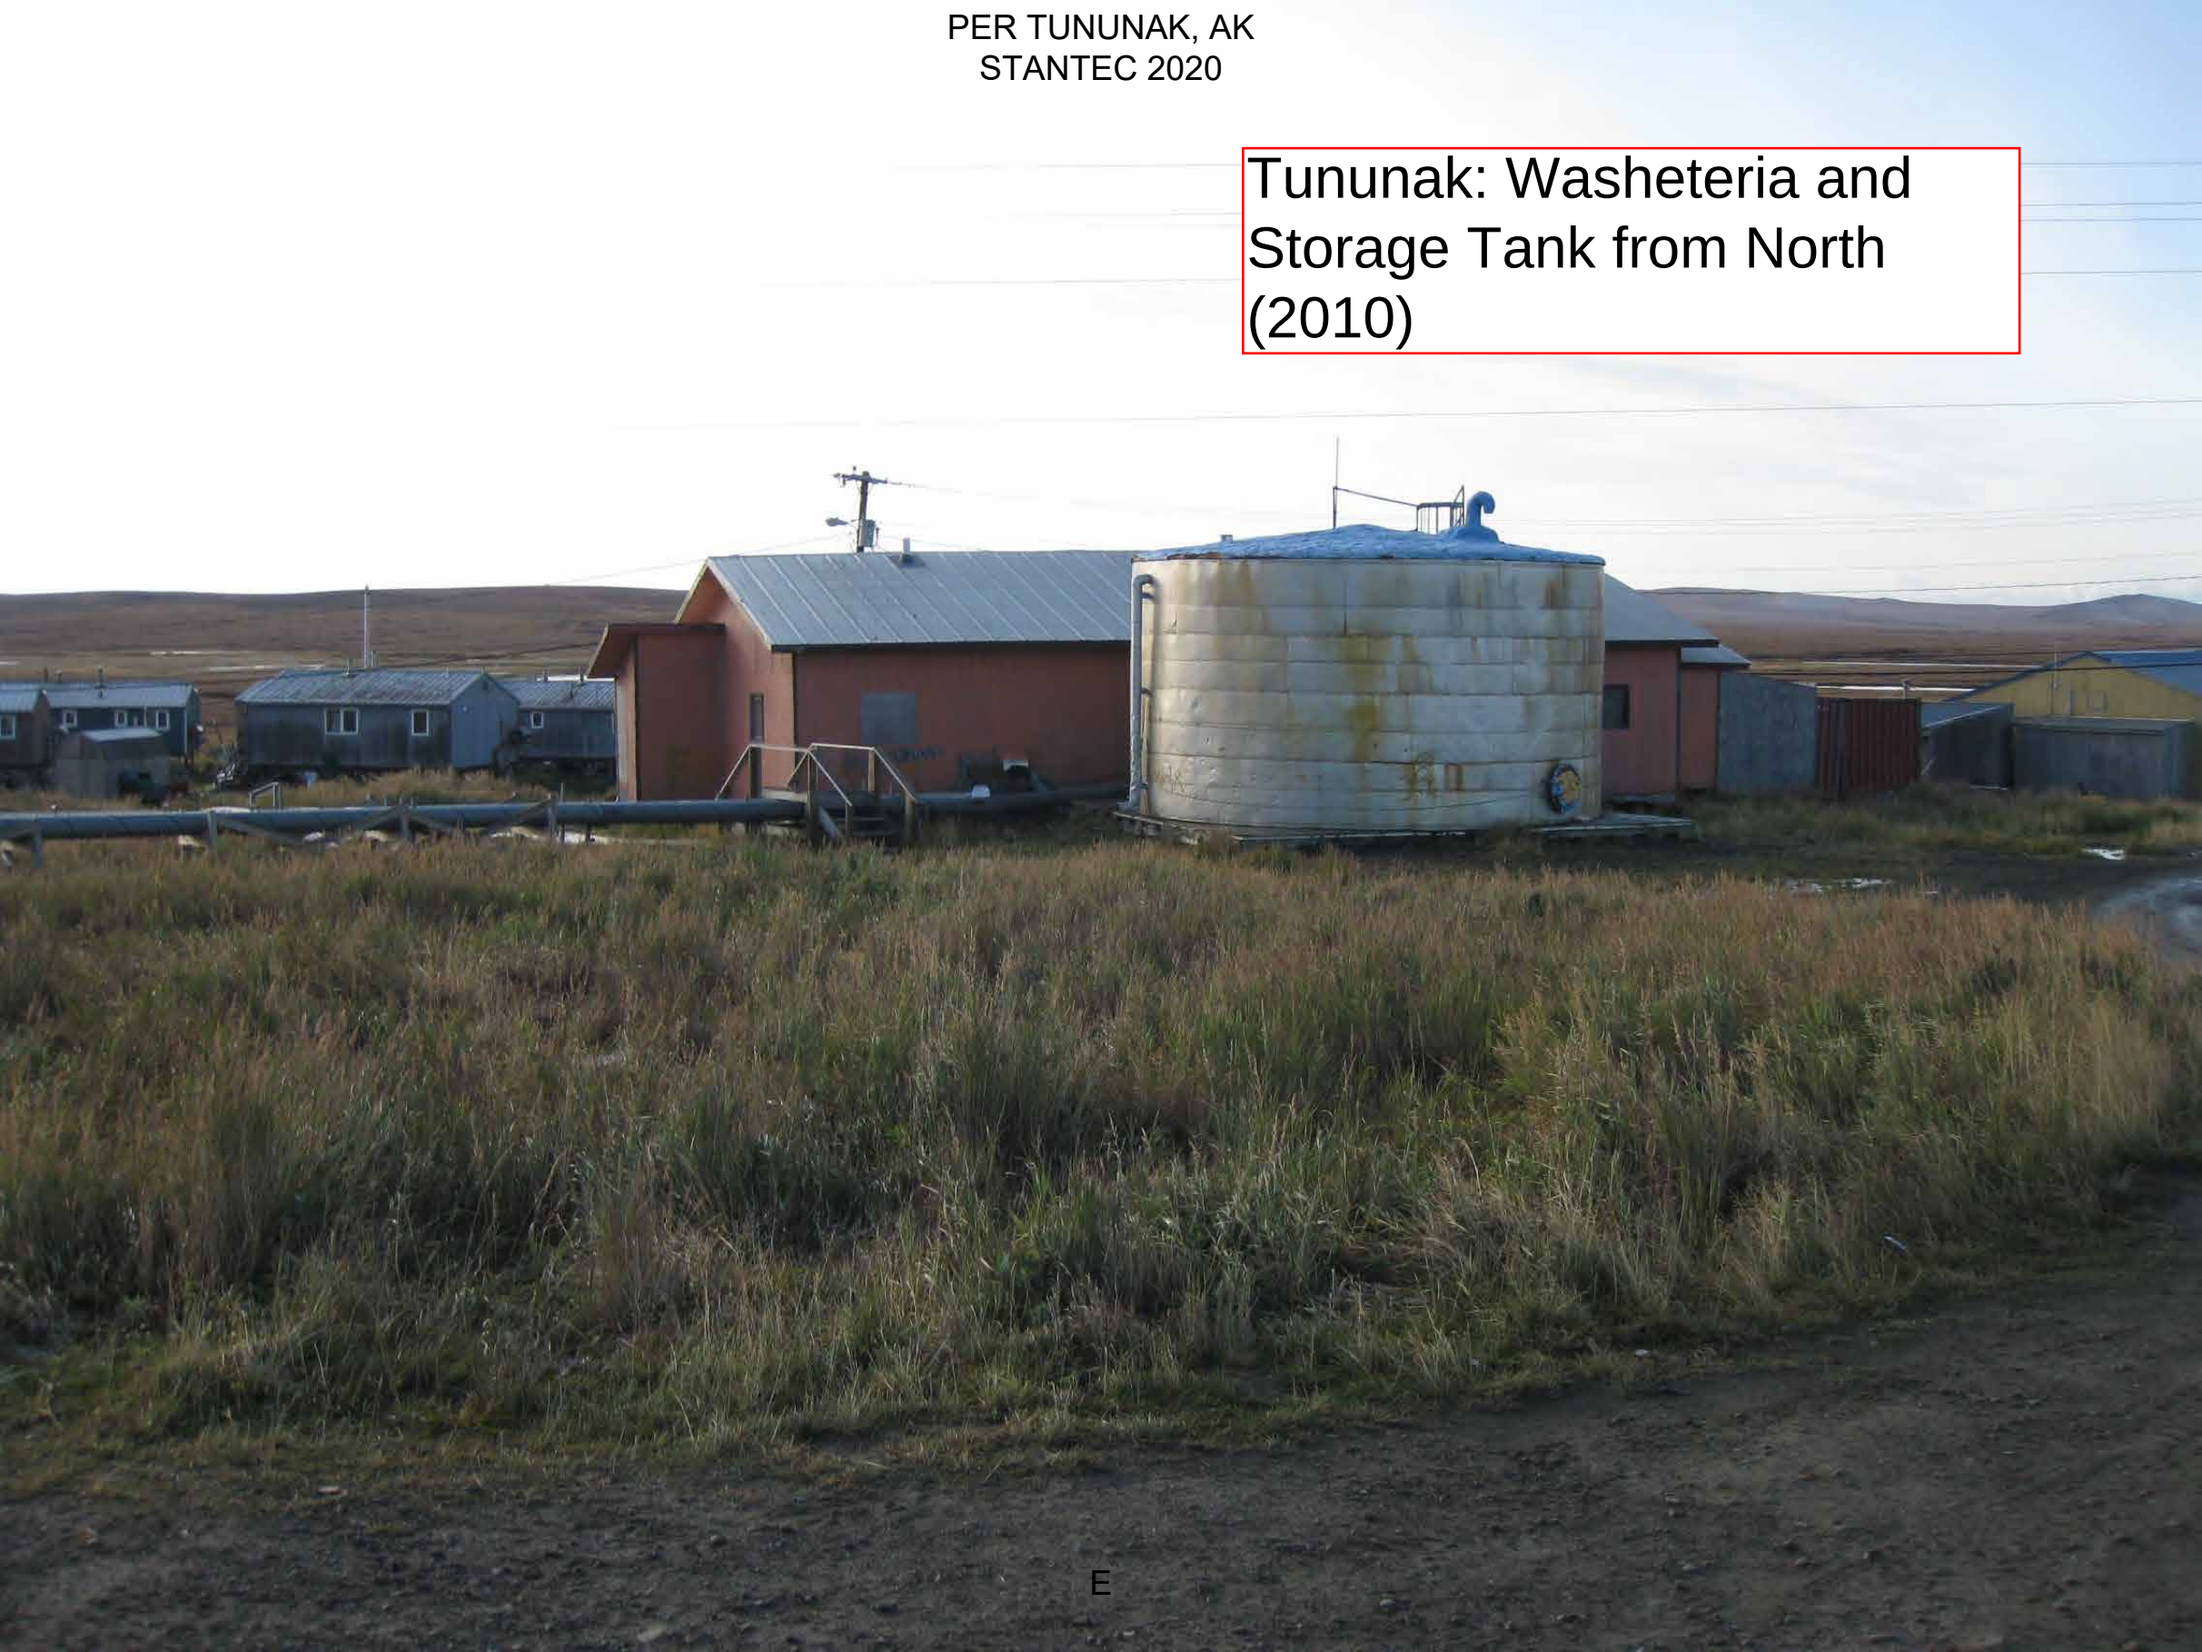
Tununak:
Washeteria from
South (2010)

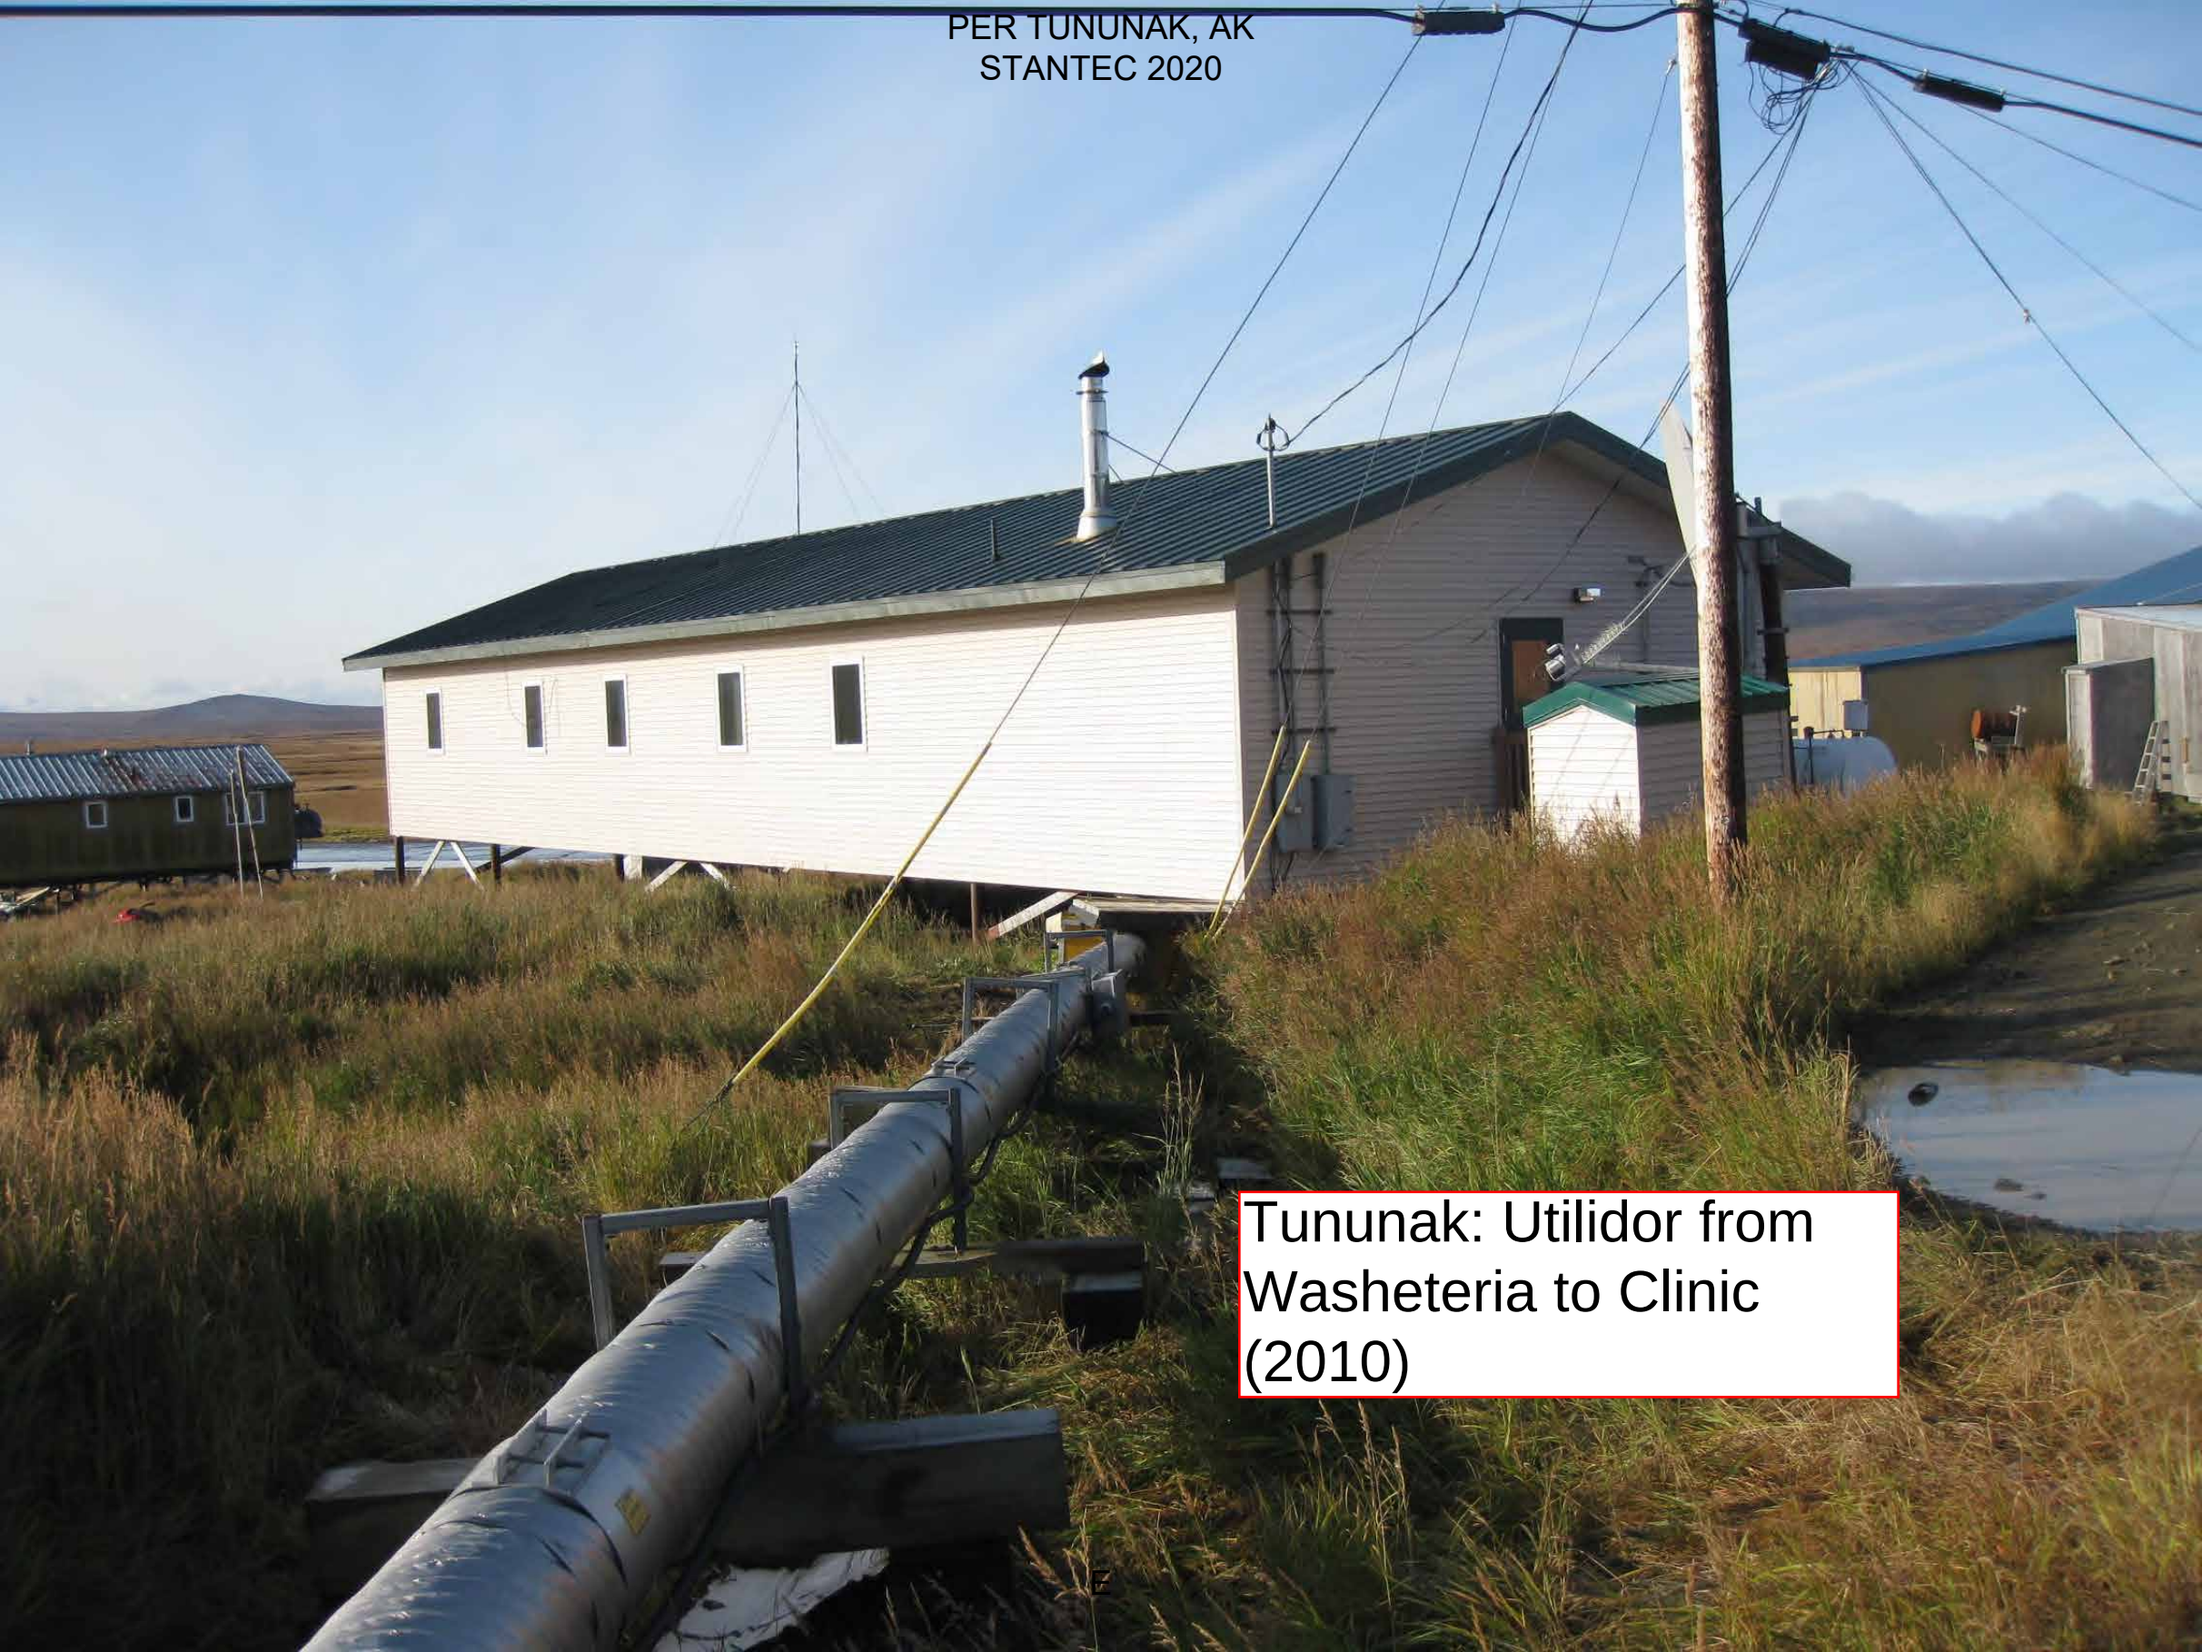
Tununak: Washeteria and Storage Tank from North (2010)
