Preliminary Engineering Report Final Draft

Kongiganak, Alaska

June 12, 2018

**Preliminary Engineering Report
for Improvements to the
Community Sewage Lagoon,
Water Treatment Plant and
Laundry Facility**

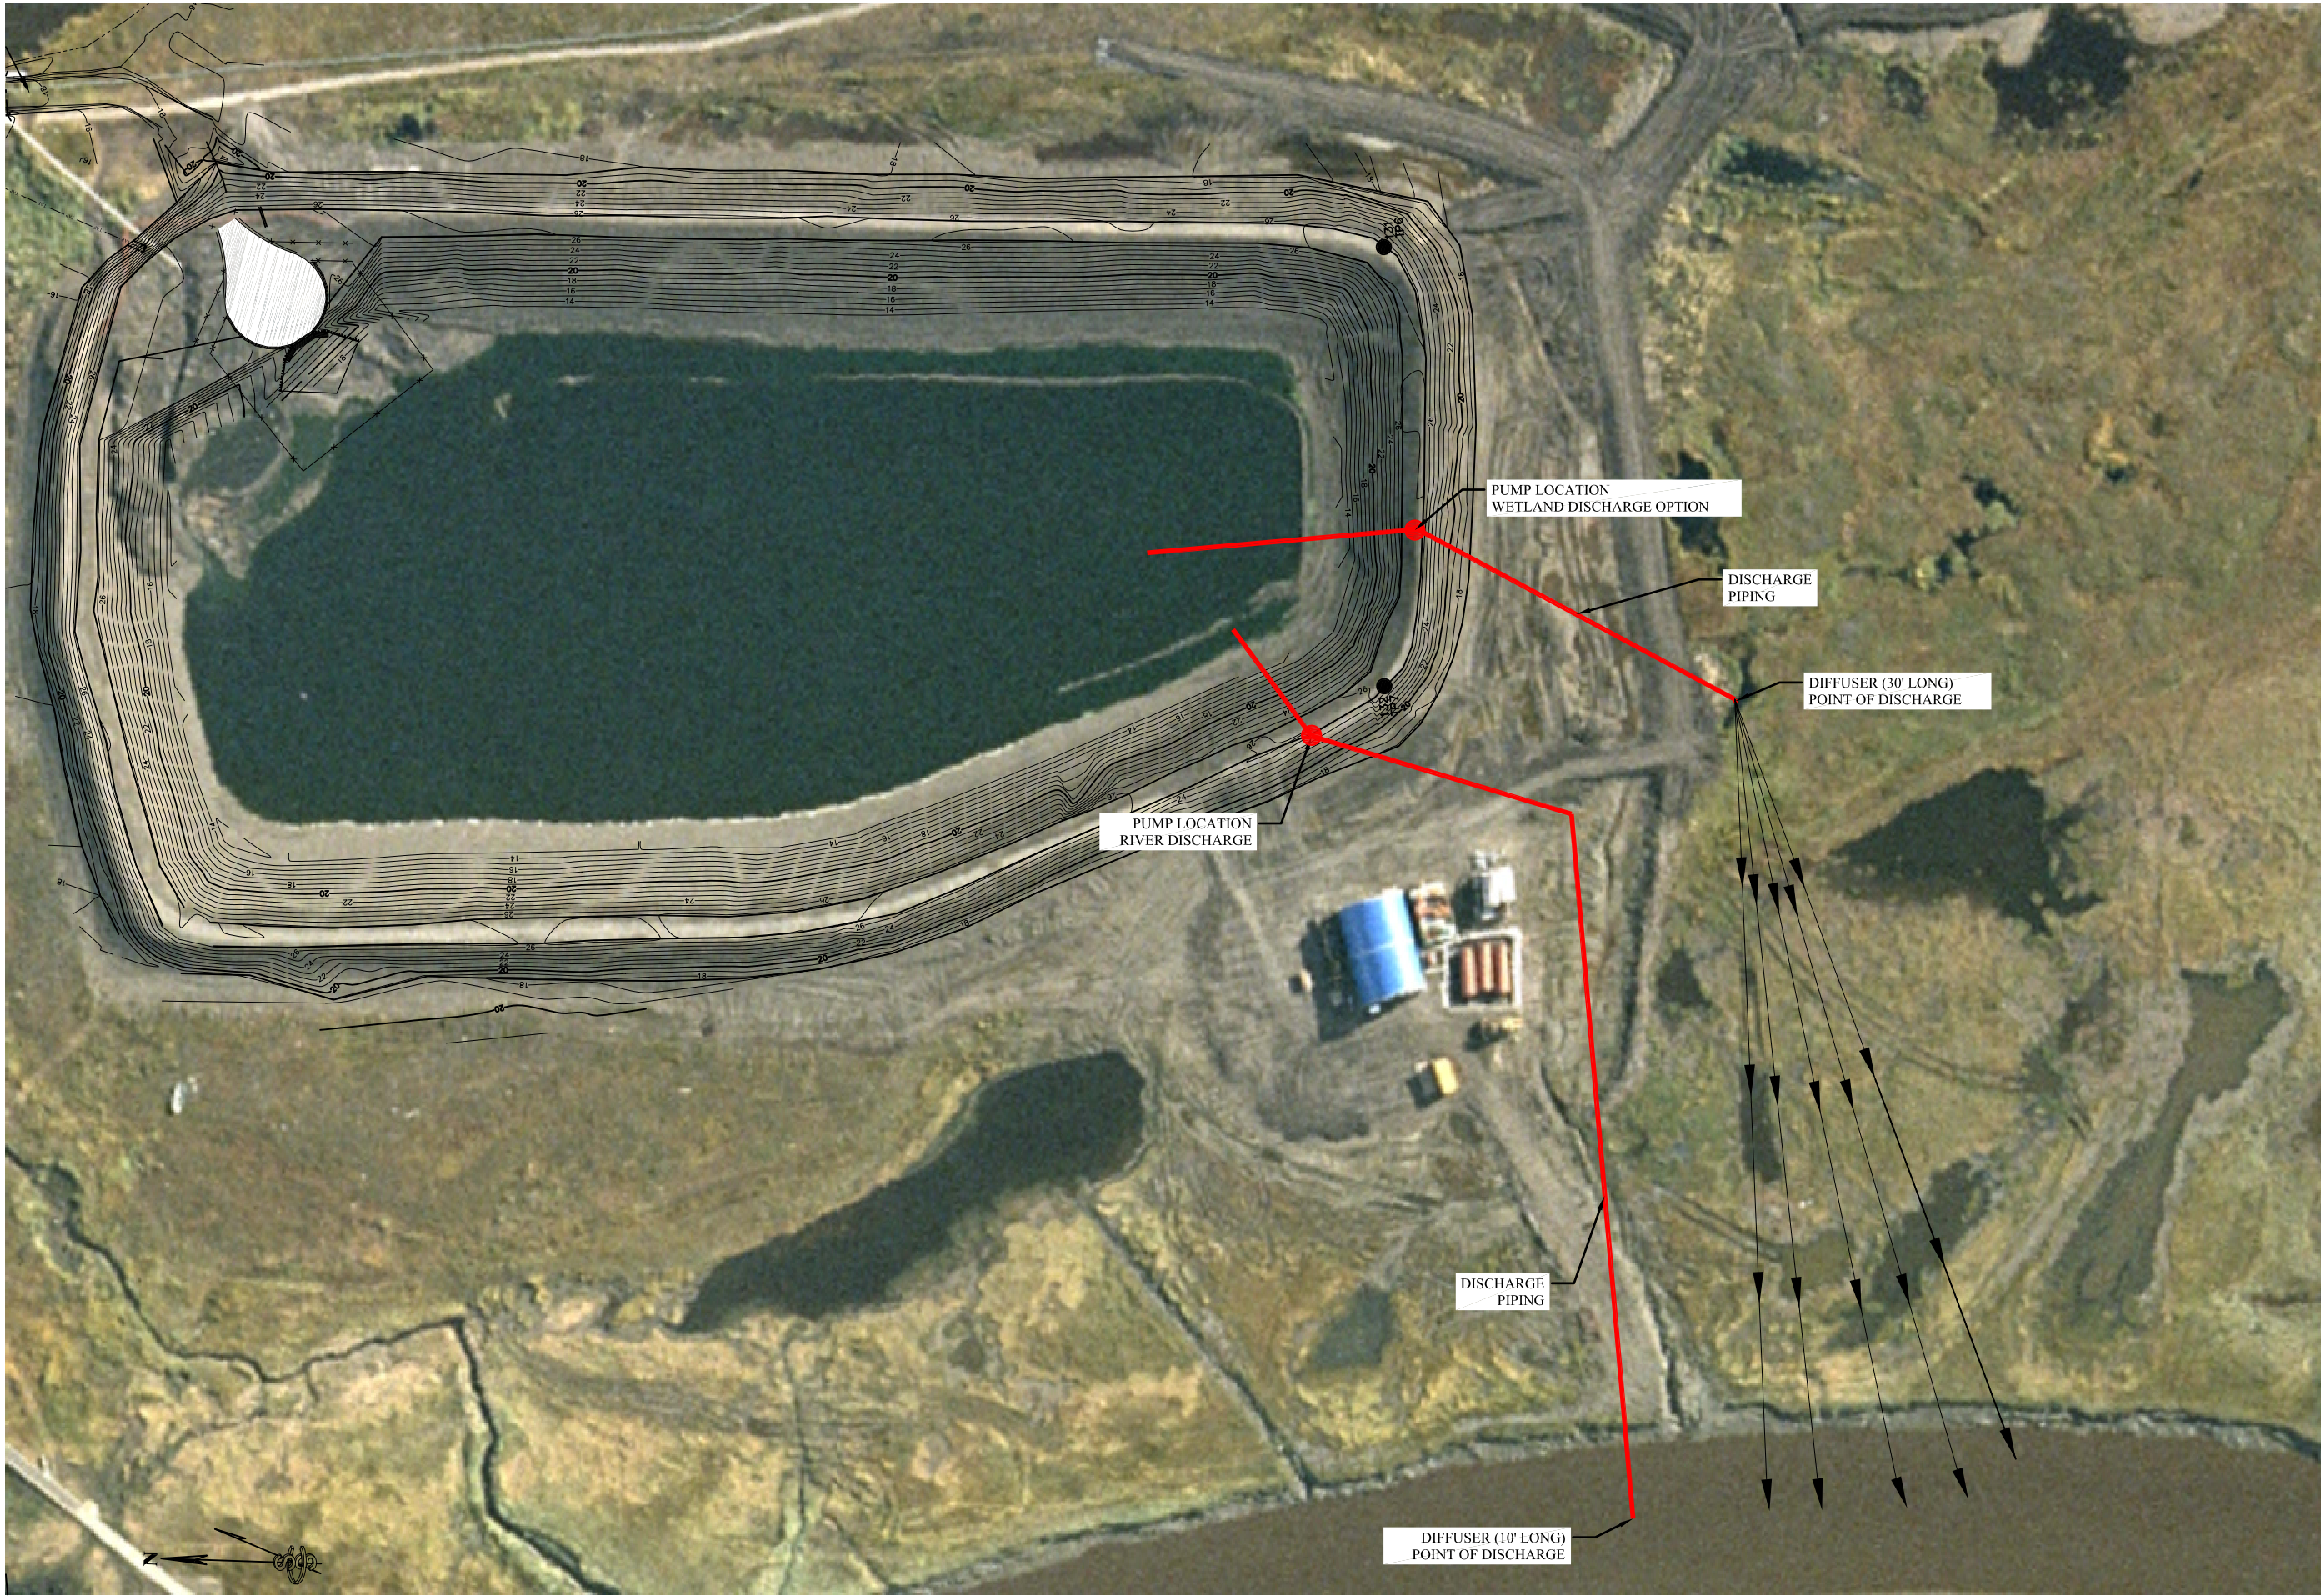
FIGURE
4

- The community has not discharged the lagoon as scheduled (every 2 years). It was last discharged in 2009 (Note: the extent of a partial discharge in 2017 could not be confirmed by the operator). Discharging over 600,000 gallons of treated sewage a year is time consuming. Depending on the water level, a discharge will take weeks to accomplish and require a couple of trips to check on the pump each day. Also, the discharge pump (Godwin DriPrime CD100M Automatic self-priming diesel pump set bought in 2004) requires repair.

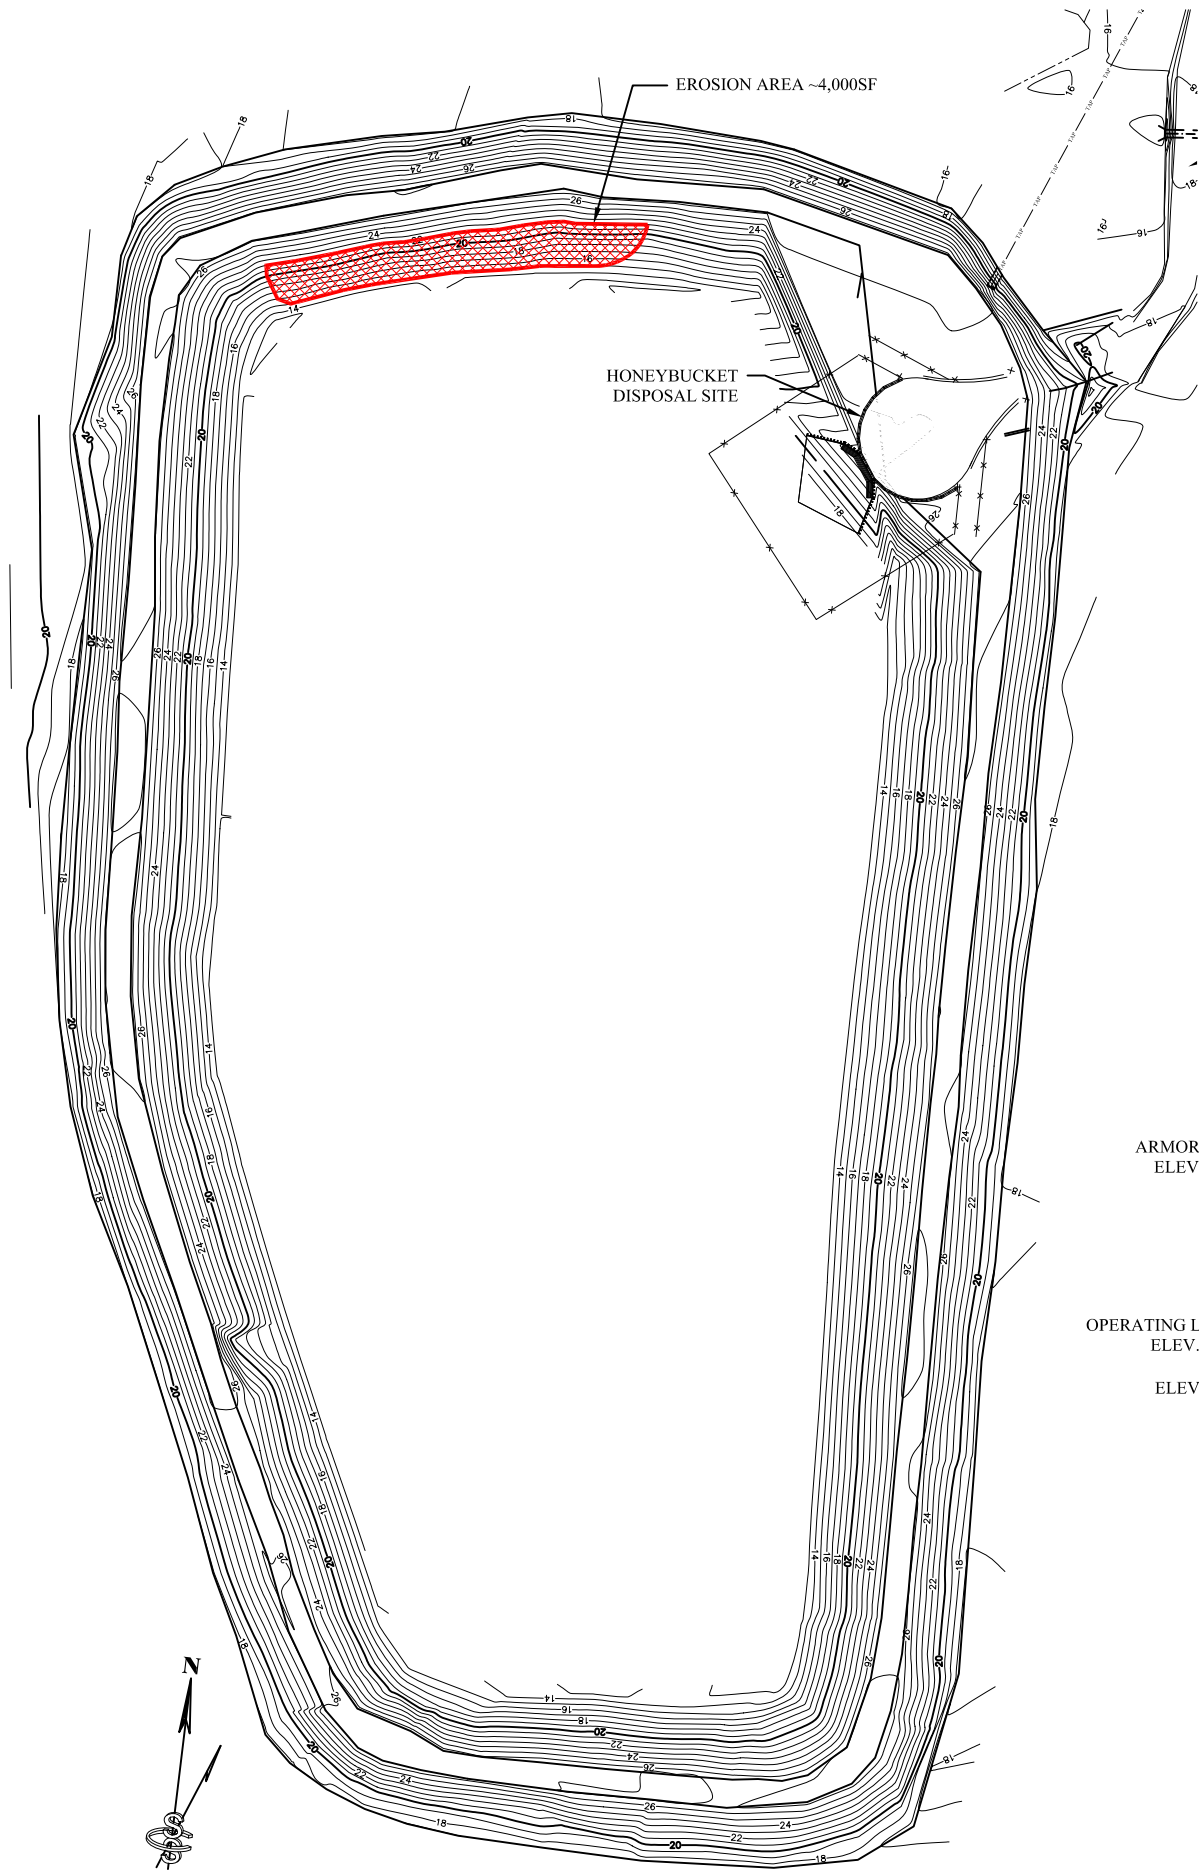
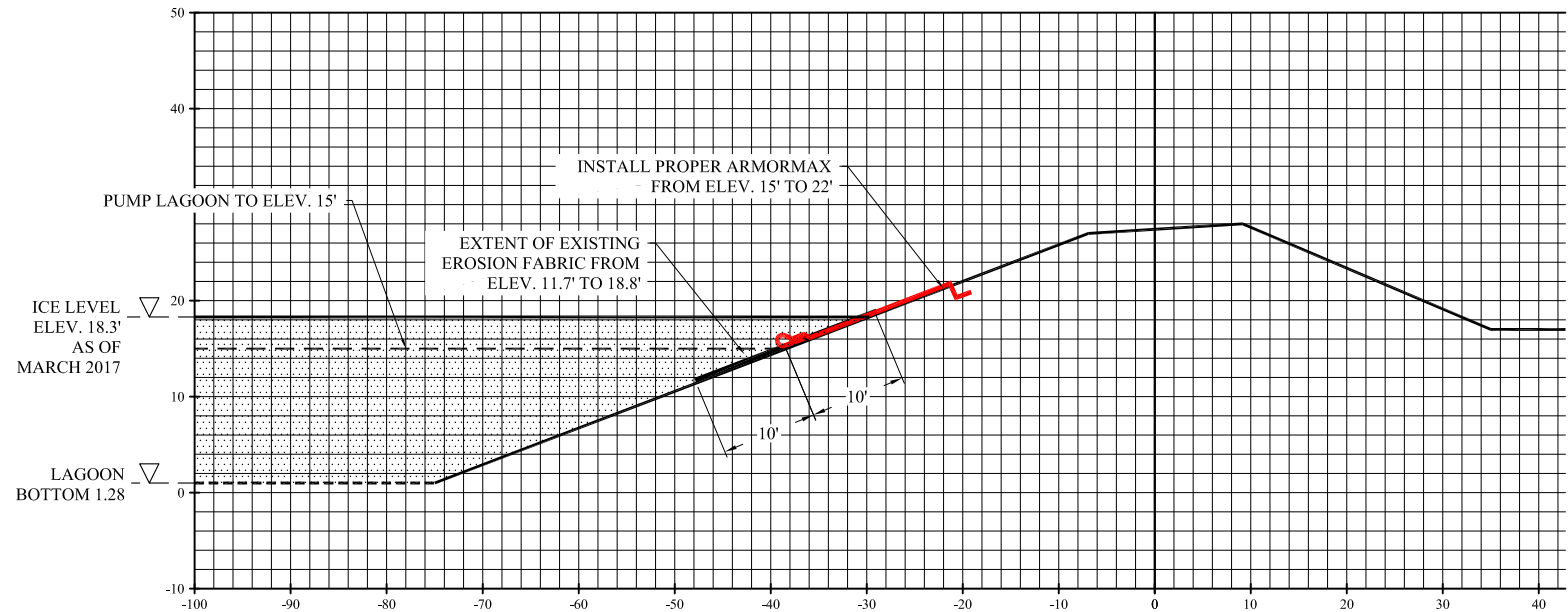
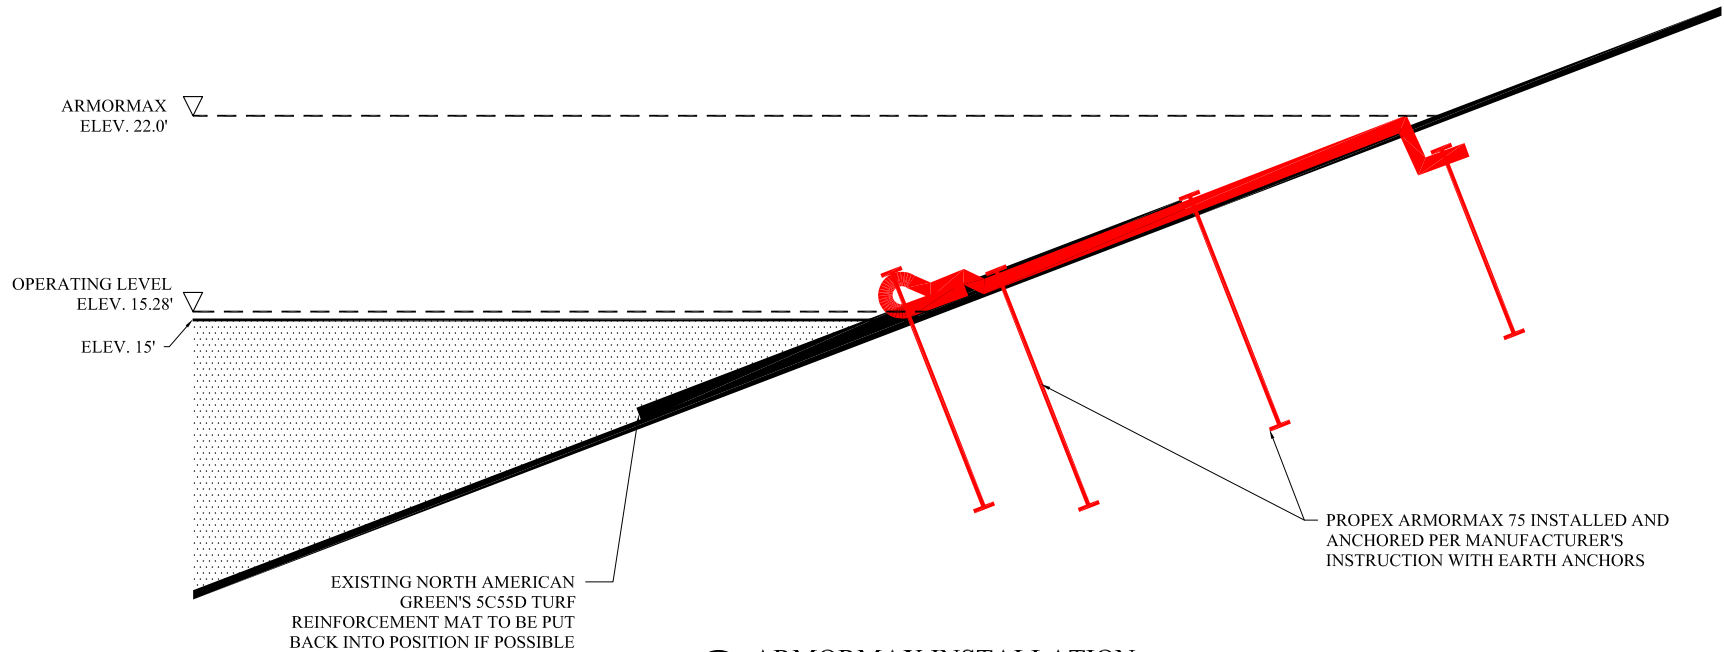
FIGURE
5

- Erosion is affecting an area of at least 100 feet in length and cutting into the berm itself 1 to 3 vertical feet. The area of worst visible erosion (above the water line) has cut into the berm up to 3 feet. The damage should be verified after break-up as a precise measurement could not be taken with the presence of drifting snow.

A new erosion control material will be installed from elevation 15 ft to approximately 22 ft. The proposed new material is a Propex Armormax product that can be keyed at the top elevation and rolled out to the water line. The Armormax can be secured with earth anchors. Refer to Attachment B, Figure 5. The slopes would then be re-vegetated.
