TECHNICAL MEMORANDUM

Subject: City of North Pole – West of Old Richardson Highway Stormwater Drainage Study

A city-wide drainage integrity overview was desired by the city. By reviewing the major drainages throughout the city looking for blockages, failed/failing structures, and other readily visible items of concern, RESPEC identified items that might disrupt the flow of stormwater and potentially create future problems. After consultation with the city, RESPEC understood that there were no known issues outside of the recently completed “West of Old Richardson Highway Study”. So, it was decided to focus on the culverts under the 10 road crossings of Thirtymile slough since it provides the main drainage pathway through the city and receives flow from the ditches of adjacent neighborhoods.

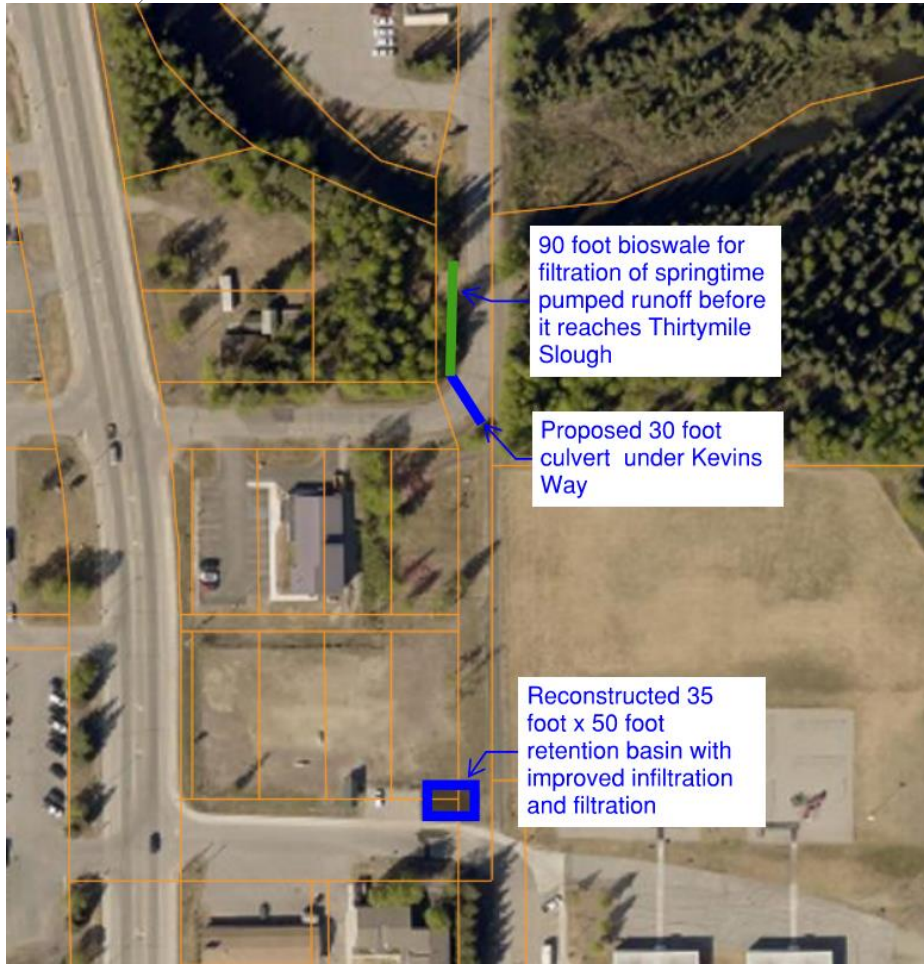
Image 1: Proposed culvert under Kevins Way/Snowman Lane curve and bioswale in the right-of-way to the west of Snowman Lane

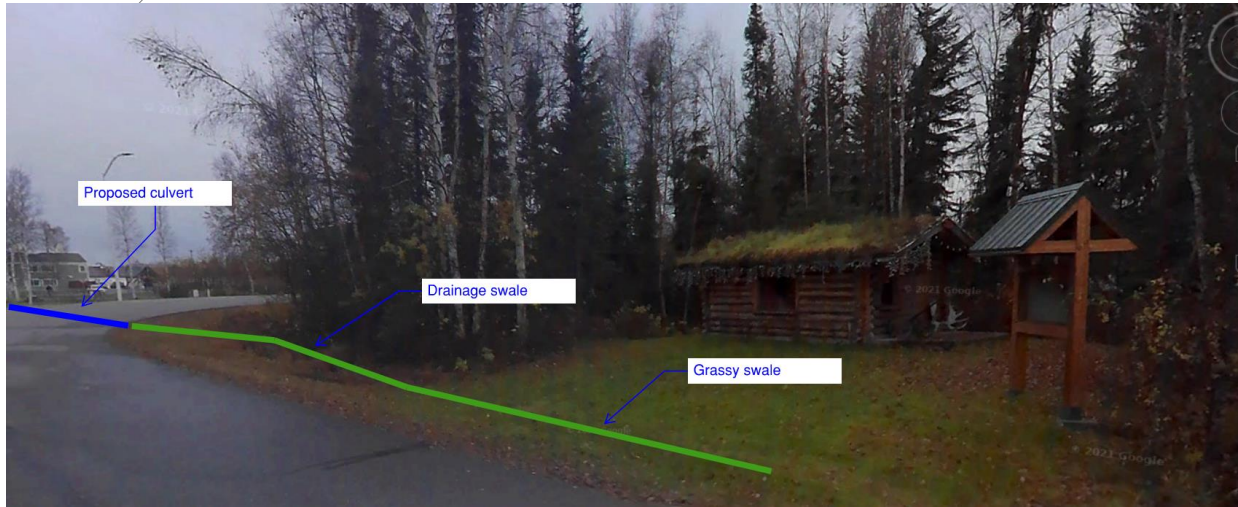
Image 2: Proposed culvert under Kevins Way/Snowman Lane curve and bioswale in the right-of-way to the west of Snowman Lane

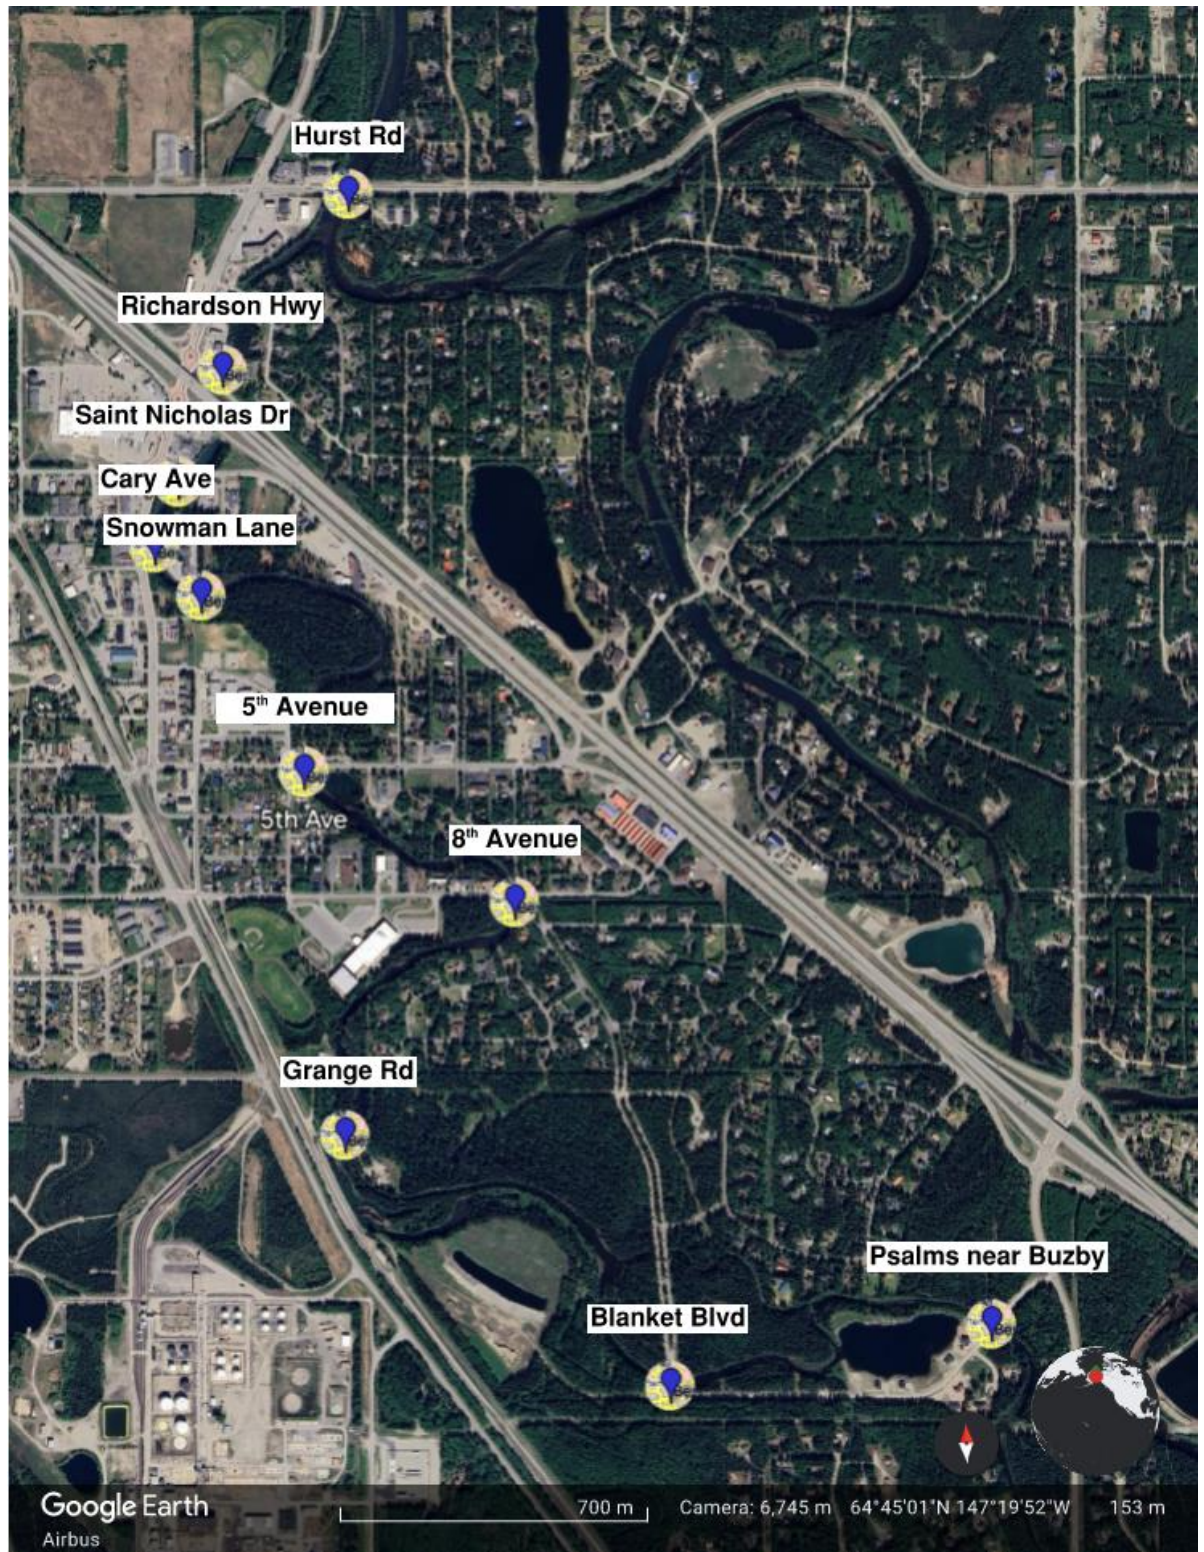
Figure 1 – Location of 10 Thirtymile slough culverts

The culverts shown in Figure 1 were visited and a summary of the observations is presented in Table 1 below. One item of note was the abundance of fish and waterfowl in the slough and traveling through the culverts.

<u>Location</u>	<u>Diameter</u>	<u>Depth of flow</u>	<u>Notes</u>
1	<u>Psalm Blvd near Buzby Rd</u>	Two 6' x 4' pipe arches w/ end sections	3'	Good condition – no deformation or settlement observed
2	<u>Blanket Blvd near Psalm Blvd</u>	7' & two 3'	3.5'	Good condition – slight vertical settlement and slight circular deformation
3	<u>Grange Rd</u>	8' multi-plate	3.7'	Good condition – slight vertical settlement and slight circular deformation
4	<u>East 8th Avenue near Blanket Blvd</u>	6' thin-wall multi-plate	1.5'	Replacement needed, culvert is deteriorating (rusting out and separated seams near inlet), and road is settling overtop on south side of 8 th .
5	<u>East 5th Avenue near Davis Blvd</u>	6'	1.5'	Replacement needed; culvert is flattening on the upper quadrant on the east side which could lead to failure
5SD	<u>East 5th Avenue storm drain near Davis Blvd</u>			Clogged with sediment
6	<u>Snowman Lane near City Hall</u>	6'	3'	Good condition – slight vertical settlement and slight circular deformation
