SUBJECT: Ekwok, Alaska Flood Survey Field Trip Report

1. On 16 October 2002 Mr. Jim Fuhrer and I traveled to Ekwok, Alaska to document the peak water surface elevation of the May 2002 ice jam flood at that community. The work was performed under Federal Emergency Management Agency Project Number SN00157N2002T of DR-1423-AK.

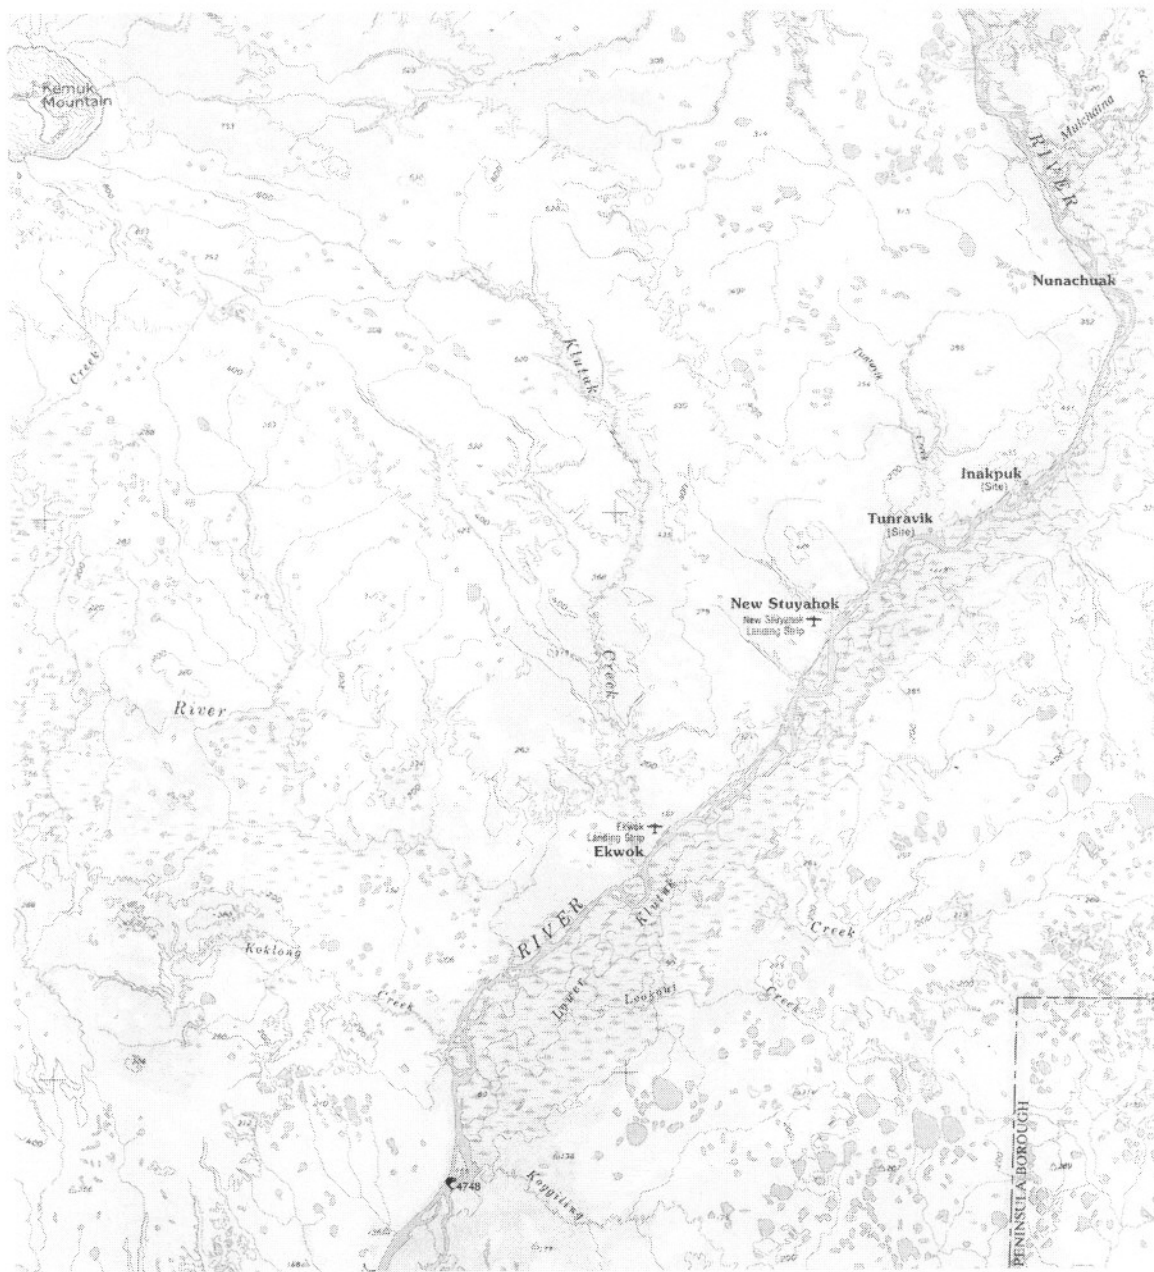
Figure 1. A local vicinity map of Ekwok, Alaska.

2. Ekwok is an Alaskan Native community of 130 located on the right bank of the Nushagak River, 43 miles northeast of Dillingham, and 285 miles southwest of Anchorage. The general vicinity of Ekwok is shown in figure 1. Figure 2 is a map of the community.
