95% Draft Preliminary Engineering Report Water Treatment Plant and Washeteria Tununak, Alaska

March 13, 2020

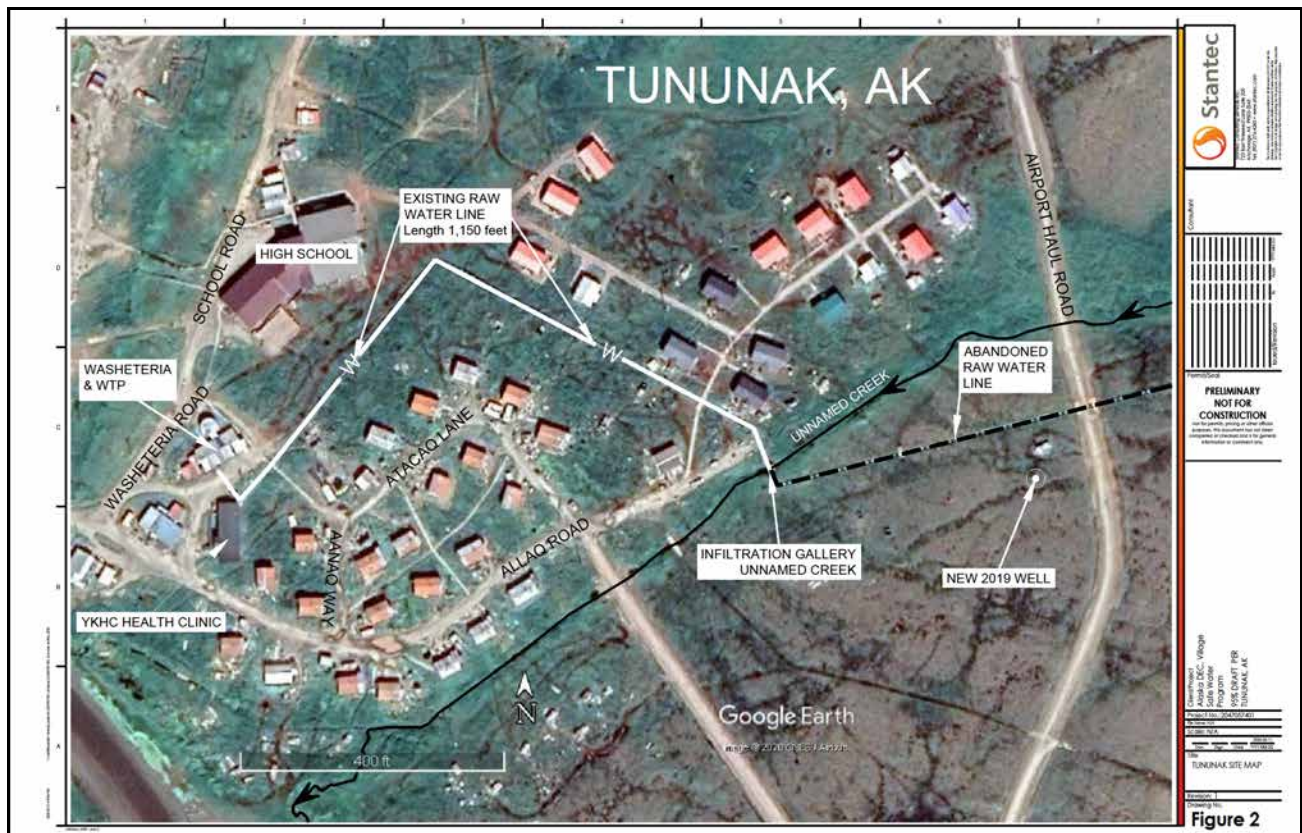
Figure 2 Tununak Existing Facilities Site Map

- Wastewater from the existing washeteria is discharged into the existing sewer drain connected to the septic tank system that is no longer shared with the LKSD Paul Albert High School. The approximate location of the washeteria sewer line and septic tank system is shown on Figure 2.

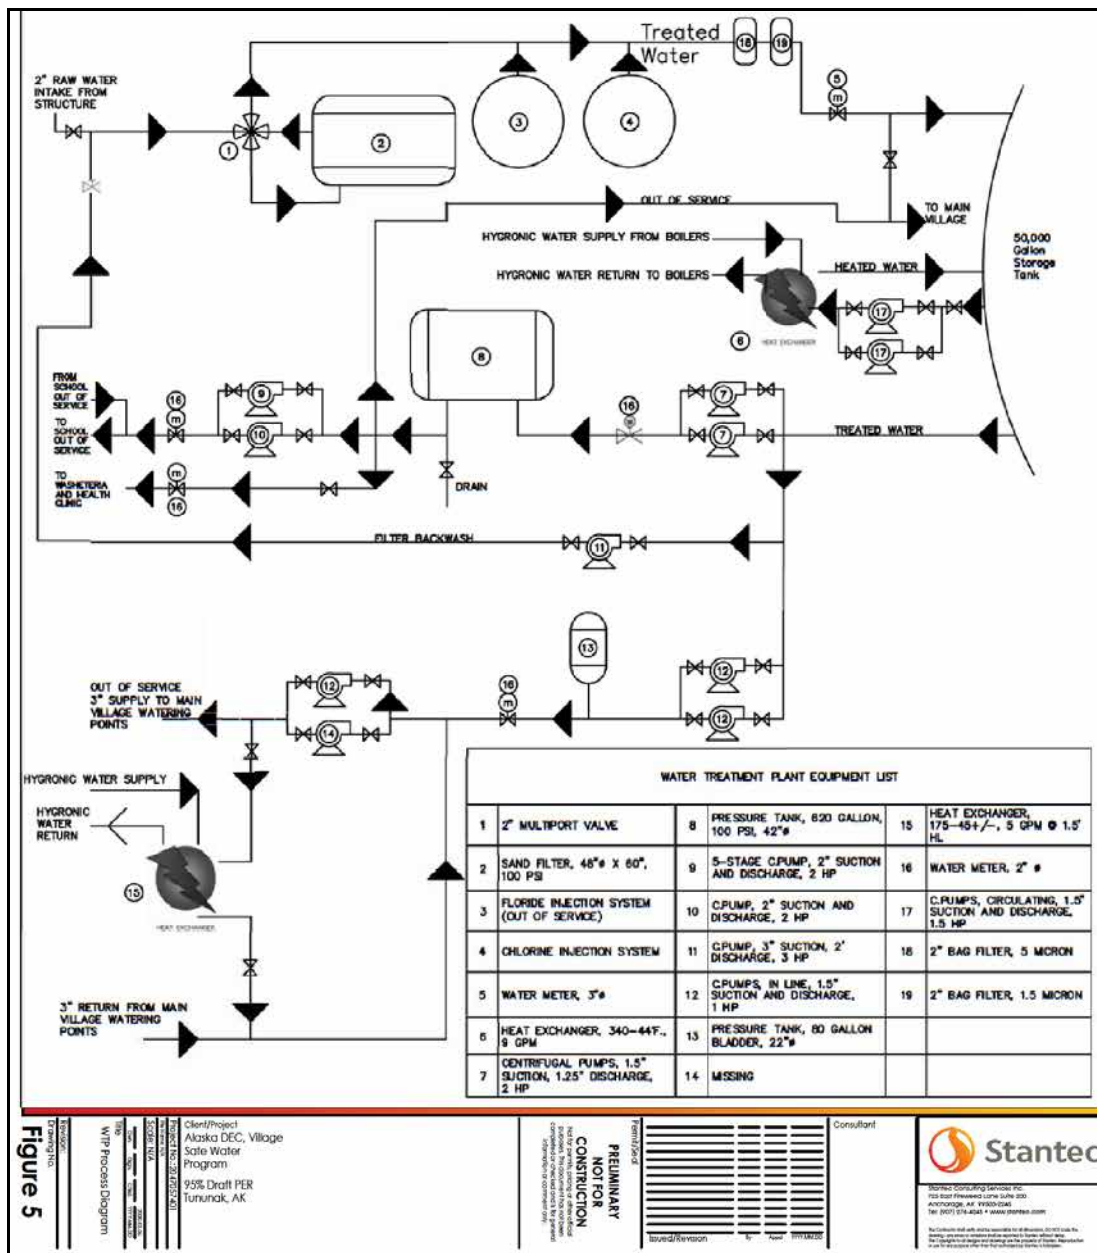
Figure 5 Process Flow Diagram of Water Treatment Plant

Figure 4, Existing Facilities Map under Section 4.1.3, shows the layout of Alternative 2. Figure 5 presented below provides a Process Flow Diagram for the replacement water treatment plant – the treatment process would be designed and altered to comply with the water treatment requirements for a surface water source and will only include one service to the neighboring health clinic.

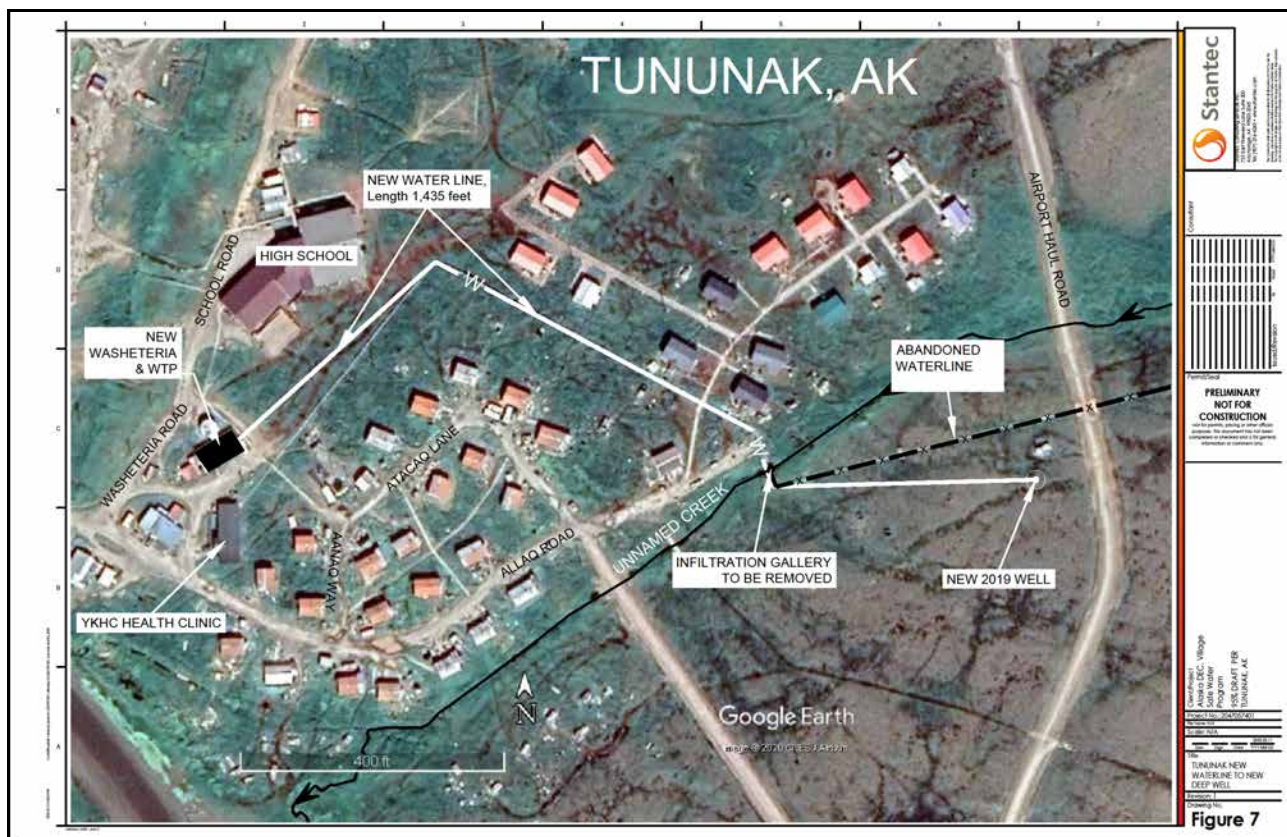
Figure 7 Alternative 3: New Waterline to Deep Well

Figure 7 is a site plan layout of the connection to the new deep water well and proposed alignment of the replacement water transmission line is shown in aerial view on Figure 2.
