Property Assessment and Cleanup Plan
Mile 13-14 Copper River Highway

Cordova, Alaska

Submitted to: Department of Environmental Conservation Reuse and Redevelopment Program

> By: Shannon & Wilson, Inc. 5430 Fairbanks Street, Suite 3 Anchorage, Alaska 99518

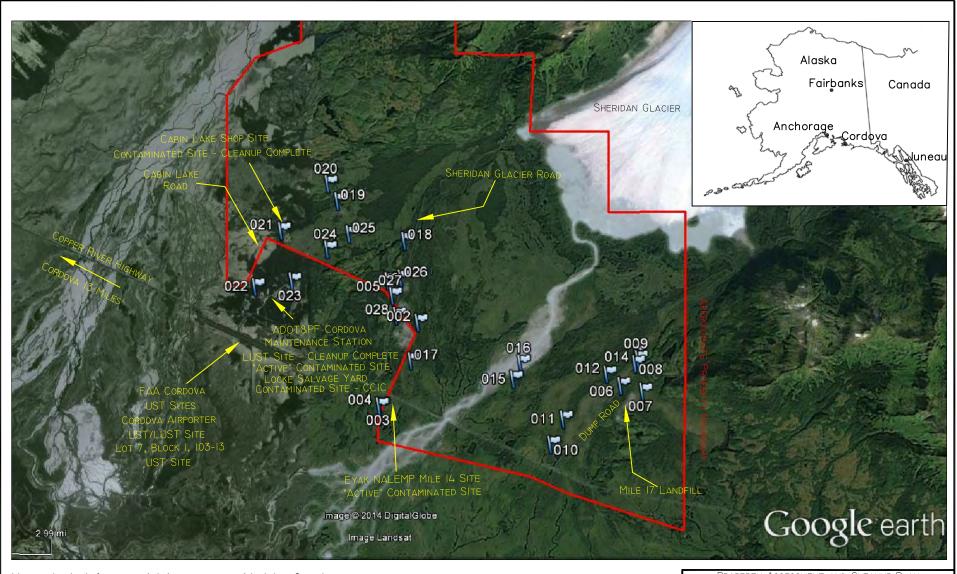
FIG. 2

Flags correspond with areas of concern identified during Shannon & Wilson's 2014 field activities (See Table 4). Note, Sites 001 through 005 were used as markers to establish Property boundaries and are not areas of concern.

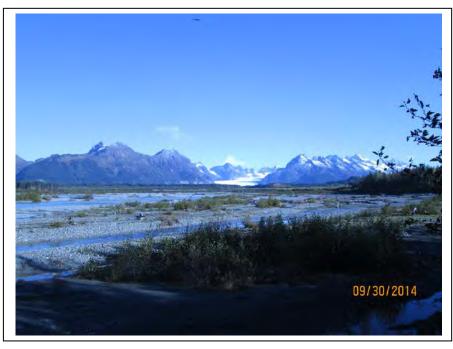
The Property is largely located north of the Copper River Highway and extends to the mouth of the Sheridan Glacier (Photo 1). For the purposes of our assessment, the Property was divided into several subsections: the Cabin Lake Road area, the Sheridan Glacier Road area, the Dump Road area, and the Mile 14 site. Figures 3 through 5 are aerial photographs of each area. Site photographs are provided in Appendix A. Field notes from the site visit are included in Appendix B.

Photo 1: Center of the Property, looking north at Sheridan Glacier from the Copper River Highway. (September 30, 2014)

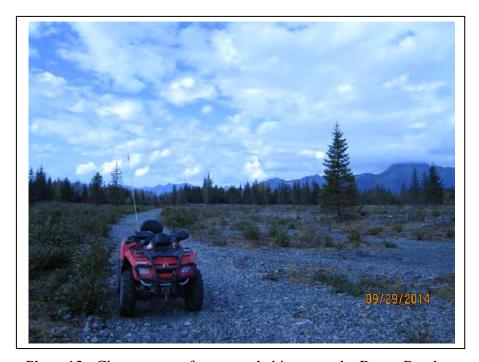
Photo 12: Clear cut area for moose habitat near the Dump Road, looking northwest. (September 29, 2014)

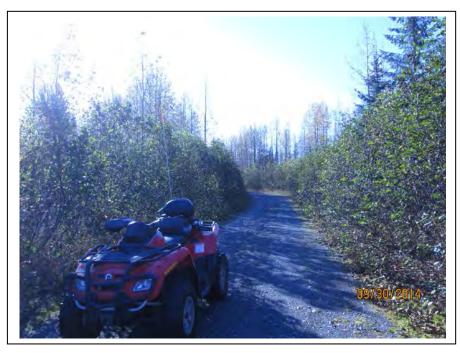
Photo 13: ATV trail near the Dump Road. (September 30, 2014)
