¹ Southeast Alaska Watershed Coalition, project #ACWA-23-05 funded by Alaska DEC from an EPA pass through grant

Summary

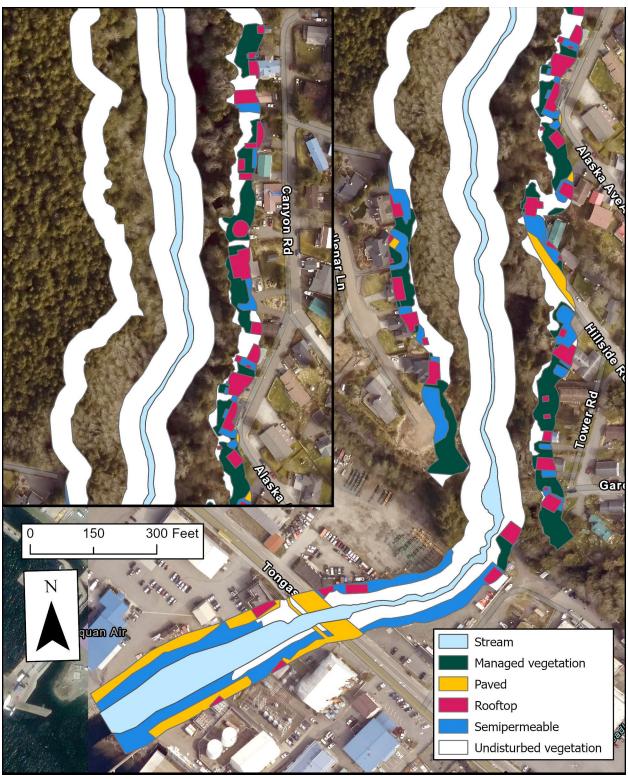
The riparian buffer directly adjacent to Carlanna Creek is mostly intact, as its steepness precludes most development (Figure 4). Within the 50-foot riparian buffer, most development is in the most downstream portion (Figure 4). In total, 22% is developed, including just 9% impervious surfaces (pavement, rooftops) and 12% pervious cover (Figure 5).

Figure 4. Land cover in the riparian buffer and terrace buffer of the lower and upper (inset) portions of Carlanna Creek. Buffers extend 50 feet from the stream bank or terrace edge.

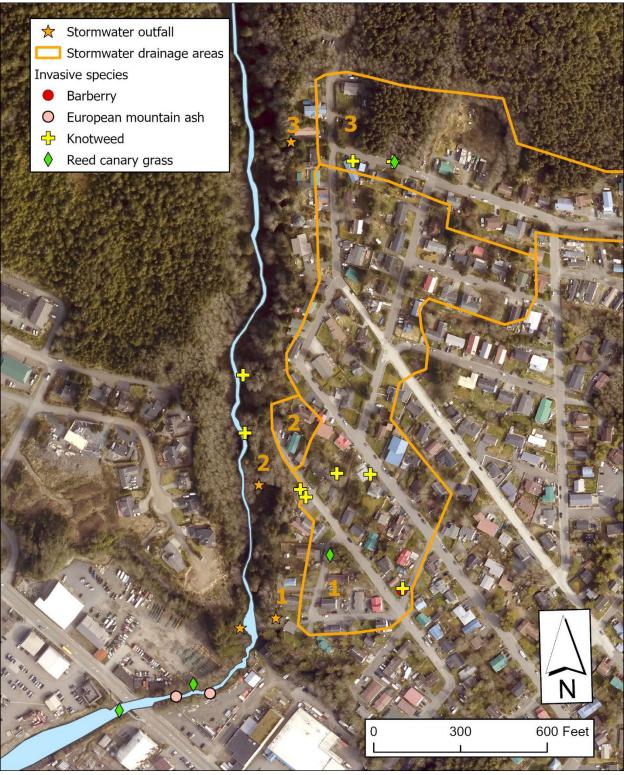
Despite limited development directly adjacent to the stream, knotweed, a highly invasive species that spreads vegetatively by rhizomes (pieces of root or stems) was documented in the riparian area (Figure 6). The most upstream mapped location of knotweed is a very large patch (at least 50 by 100 ft) that extends up the slope on river left and has established on river right as well (Figure 7). There are documented knotweed patches in the neighborhood on river left, and the infestations in the riparian area may have been spread by yard debris that was dumped or via stormwater carrying pieces of knotweed.

Figure 6. Locations of stormwater outfalls and approximate contributing areas (numbered), and locations of invasive species along Carlanna Creek and in the neighborhood to the east (neighborhood invasive species inventory was not comprehensive). The contributing area for the outfall on river right was not mapped.

- Invasive plant survey and management; especially knotweed, including along the stream and in the neighborhood area on the east side of Carlanna creek.
- Restore damaged riparian vegetation in the downstream developed areas and on steep slopes to prevent erosion (Figure 9).
- > Education and outreach about not dumping yard waste into the riparian area.
- Establish a setback from the terrace edge for any future development.
- > Potential stormwater BMP project (requires additional vetting for feasibility and efficacy):
 - Explore stormwater BMP opportunities for parking lot runoff on the property NW of Tongass Ave., including enhancing the riparian area and/or the drainage ditch (Figure 9).

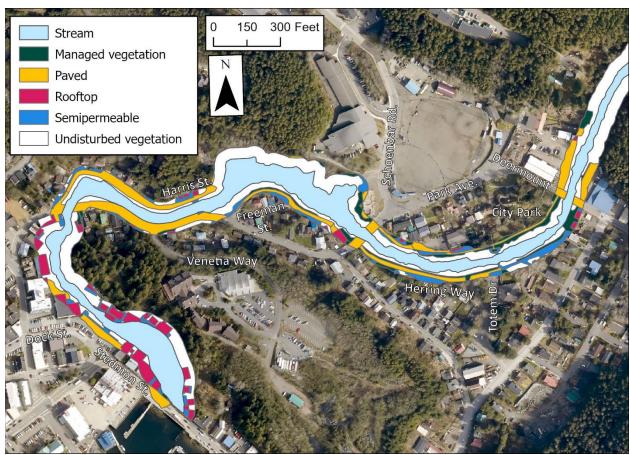
An estimated 50% of the 50 foot riparian buffer along the urban stretch of Ketchikan Creek, from Stedmon St. to upstream of the Ketchikan Public Utilities facility north of Deermount St., is developed (pavement, rooftop, semi-permeable, and managed vegetation like lawns), with 33% impervious surfaces (pavement, rooftop) and 9% semi-permeable cover (Figure 25, Figure 26). Within the first 25 feet, 35% of the cover is developed, including 24% impervious surfaces (Figure 26). Some areas of the creek have development right up to the bank, especially in the lower reaches, while others have only narrow strips of vegetation remaining. The most intact areas include the natural area on the north side of the creek between the Harris St. bridge and Park Ave., and through City Park (Figure 25).

Figure 25. Land cover in the 50-foot riparian buffer of Ketchikan Creek.

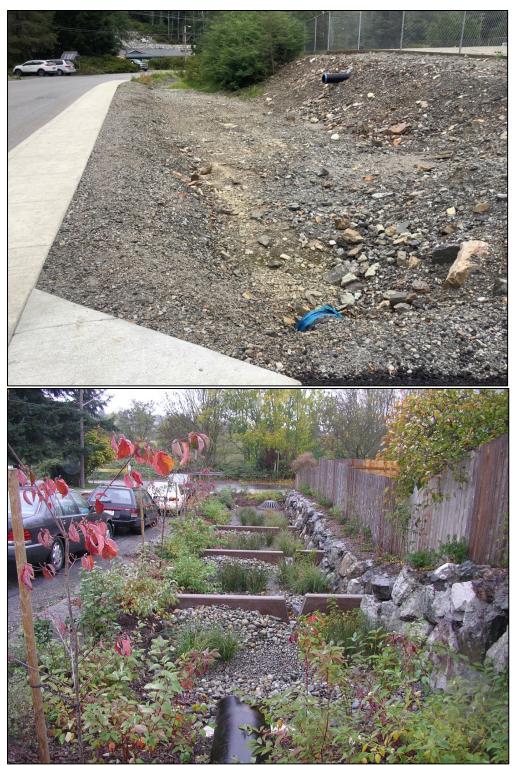
Figure B.3. Top: Unvegetated gravel ditch along the south side of Schoenbar road that could be upgraded with check dams, vegetation, and curb cuts to intercept, infiltrate and treat stormwater runoff. Bottom: Example of a biofiltration swale equipped with check dams to slow water movement from one cell to the next that could replace the gravel conveyance ditch picture above. An elevated overflow drain at the bottom of the feature (upper middle) prevents localized flooding if inflows exceed infiltration capacity.

- Existing long sloped gravel trenches that currently function primarily as runoff conveyance structures, such as along Venetia Way and Schoenbar Rd (Figure B.3.).
- Existing vegetated areas that already or could receive stormwater runoff, such as
 the vegetated stormwater ditch in the Totem Heritage Center parking lot, and
 between Schoenbar Way and Schoenbar Creek in front of the charter and middle
 schools.

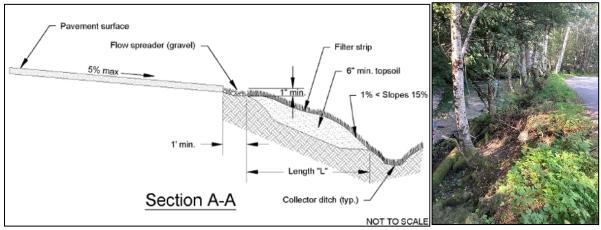
Figure B.4. Left: Side view of a vegetated filter strip design, with flow spreader between pavement and vegetation (SWMMWW). Right: Riparian strip along Herring Way where runoff treatment could be protected/enhanced and erosion reduced by including a flow spreader and restoring native vegetation.

Existing riparian/vegetated areas directly adjacent to roads or parking lots, including
Herring Way, Freeman St. alley, and the parking lot NW of Tongass Ave and Carlanna
Creek. Some of these areas suffer from erosion due to gully formation and social trails,
and flow spreaders could help ensure runoff is more uniformly distributed into the
riparian vegetation and reduce erosion.

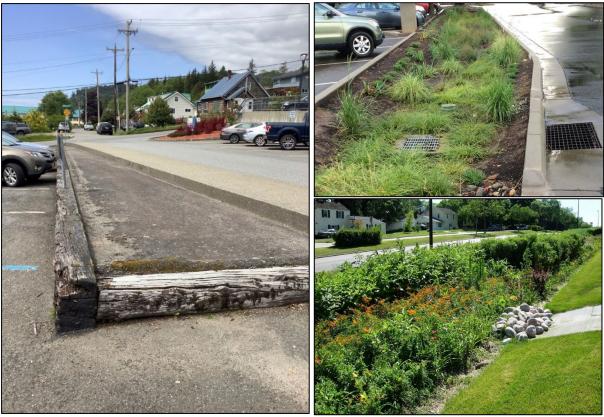
Figure B.5. Left: Unused paved area in office complex parking lot on Carlanna Lake Rd. that could be converted to an infiltration basin or bioswale to capture and treat stormwater runoff from the upper parking lot and/or part of the lower lot. Top right: Example of an infiltration basin that accepts parking lot runoff via curb cuts. Bottom right: Example of a bioretention cell (SWMM LID Controls).

- Existing relatively large flat, unused gravel/paved areas along parking lots and roads, including in front of Houghtaling Elementary School, and 130 Carlanna Lake Rd office complex parking lot (Figure B.5.).
- Existing relatively flat vegetated areas that could accept stormwater runoff, such as downslope side of Baranof Ave by Hoadley Creek.
