GROUND WATER INVESTIGATION

Tanana, Alaska

November 1996

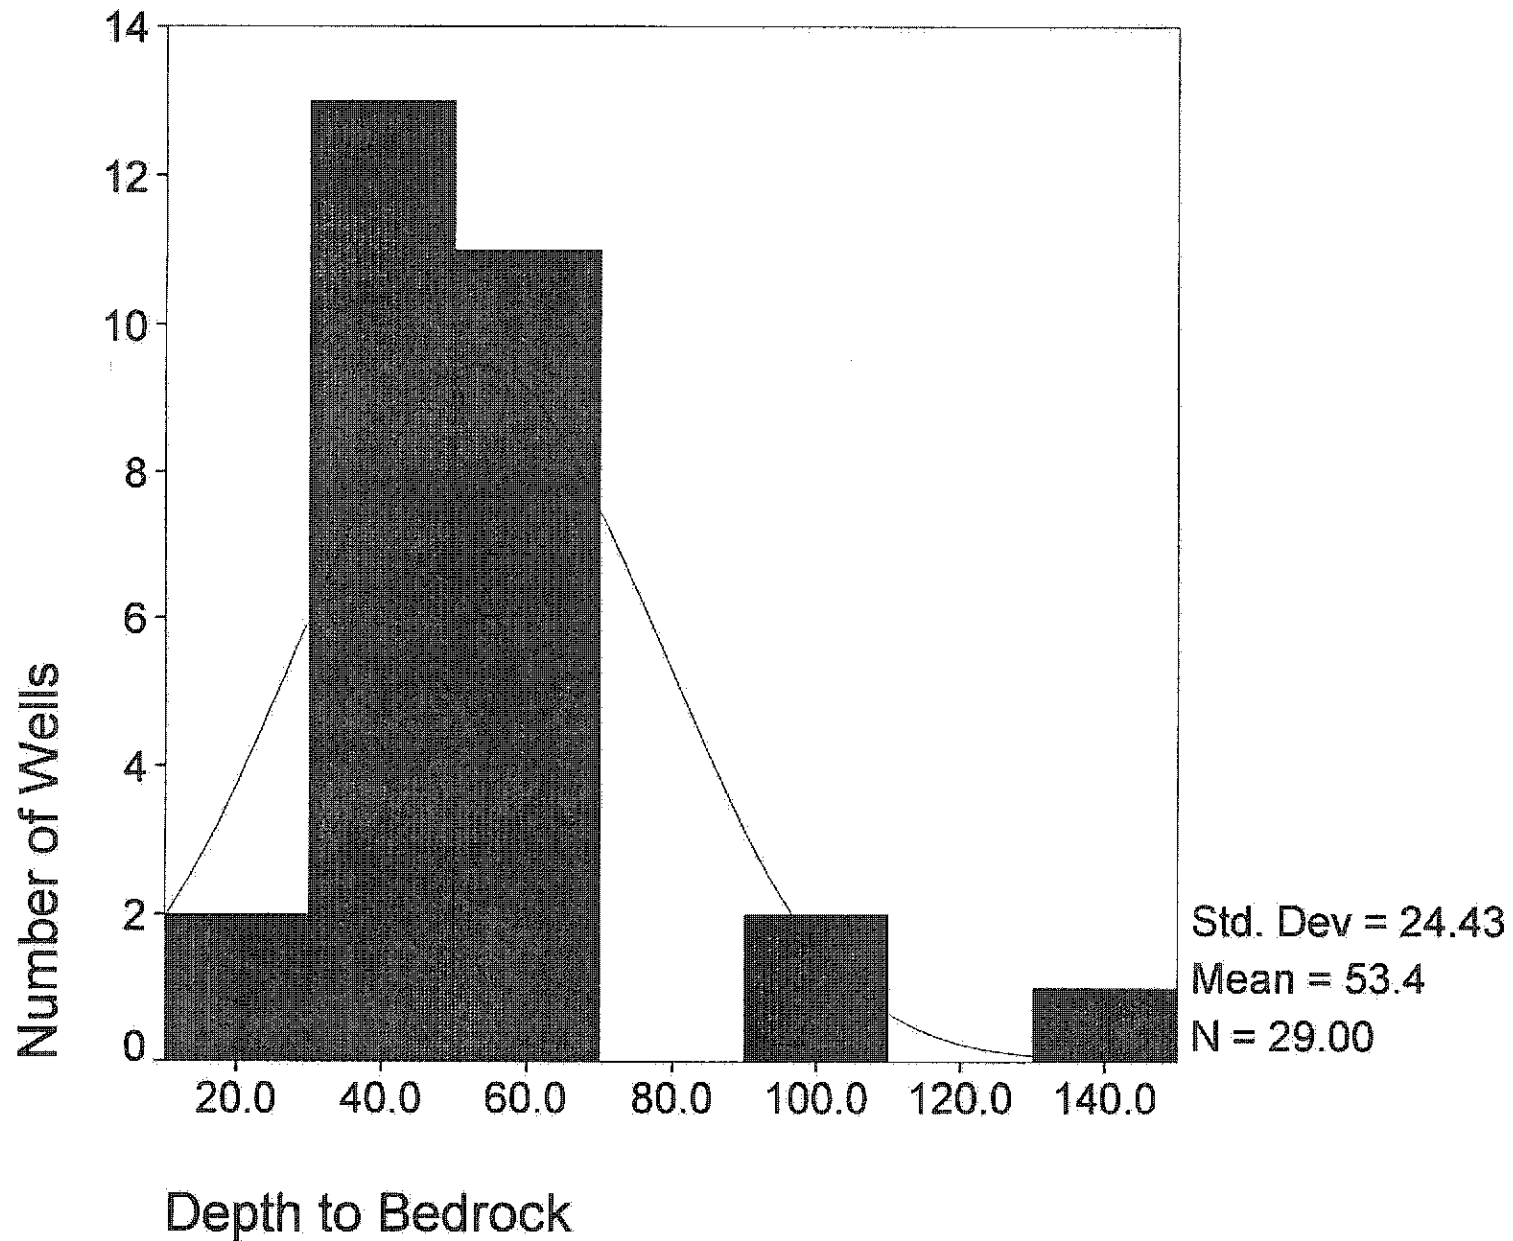
FREQUENCY DISTRIBUTION OF DEPTH TO BEDROCK

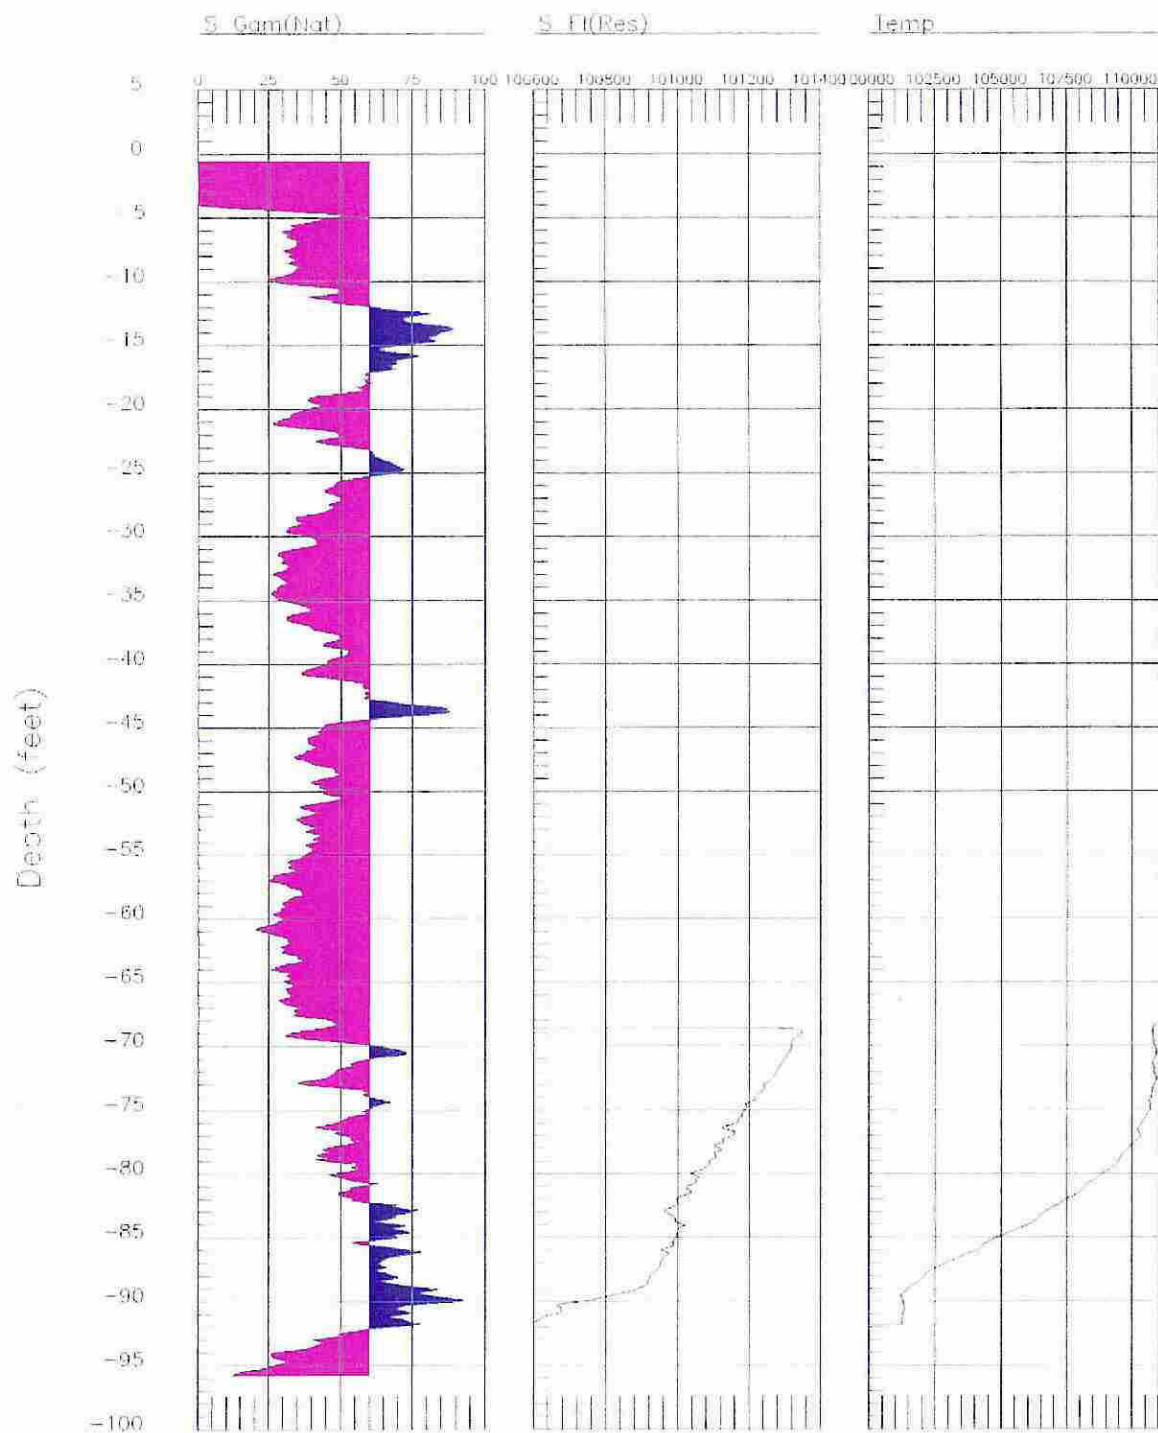
Well Name: Native Council Well
File Name: COUN-DN1
Location: Tanana, Alaska
Elevation: 0 Reference: Ground Surface

The stratigraphy in Tanana is highly variable. Wells less than 100 feet apart show little to no correlation. An example of this is the very poor correlation between the School Well and the Native Council Well shown in the geophysical well logs (APPENDIX B). This degree of variability, however, appears to be controlled by local features existing within a larger, fairly consistent sedimentary sequence. Our simplified stratigraphic model of the area contains four major units. We combine the top two units of FIGURE 2 because the constraints of the equipment used in well logging cause data near the top of the well to be less accurate. Results from well logging show that five of the seven wells have similar stratigraphic sequences. APPENDIX B contains the well logs from the geophysical well logging.

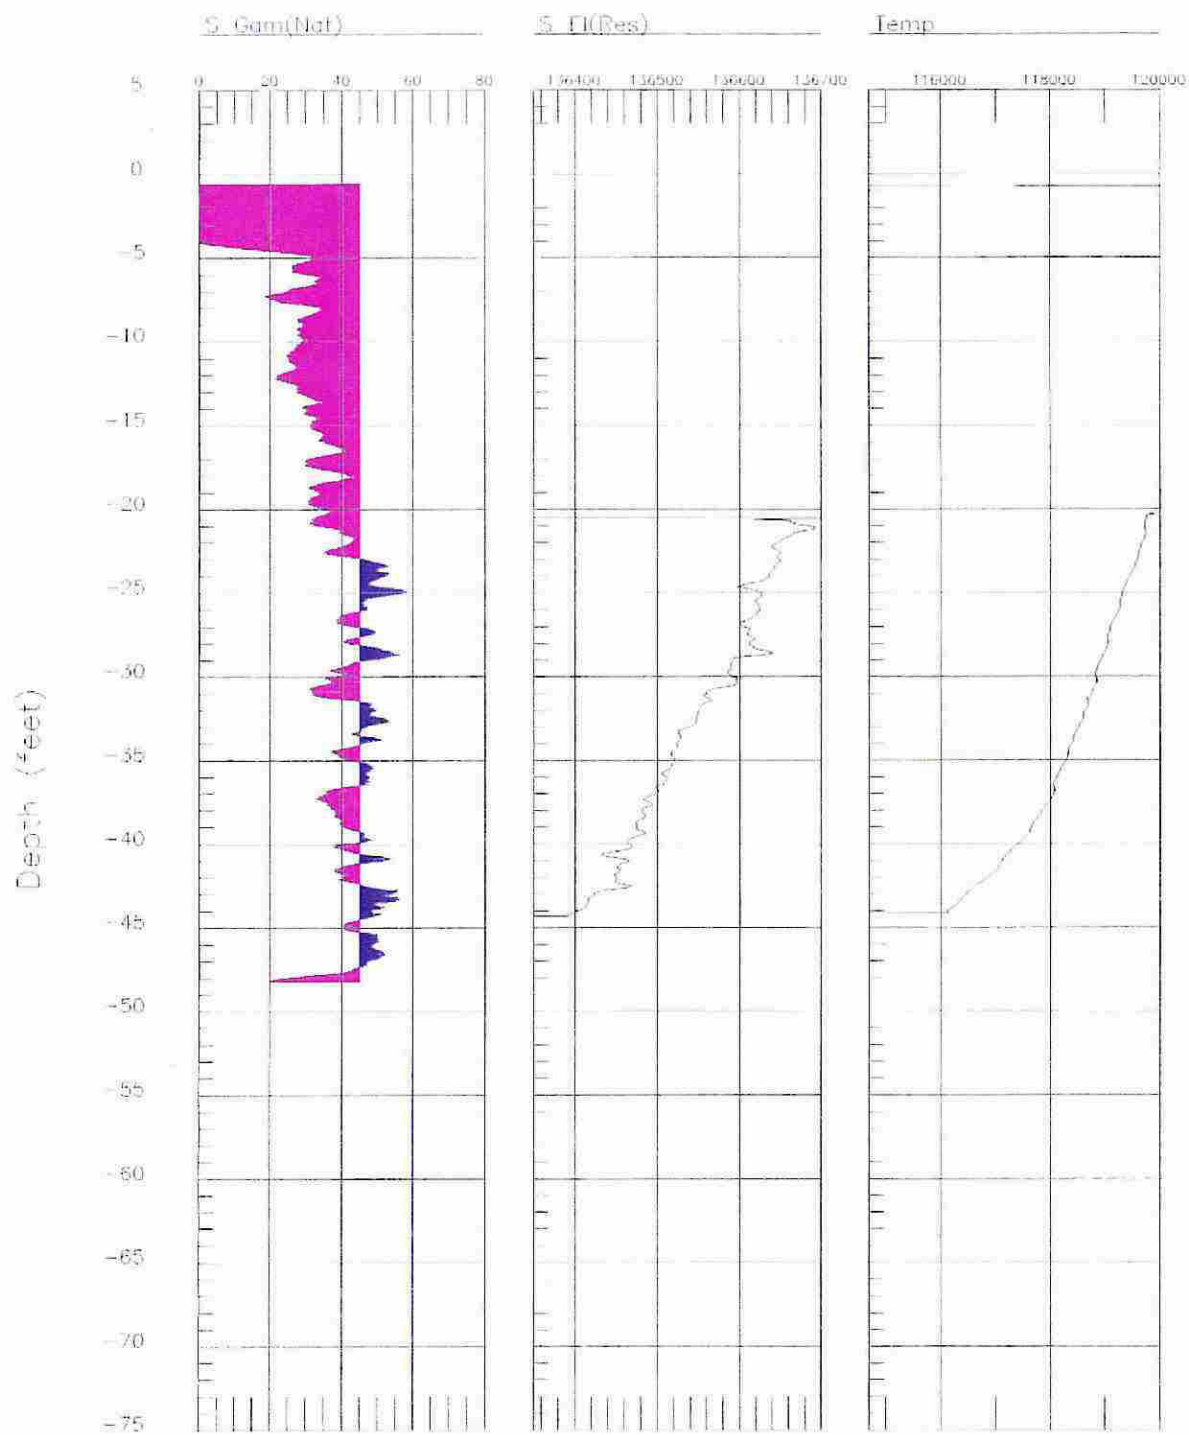
Well Name: Josephine's Well
File Name: JOSE -DN1
Location: Tanana, Alaska
Elevation: 0 Reference: Ground Surface

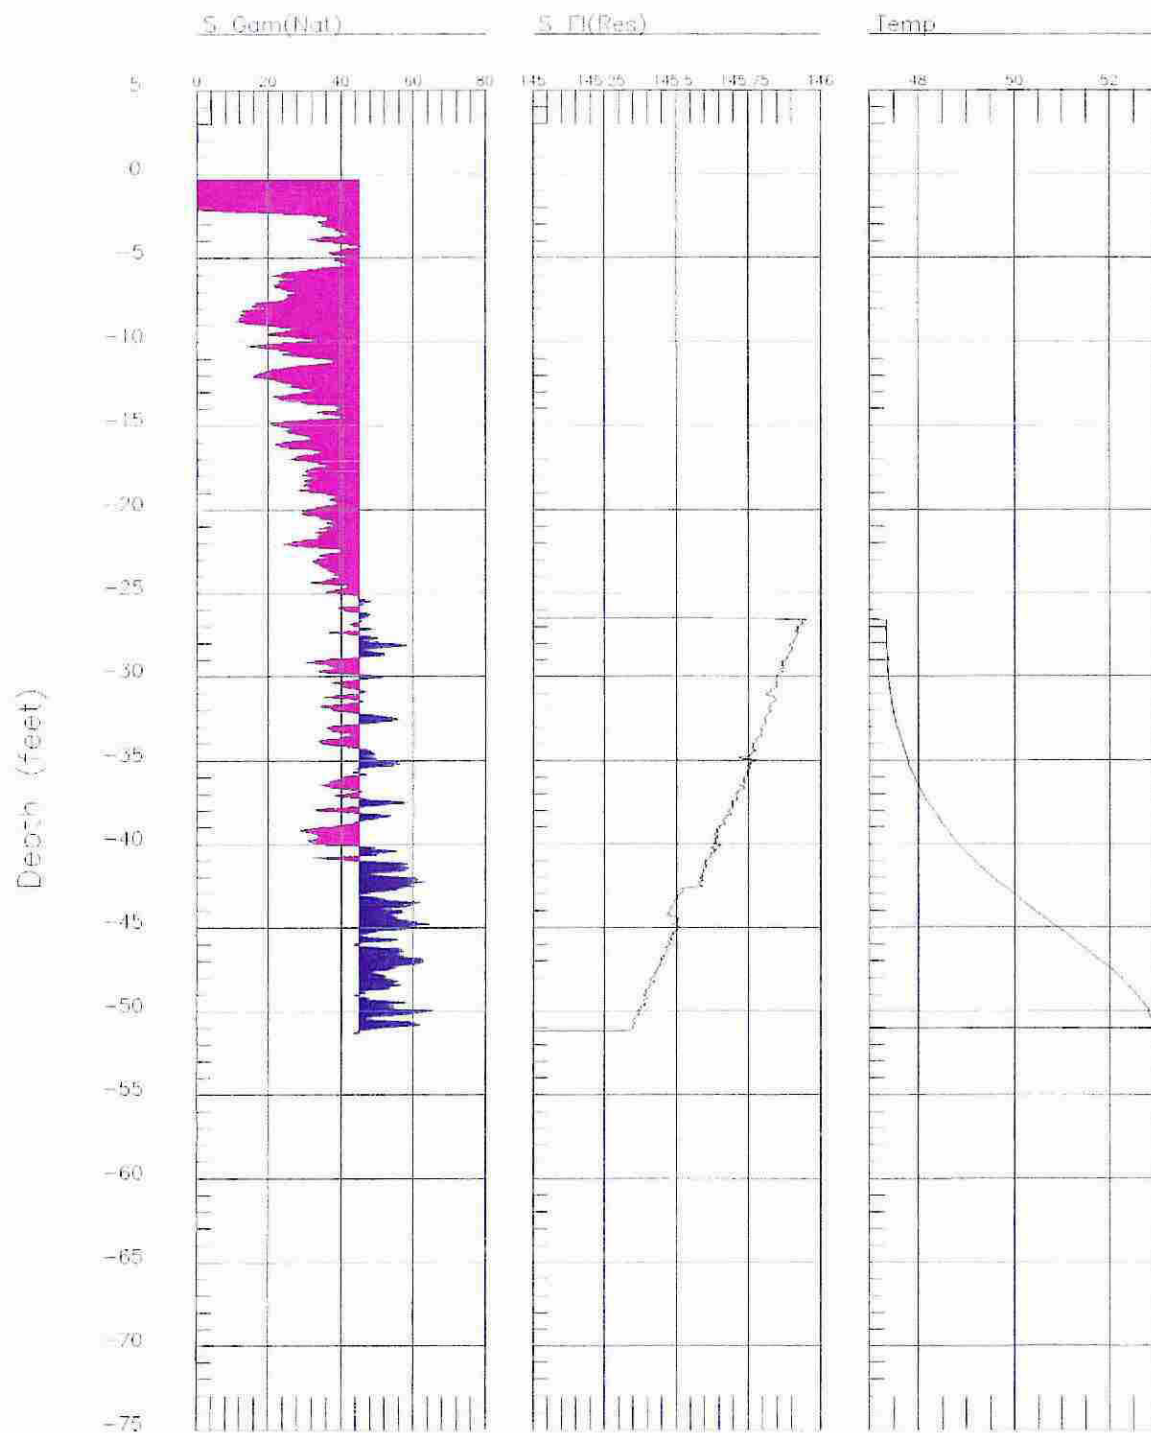
Well Name: Schoof Well
File Name: SCH00-BN1
Location: Tanana, Alaska
Elevation: 0 Reference: Ground Surface

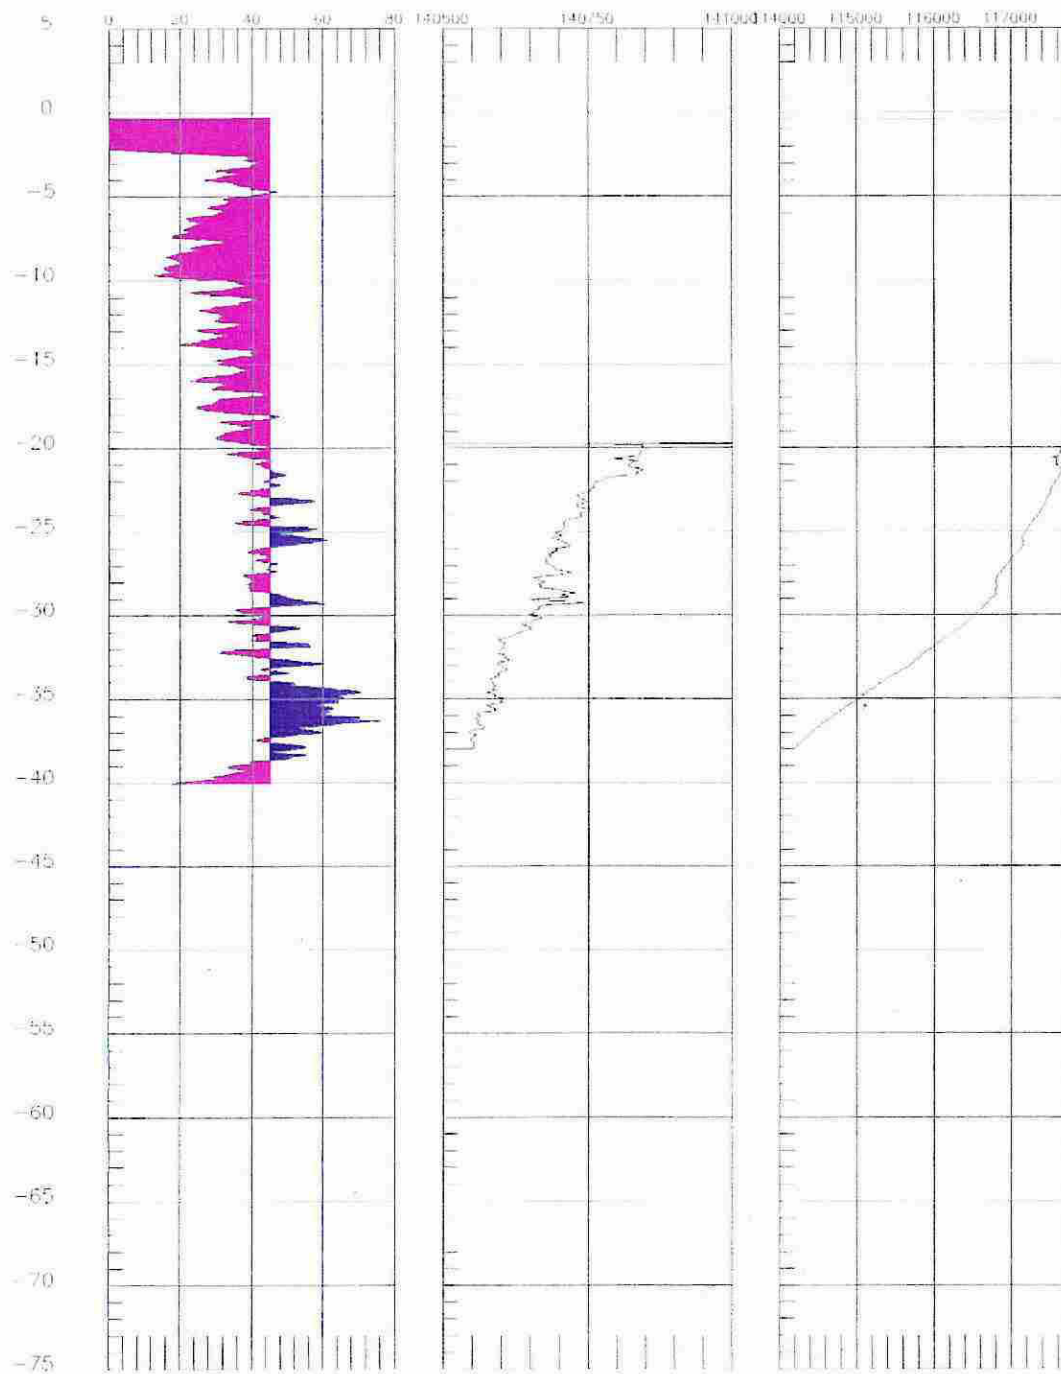
Well Name: School Superintendent's Well
File Name: SUP2.DN1
Location: Tanana, Alaska
Elevation: 0 Reference: Ground Surface

S. Gam(Nat) S. Fl(Res) Temp

Depth (feet)
