Soil Engineering Services  
Episcopal Church Rehabilitation  
Tanana, Alaska

HLA Job No. 9661,001.08

Harding-Lawson Associates  
624 West International Airport Road  
Anchorage, Alaska 99502  
(907) 276-8102

October, 1980

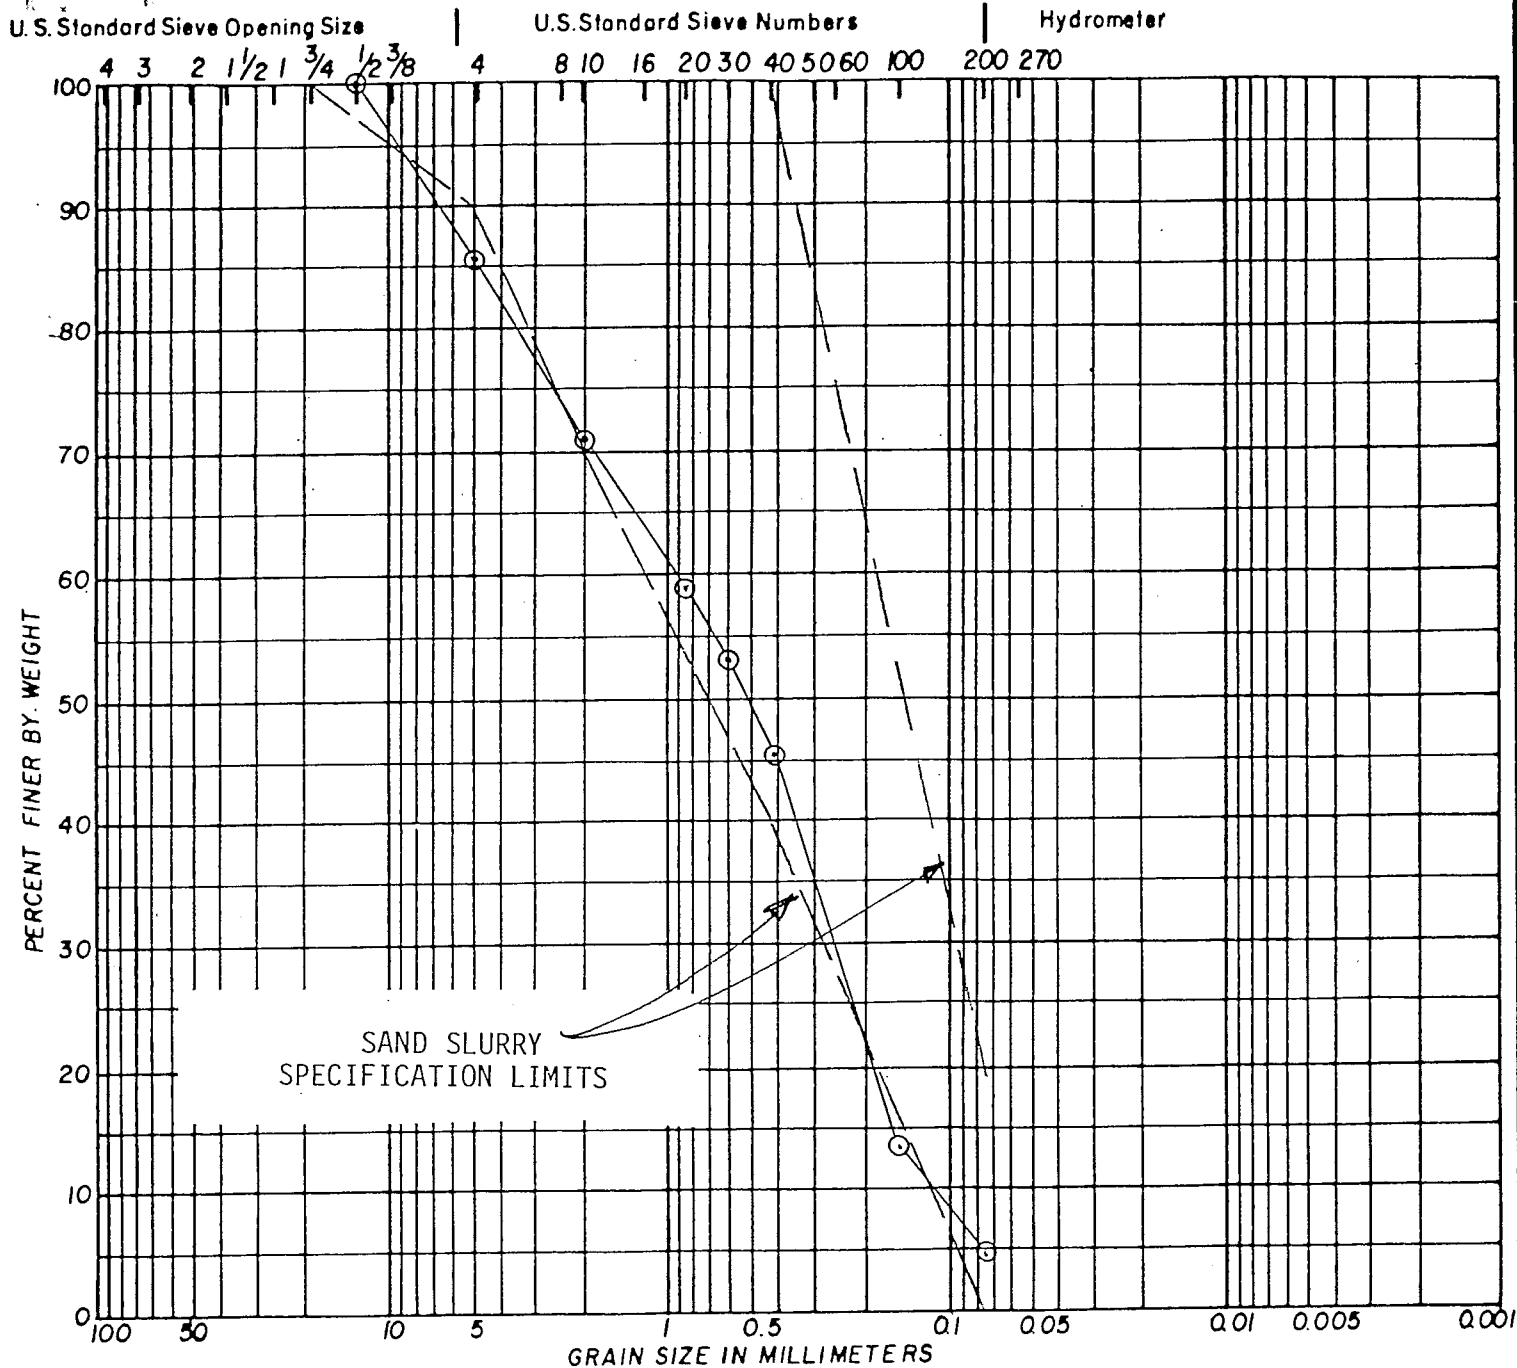
8

COBBLES	GRAVEL		SAND			SILT OR CLAY
	COARSE	FINE	COARSE	MEDIUM	FINE	
Symbol	Sample Source					Classification
⊙	Stockpile (City of Tanana) Sampled By Others					GRAY GRAVELLY SAND (SP)
<b>HARDING - LAWSON ASSOCIATES</b>
