# DUCK CREEK WATERSHED

## Management Plan

Juneau, Alaska  
July 1999

**K Koski and Mitchel Lorenz**  
National Oceanic and Atmospheric Administration  
National Marine Fisheries Service  
Alaska Fisheries Science Center  
Auke Bay Laboratory  
11305 Glacier Hwy., Juneau, Alaska 99801

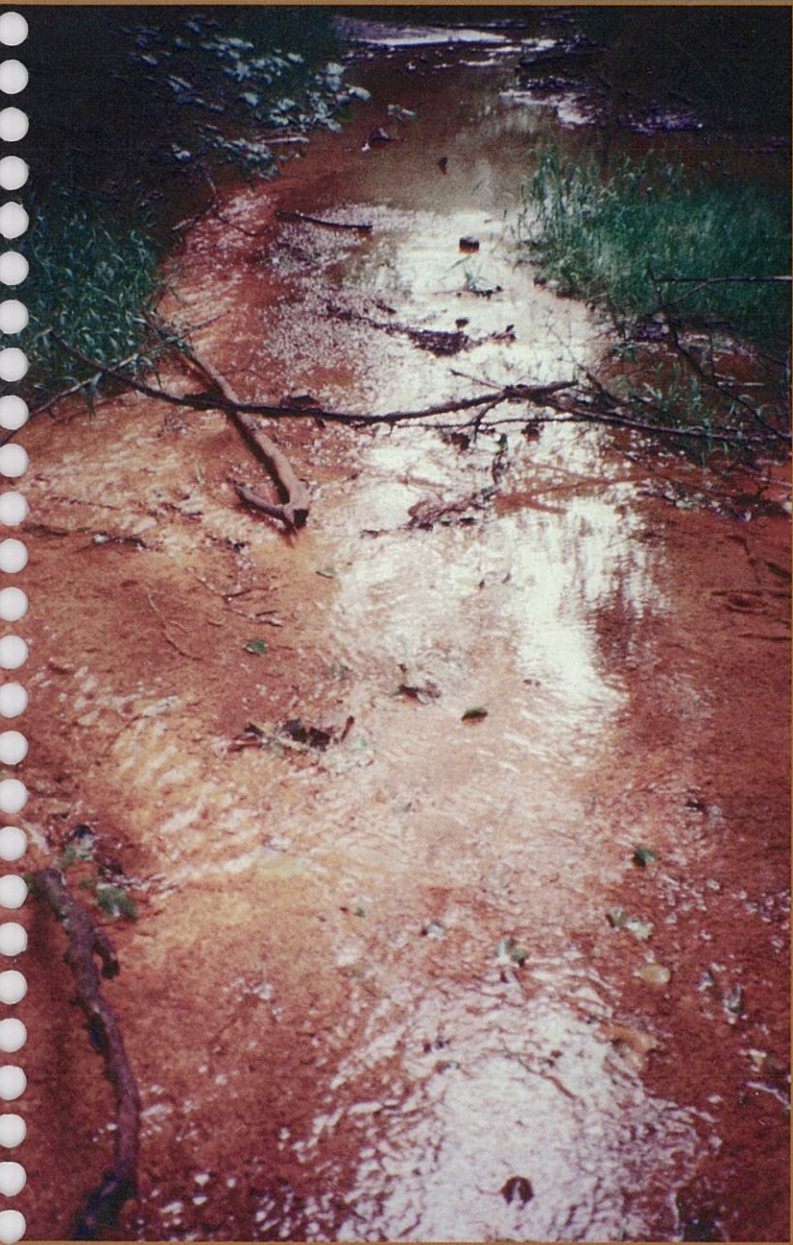
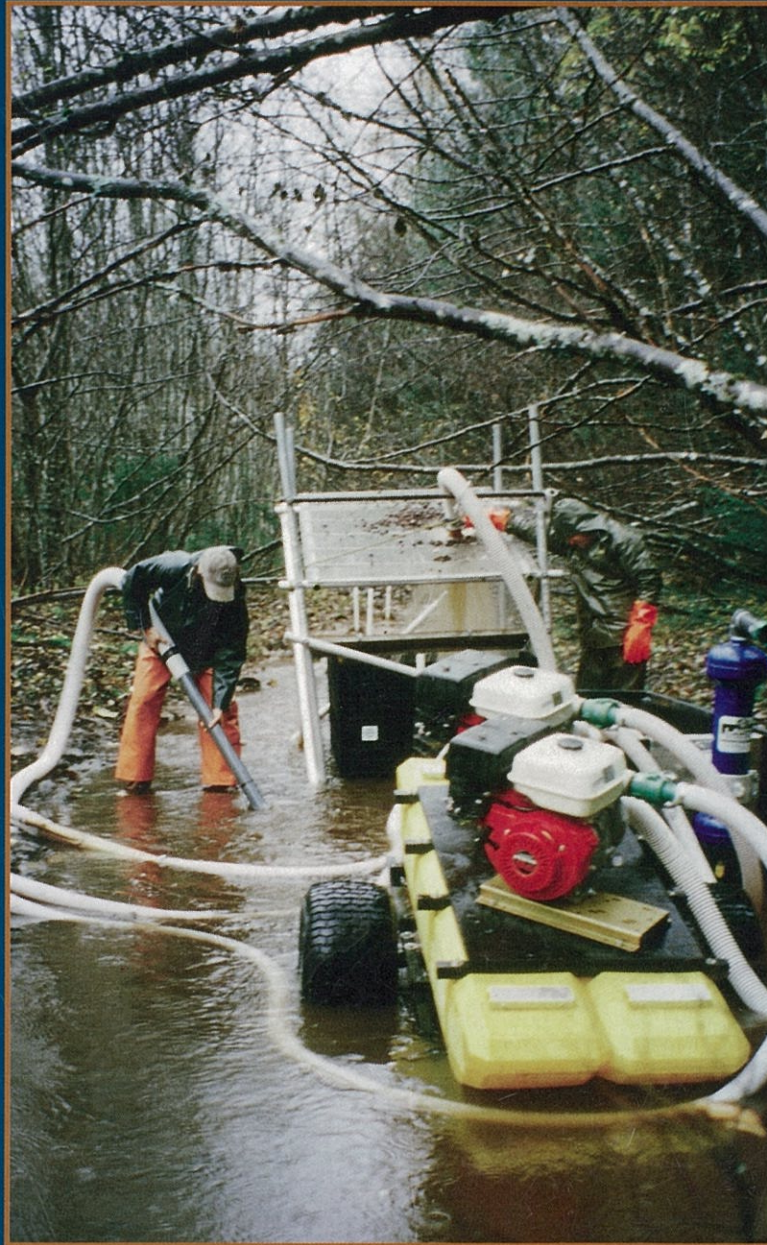
Cover: Sequence of restoring salmon spawning habitat and channel morphology in Duck Creek between Taku Blvd. and Mendenhall Blvd., Juneau, Alaska. Pictured on front cover: left, stream clogged with fine sediment and iron floc from decades of neglect and poor land-use management; right, hydraulic dredge used to remove fine sediment. Pictured on back cover: left, redefined stream channel with clean gravel bottom; right, revegetated floodplain with the redefined channel.

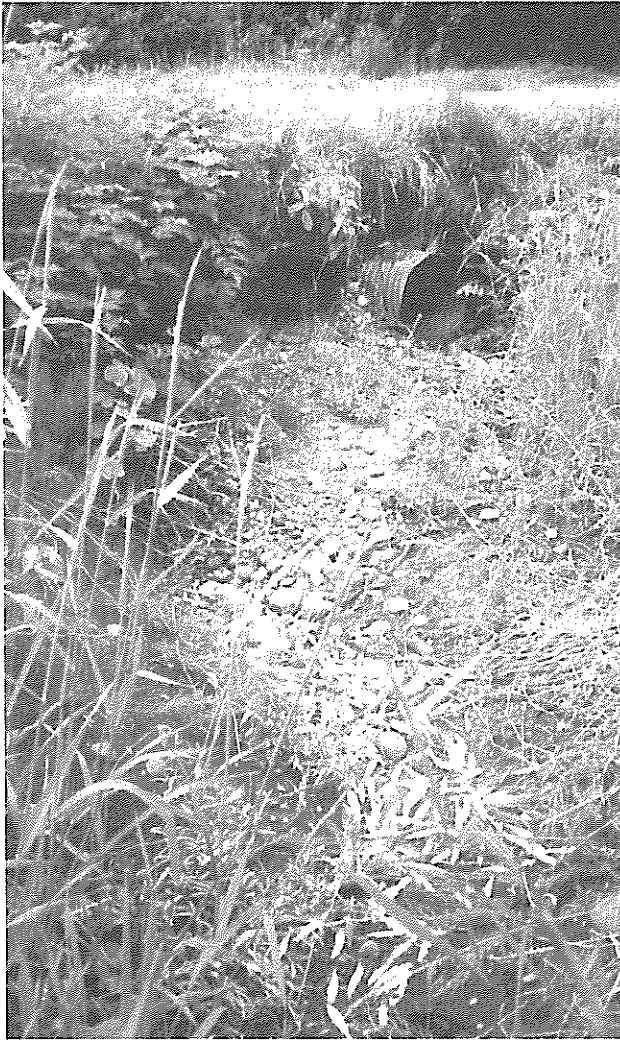
Figure 4 (above).--dead salmon and Dolly Varden stranded by the lack of flow. (Photo by Kevin Brownlee, ADFG).

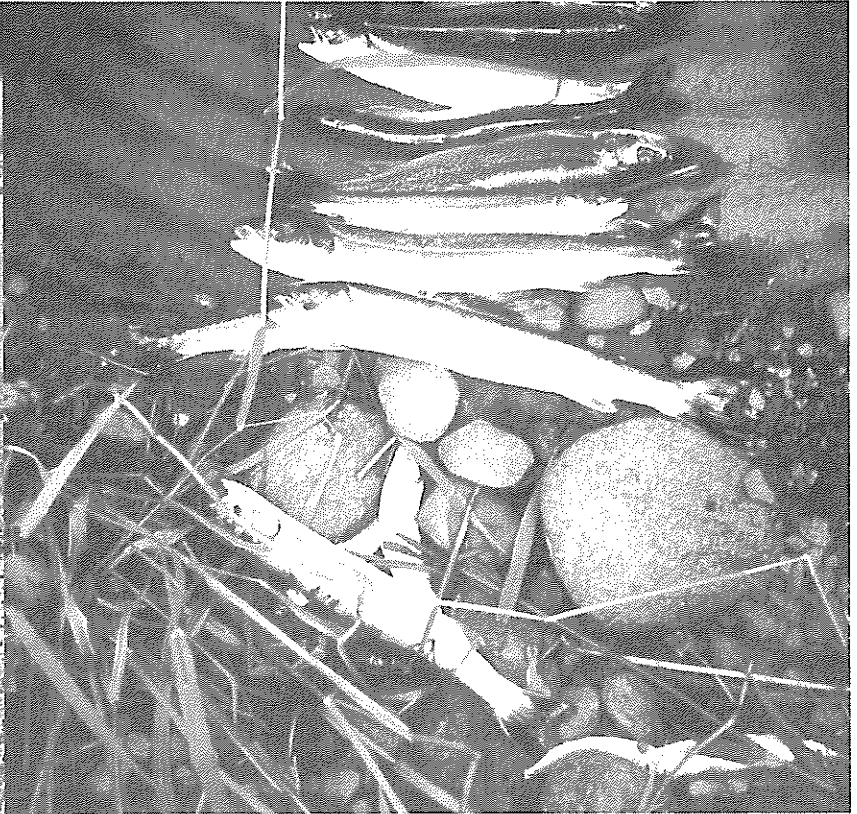
Figure 5 (left).--Lack of flow at perched culvert. (Photo by NMFS).

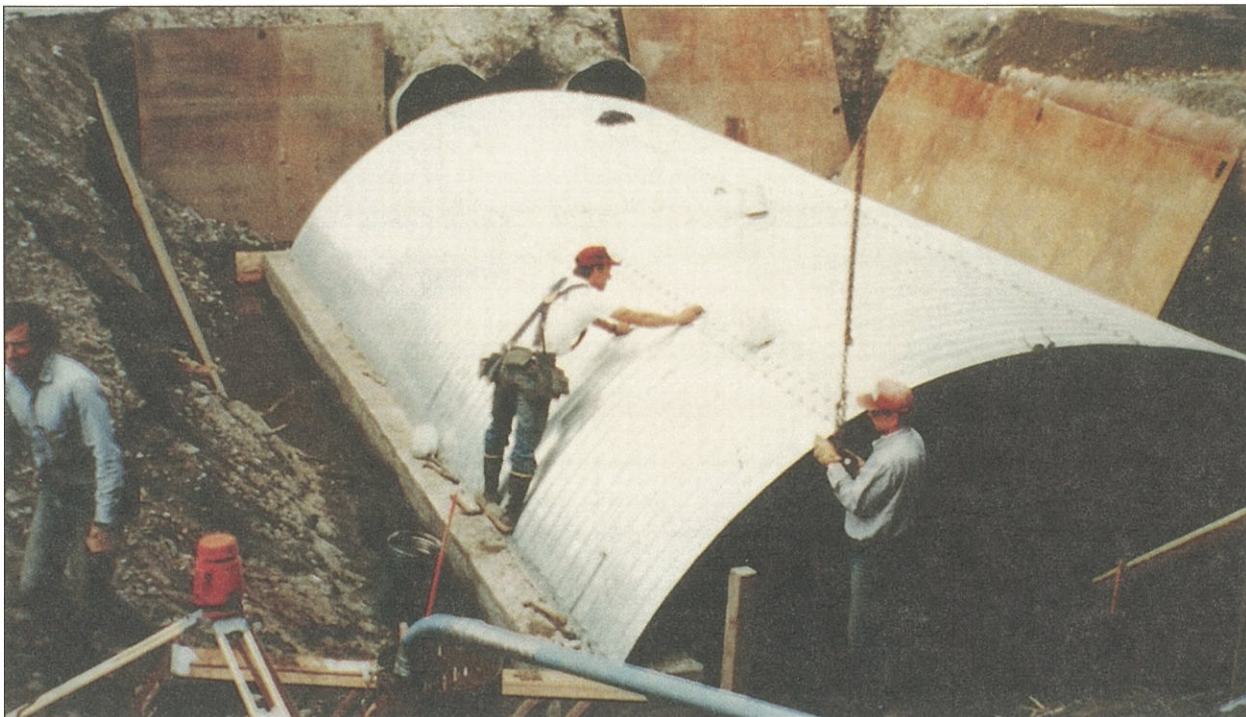
Figure 7.--Perched culverts being replaced with an arch culvert at Stephen-Richards Drive.  
(Photo by Jan Caulfield, CBJ).

crossings has been 15-20% higher than design estimates for culvert crossings. The cost of a 17-ft wide arch at Stephen Richards Drive was about \$65,000 in 1995 and two attractive wood bridges on floating concrete piers were installed in 1998 at \$25,000 each. At a minimum, ten other stream crossings need replacement or improvement so that other restoration work (on fish habitat, streamflow augmentation, and channel morphology) can proceed.

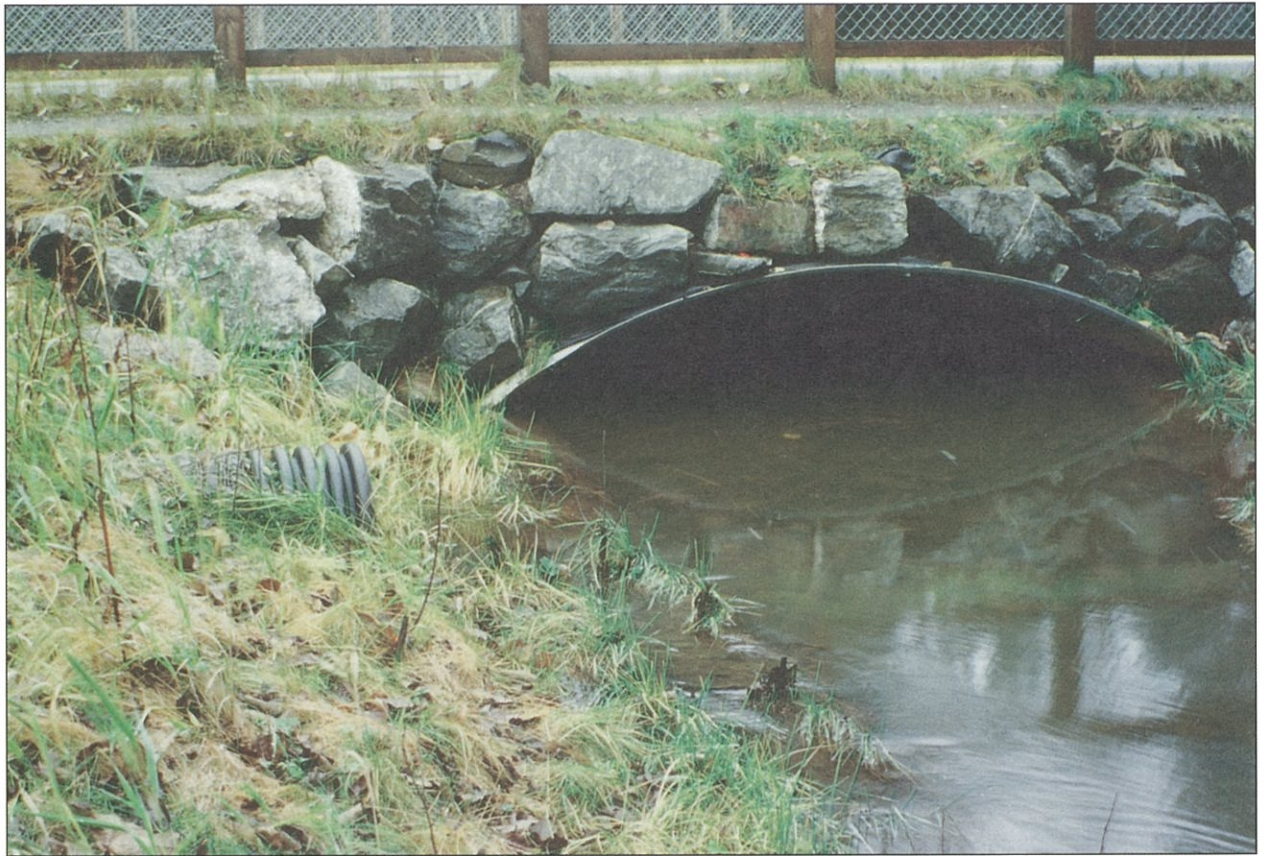
Figure 8.--Water flowing through new arch at Stephen-Richards Drive. (Photo by NMFS).

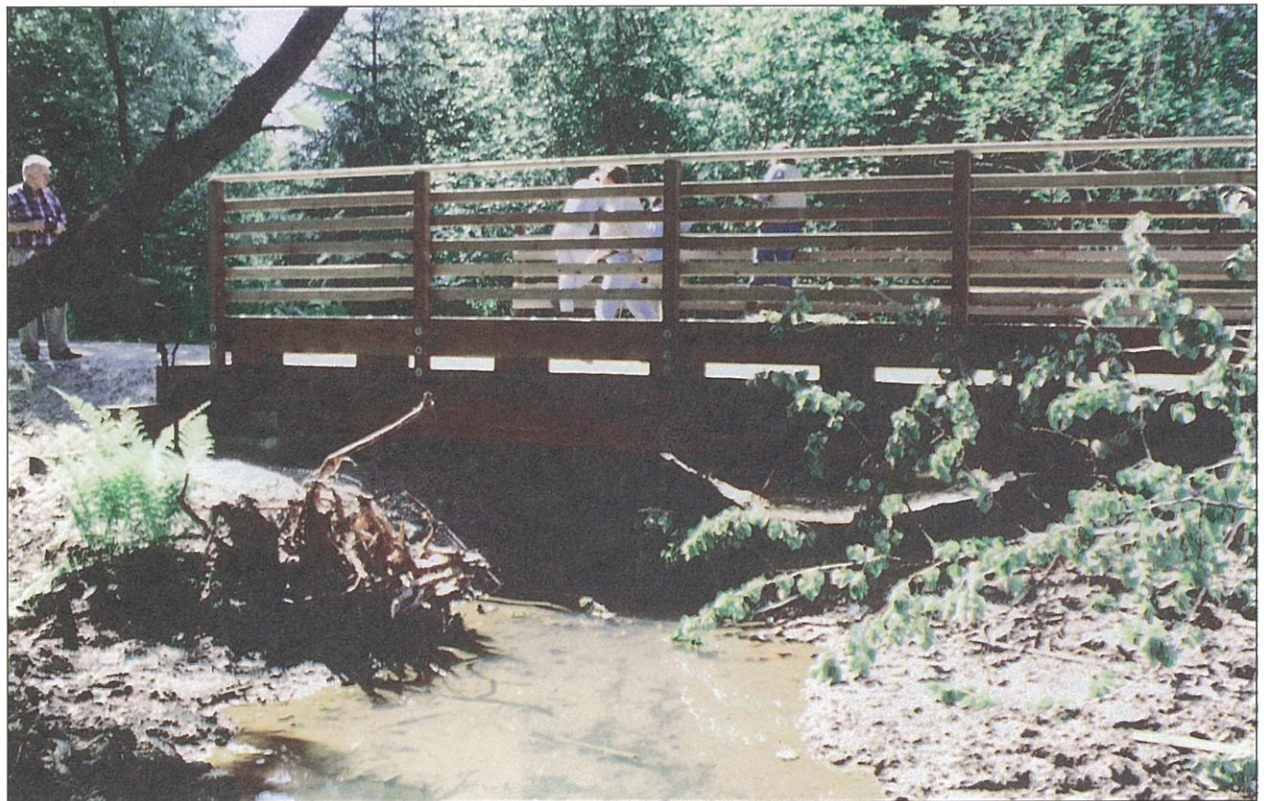
Figure 9.--Timber bridge used to replace a perched culvert on a private driveway. (Photo by NMFS).

- Kiowa Drive and south El Camino crossings of the El Camino Fork of Duck Creek were replaced with pipe arch culverts with concrete floors covered with gravel and the grade was lowered about 1 ft (structural concrete floors had to be used due to underlying sewer pipes);
- A 17-ft wide bottomless pipe arch was installed at Stephen Richards Boulevard (Fig. 7 and 8);
- The El Camino Fork crossing of Mendenhall Loop Road was enlarged and grade was lowered approximately 1 ft;
- Culverts on two private driveways downstream of Nancy Street were replaced with wooden bridges (Fig. 9).

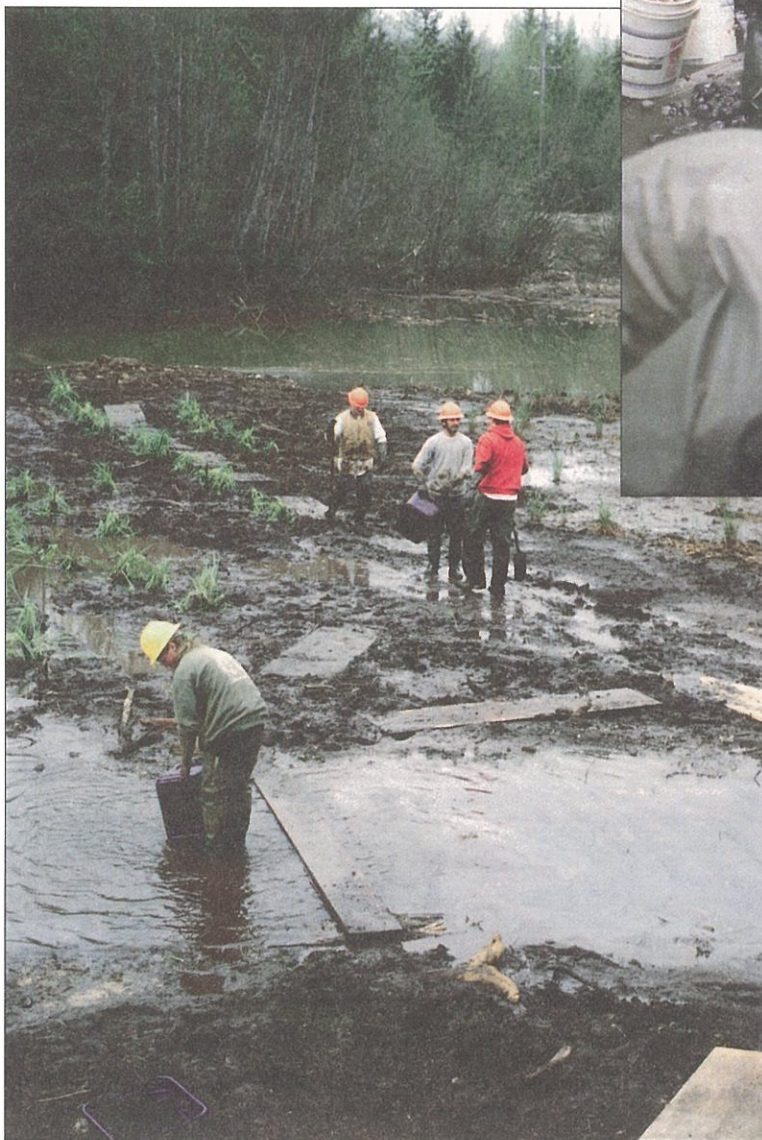
Figure 11.--Development of a stormwater treatment marsh in a dredge pond on the east fork of Duck Creek. (Photo by NMFS).

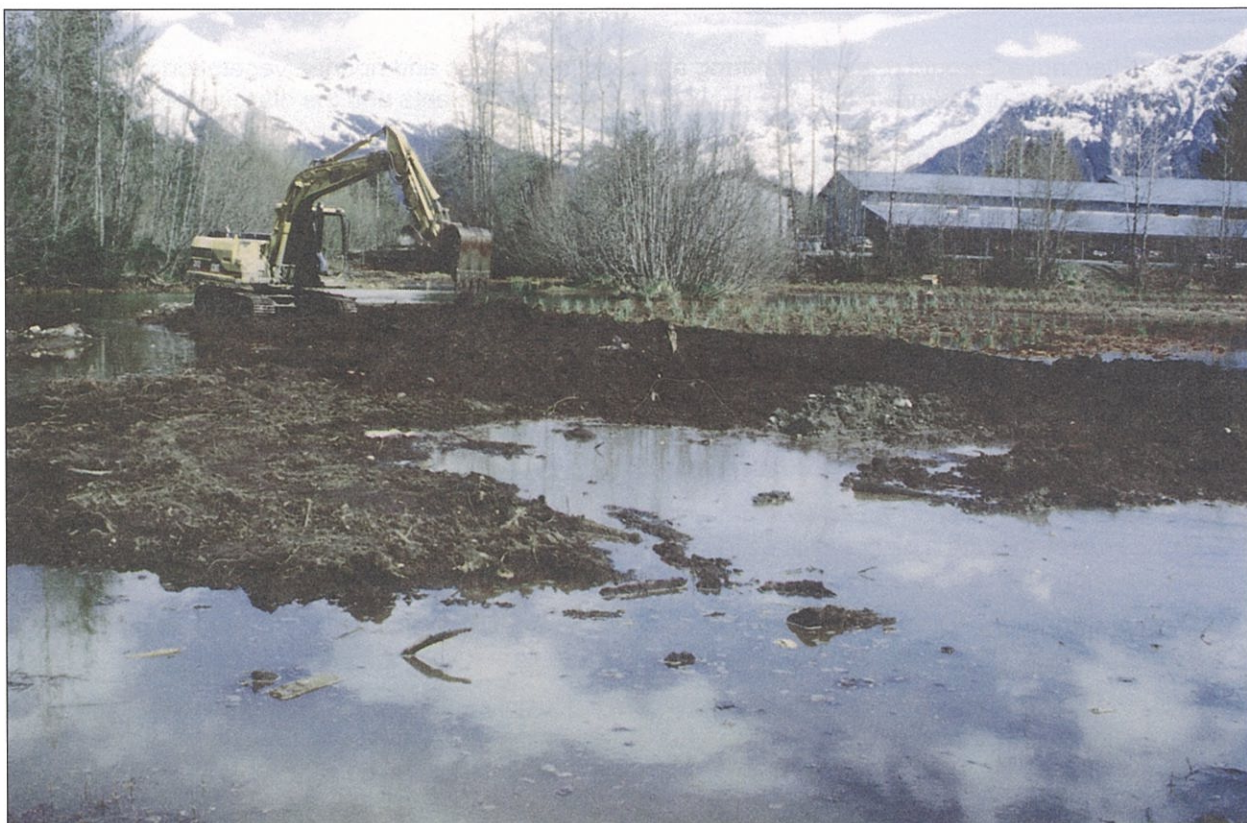
Figure 12.--The dredge pond that was developed into a stormwater treatment marsh. (Photo by NMFS).

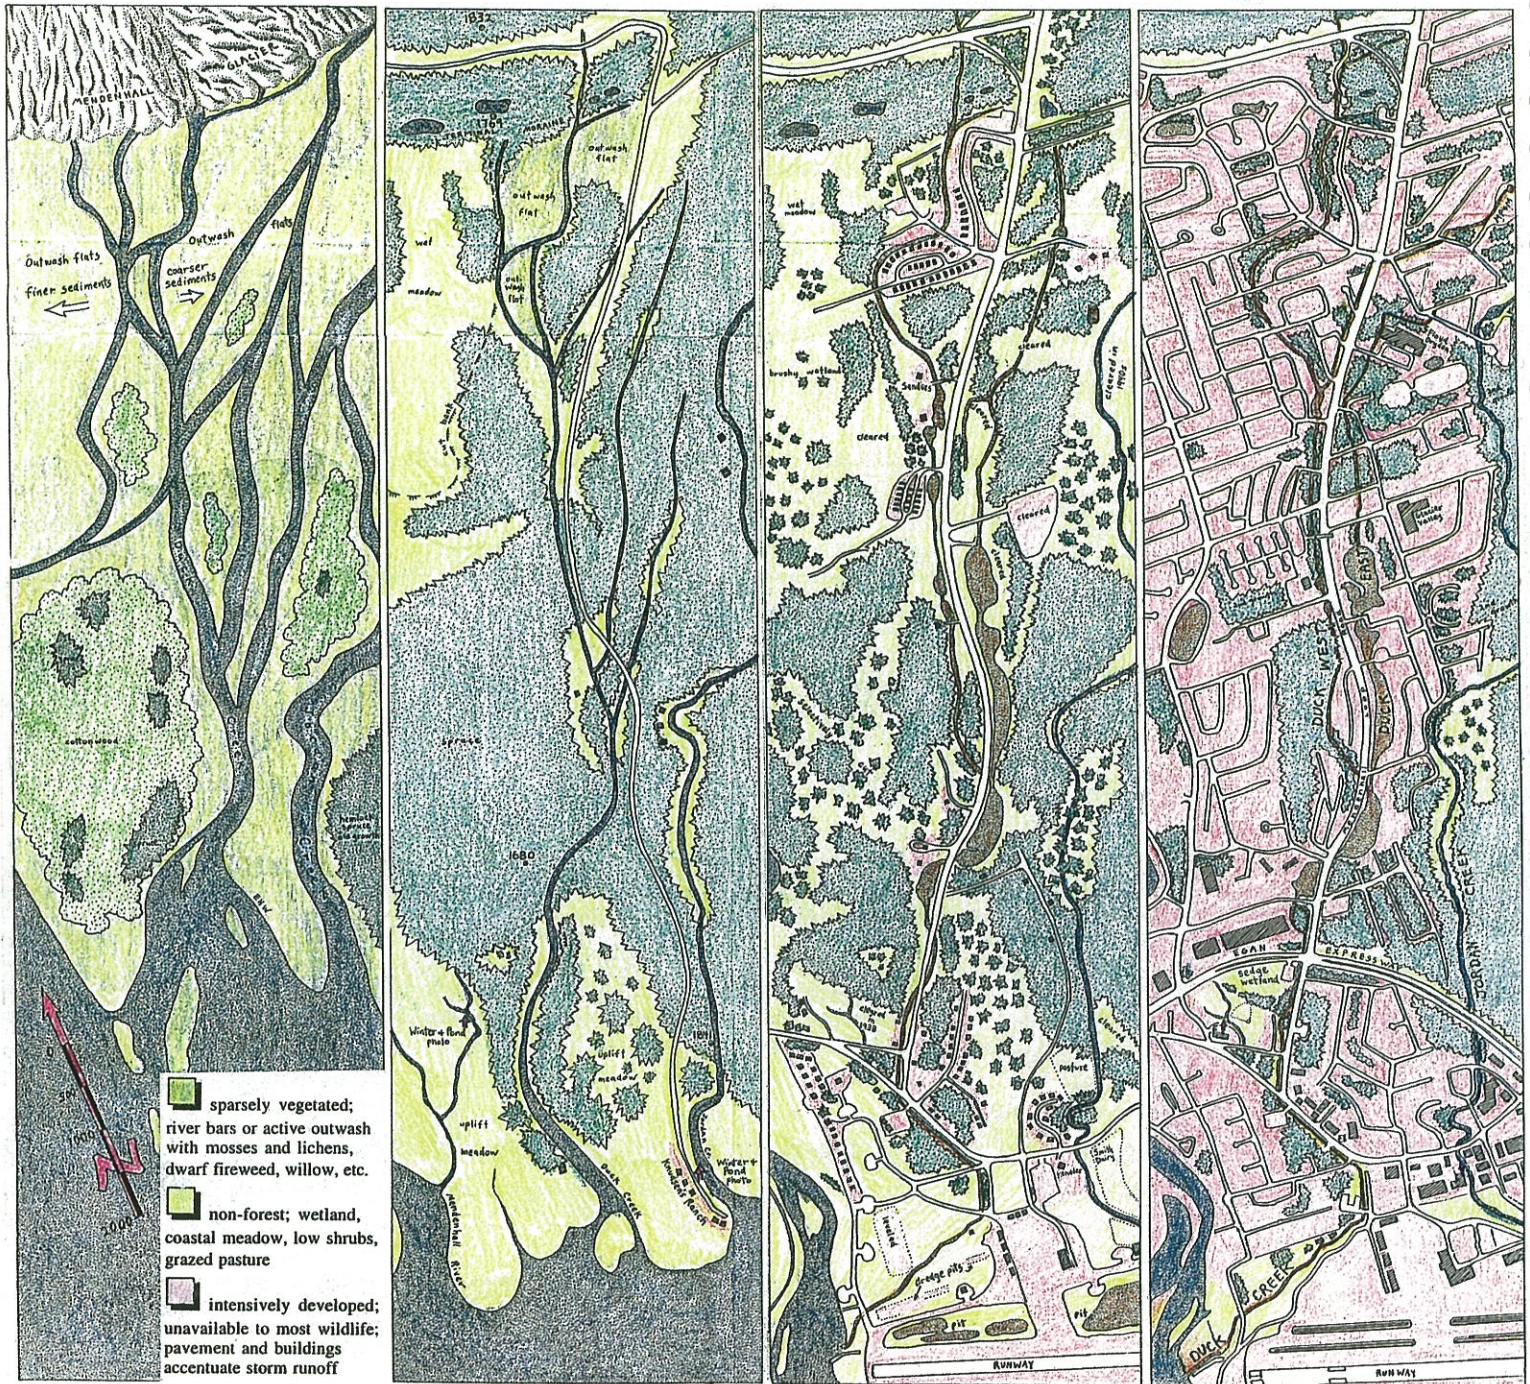
The Duck Creek channel has been moved little since 1962 but road crossings (counting both forks) have increased from 18 to 39, and most of the creek is now within a stone's throw of a road or house. Pavement and roofs send storm runoff directly into the creek, which exaggerates flood hazards even though much of the creek now goes dry during low flows. Only shreds of the original forest and wetland remain, and these patches are mostly isolated from the channel, making it hard for wildlife to use the stream, which has the least remaining natural habitat of any watershed in Southeast Alaska.

Figure 13.--Two centuries of development on Duck Creek. (Maps by Richard Carstensen, Discovery Foundation).

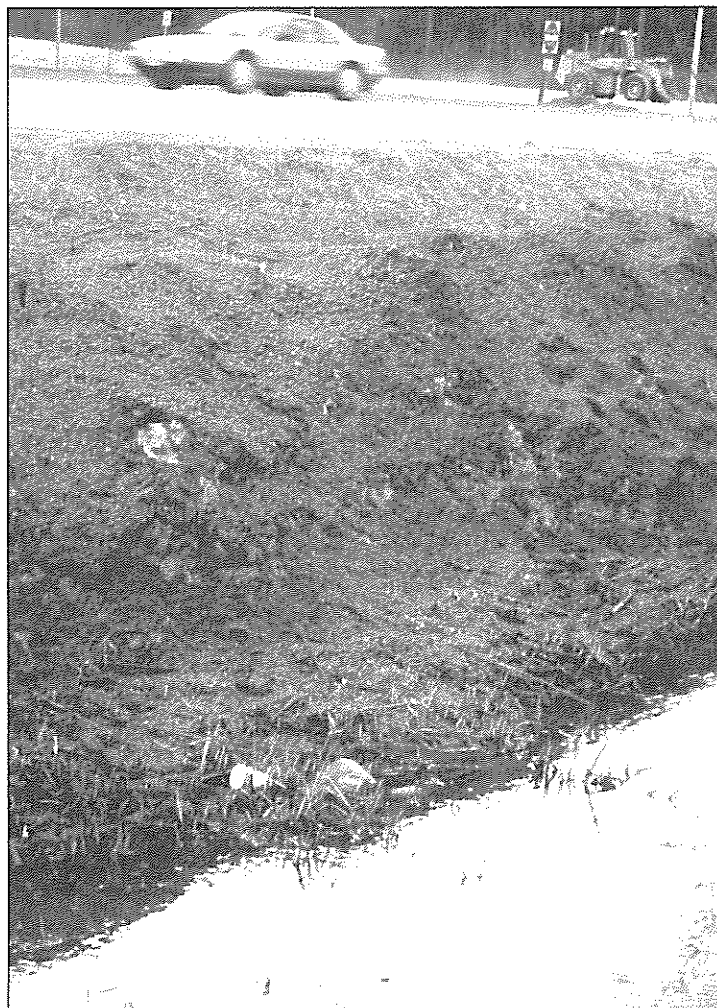
Figure 19.--Sediment (sand) entering Duck Creek in an area devoid of riparian vegetation.
