# Alaska's 2011 Air Monitoring Network Plan

## Chapter 1 – Monitoring Plan

State of Alaska Department of Environmental Conservation  
Division of Air Quality  
Air Monitoring and Quality Assurance Section  
619 E. Ship Creek Ave. Suite 249  
Anchorage, AK 99501

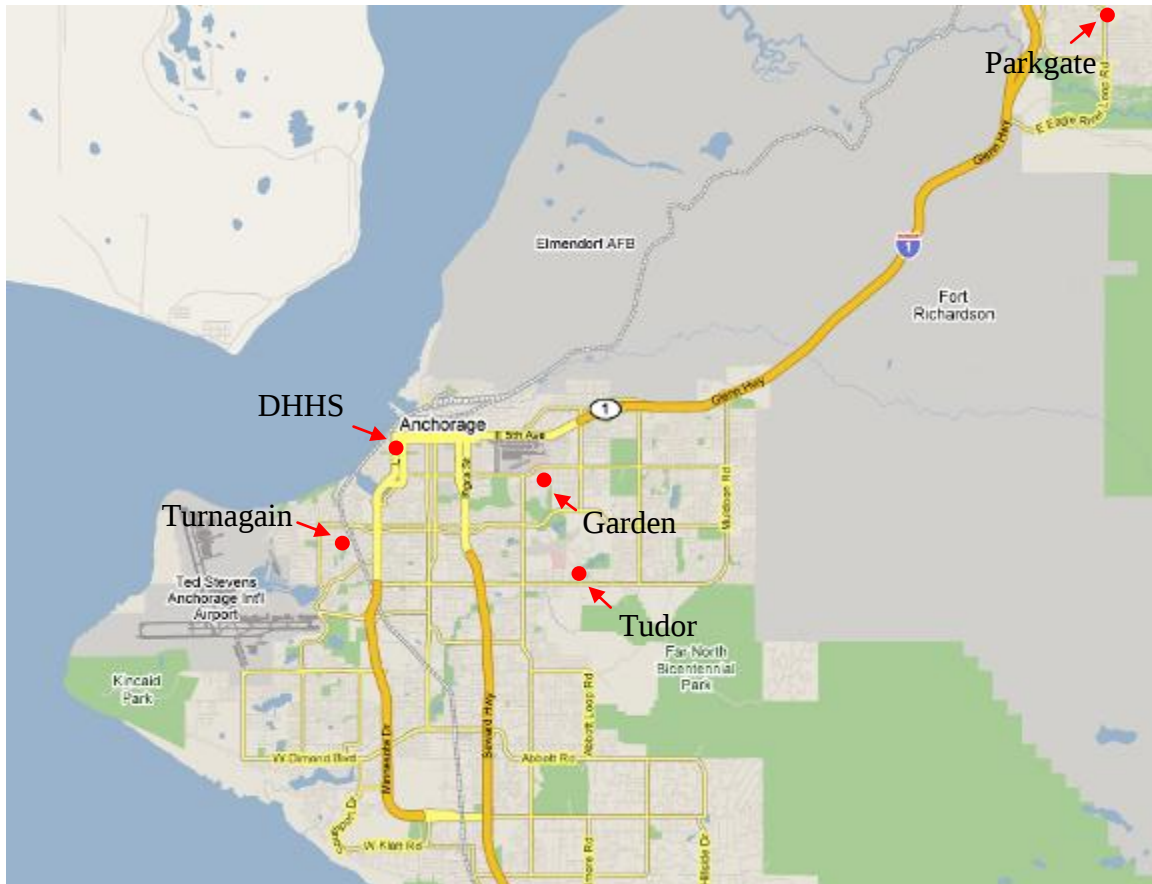
**Figure 2.1:1:** Map of Anchorage area. Red dots indicate monitoring sites.

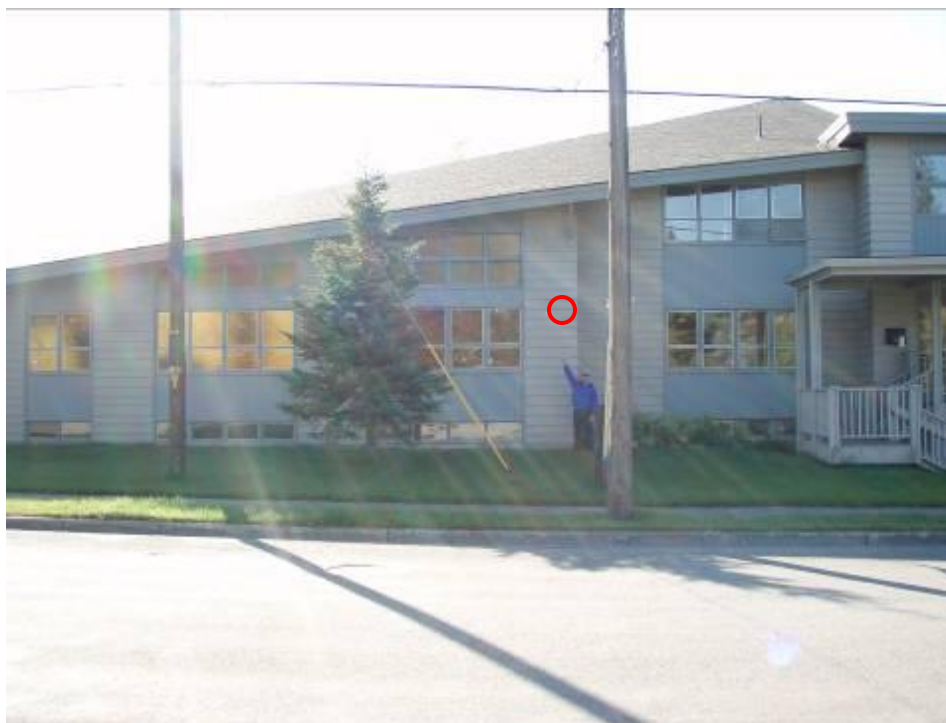
**Figure 2.2:3:** View of CO probe at Garden Site. The red circle indicates where the probe is located.

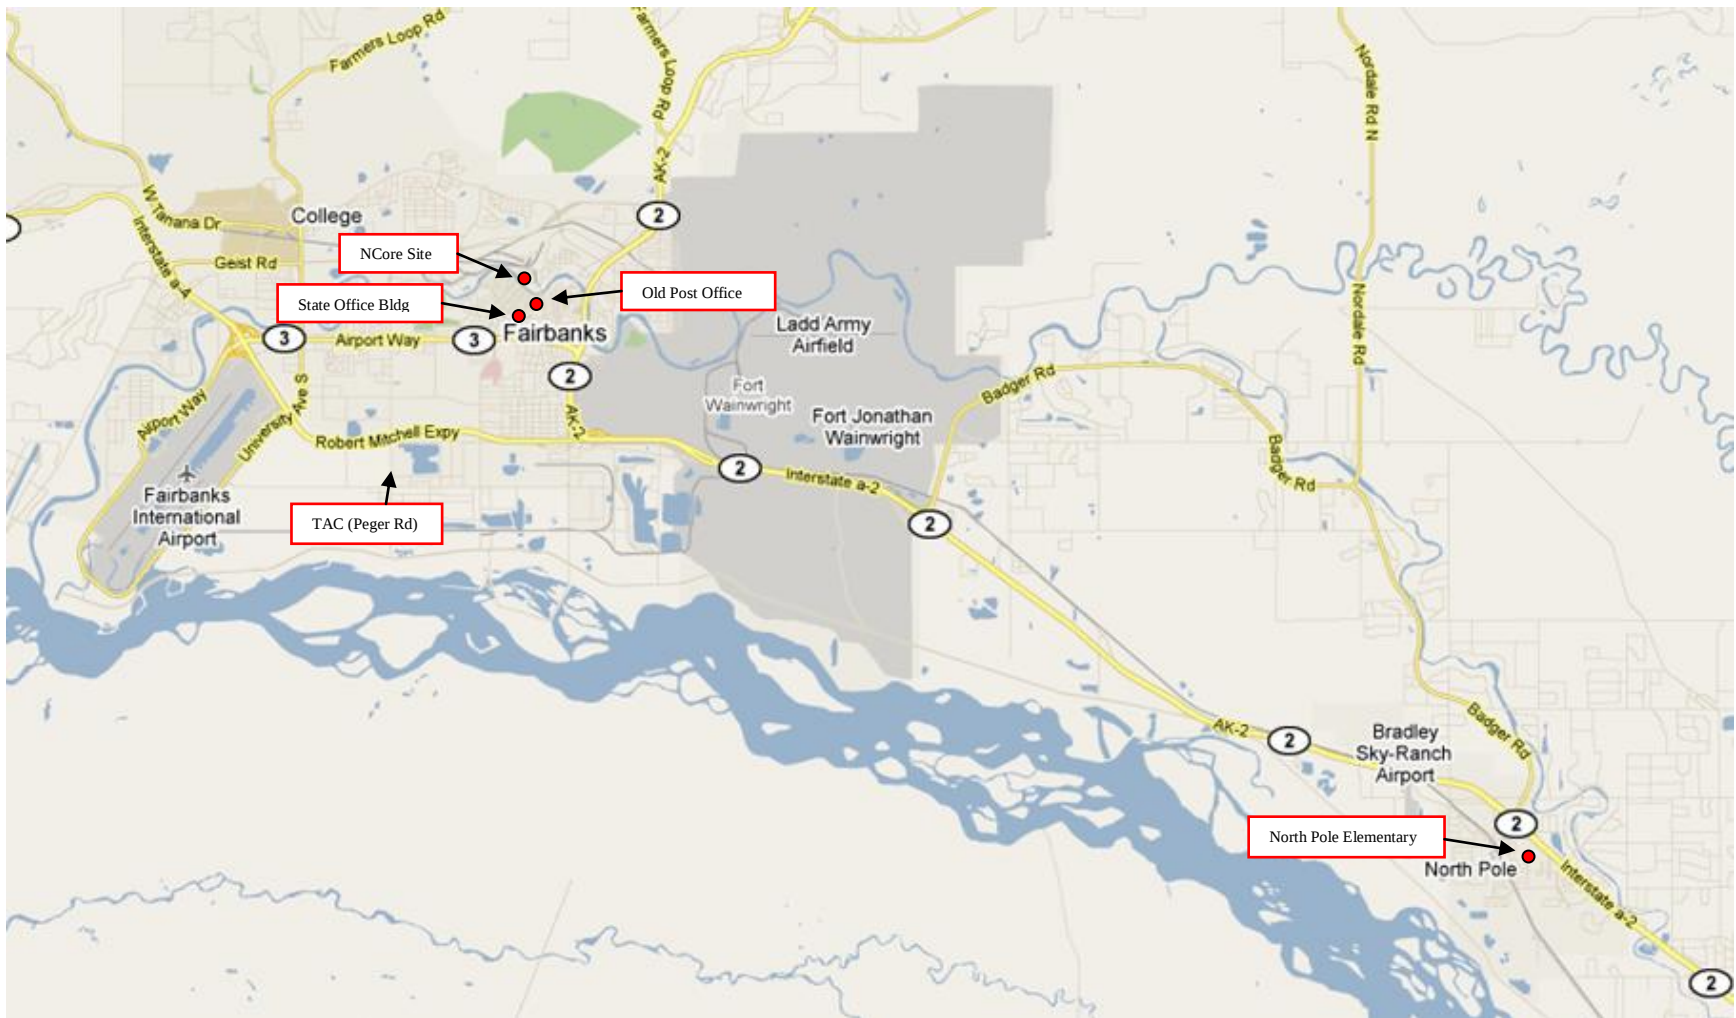
**Figure 3.1:1 Map of the Fairbanks and North Pole Area. Red dots indicate the locations of the monitoring sites.**
