Tuntutuliak Water Improvements

Preliminary Engineering Report

Tuntutuliak, Alaska

65% Draft Report (Revised)

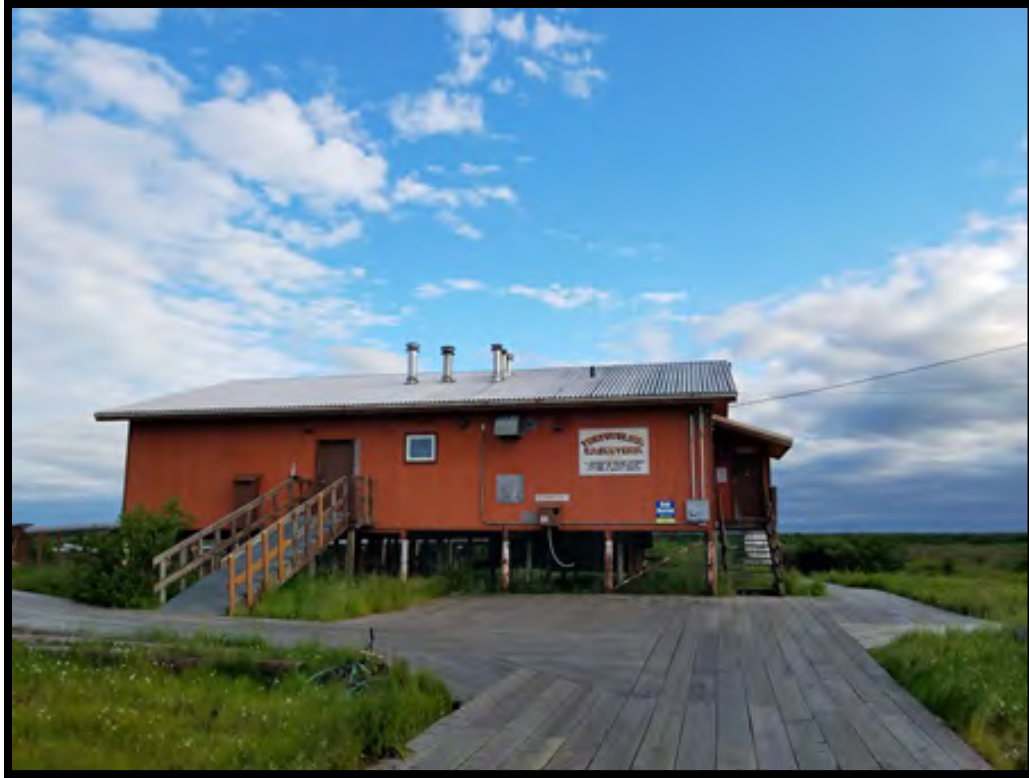
Figure 1: Washeteria

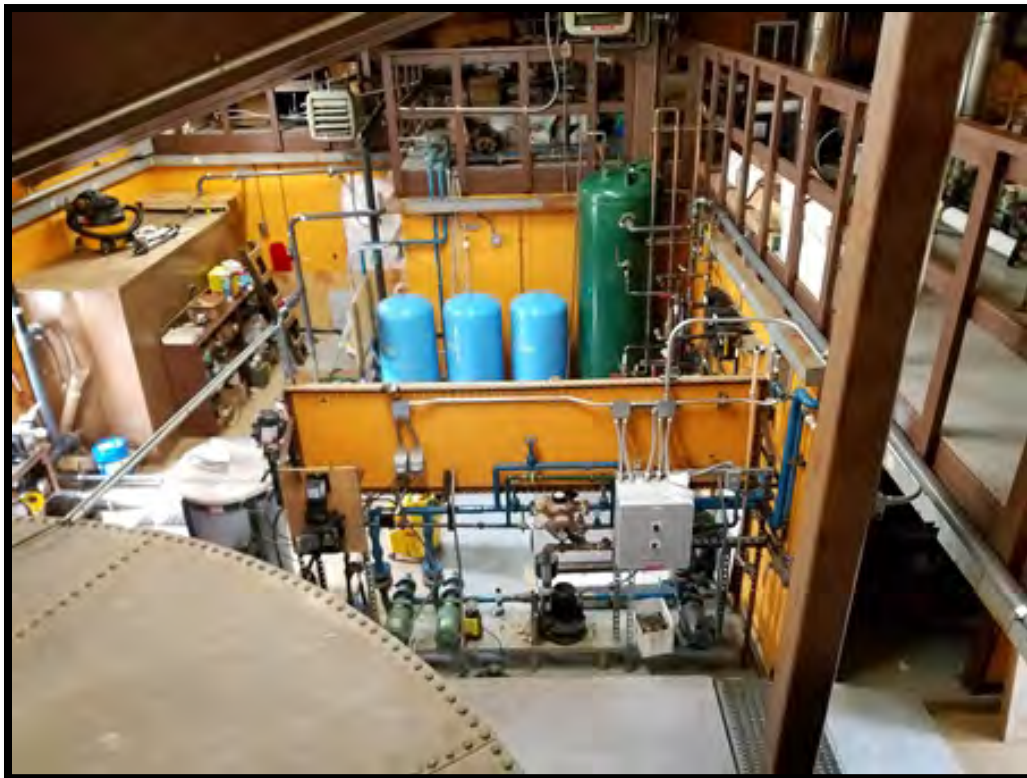
Figure 2: Water Treatment Plant (WTP)-Interior

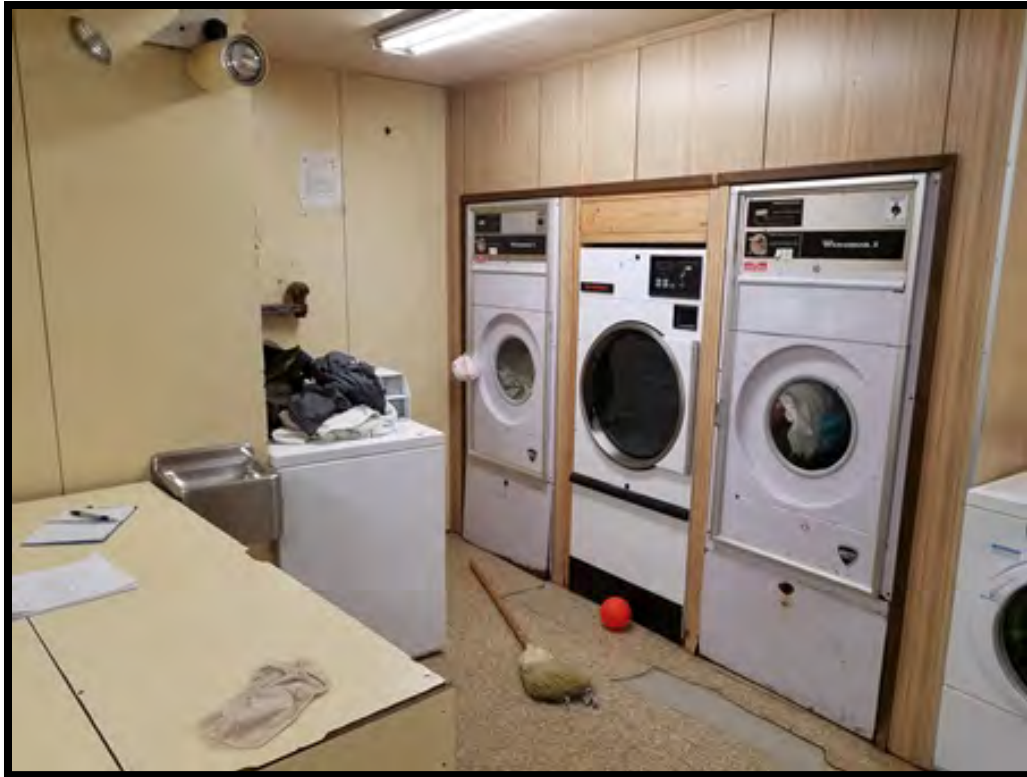
The washeteria is significantly undersized for the usage. There need to be at least eight washing machines and six dryers to meet the current demand. The washeteria doesn't have enough area for seating or tables for folding laundry. Residents have to stuff the clean clothes back into bags and carry them home.

Figure 7: Dryers and folding table

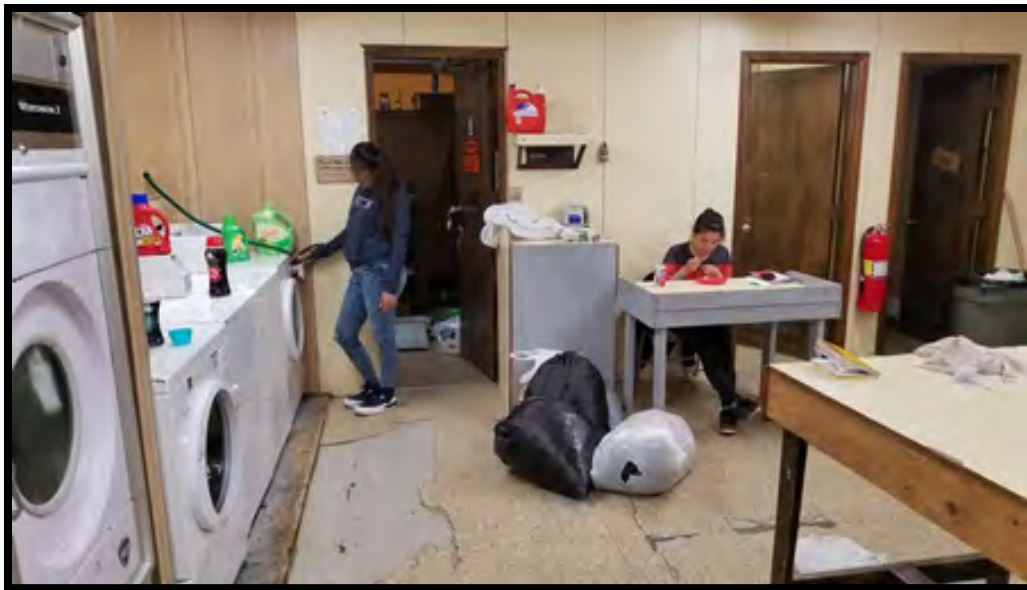
Figure 8: Washer, manual filling with hose.

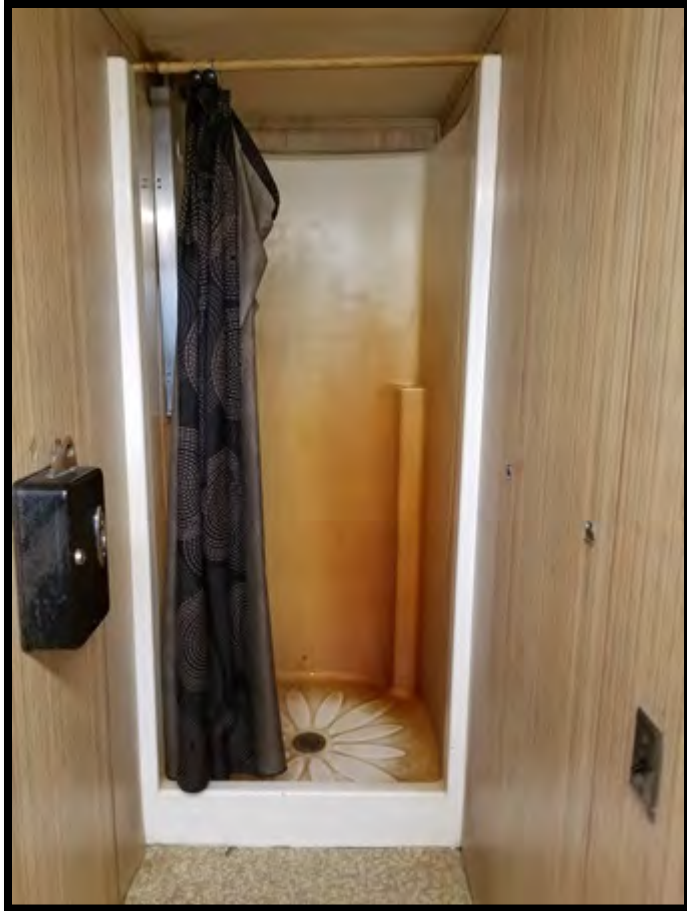
Figure 9: Women's only operable shower.

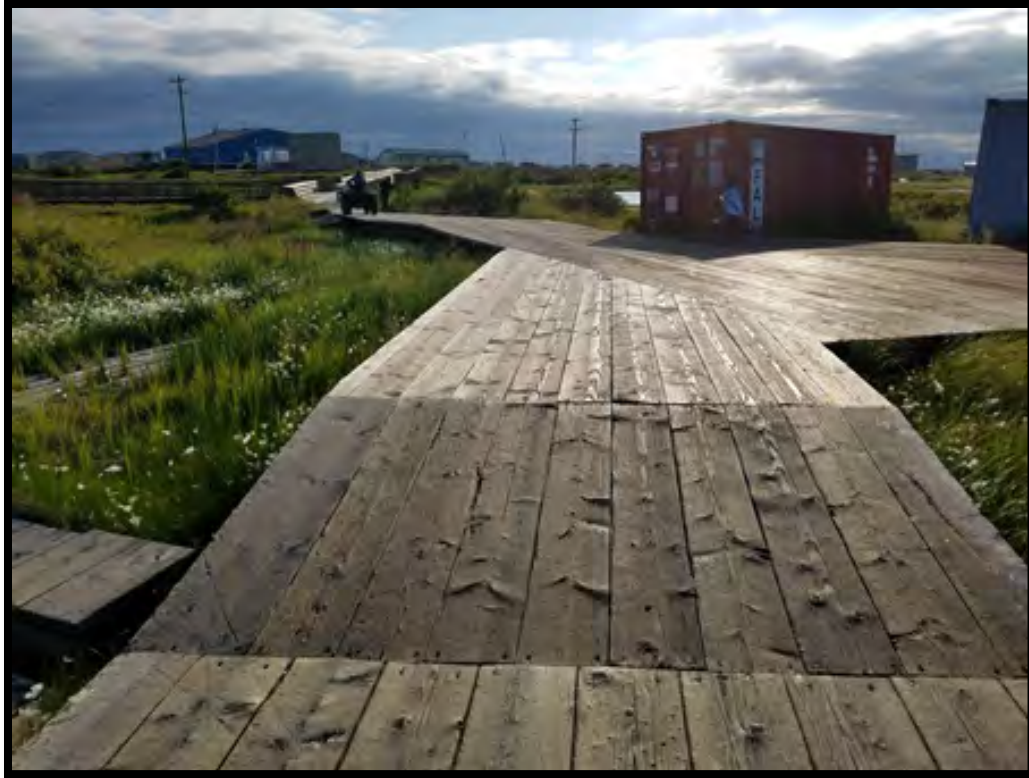
Figure 13: Typical boardroad

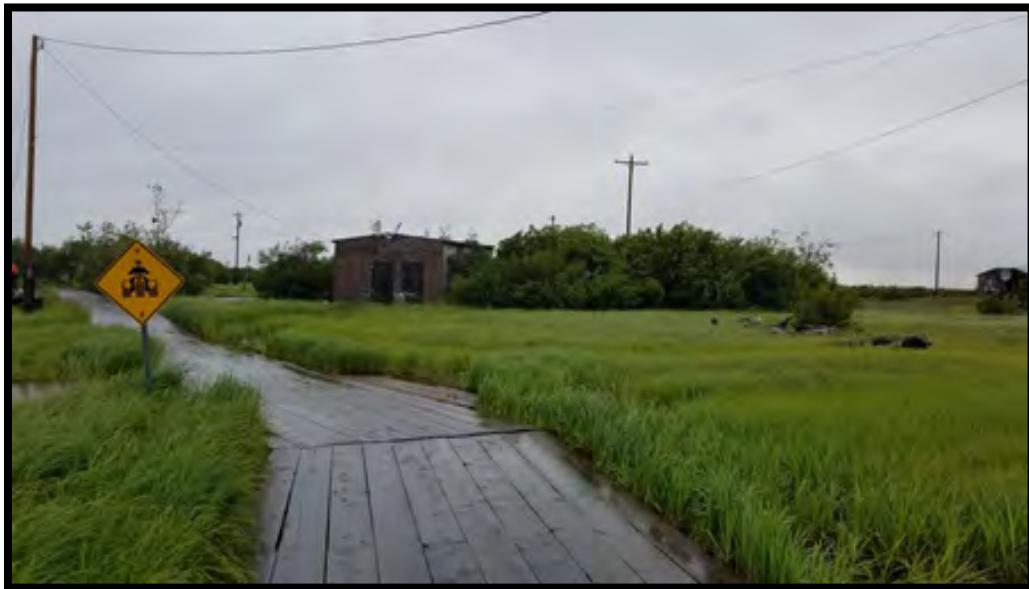
Figure 14: Typical boardroad, floating on tundra and marshy area

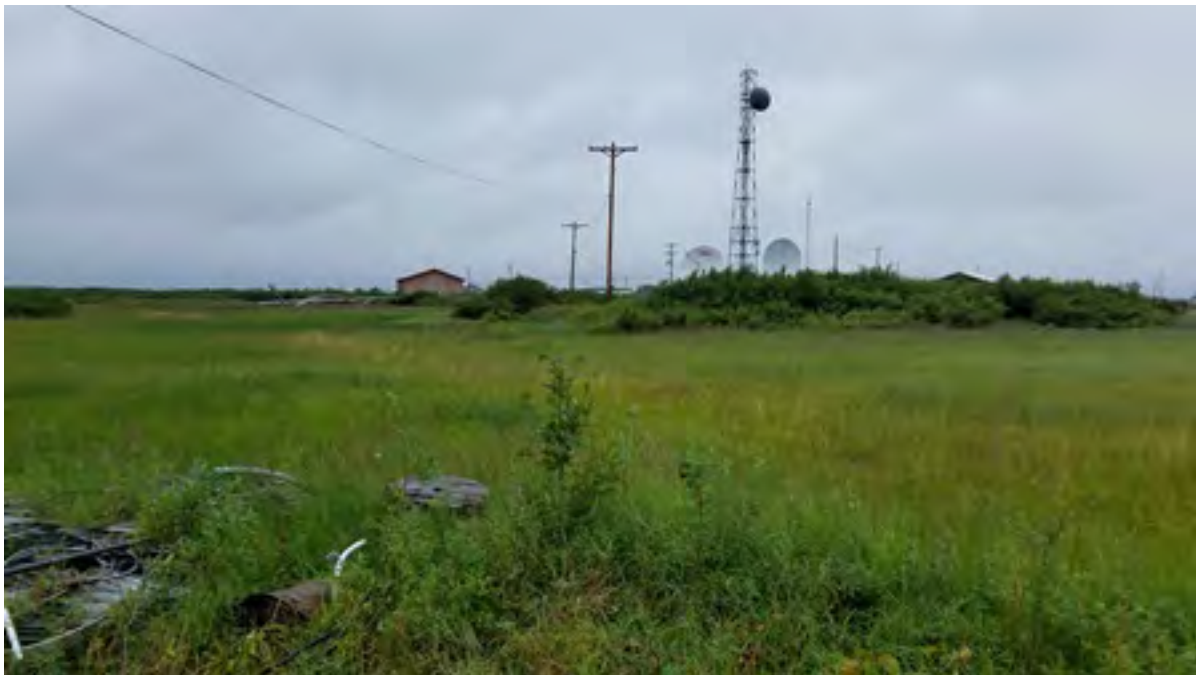
Figure 22: Potential new washeteria site by power plant, looking towards the current washeteria.

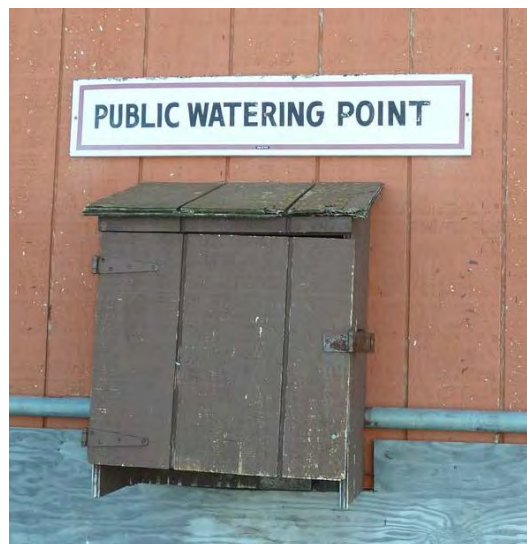
The existing watering point is manually operated using a button-activated solenoid valve in the WTP. The existing watering point control is not working. This configuration does not prevent excessive waste of water nor does it allow for revenue to be collected for water. The watering point does not extend out from the building and does not currently have a flexible hose for the discharge, making it difficult to fill containers on a vehicle. Upgrades are proposed to add a coin operated solenoid to allow revenue collection and prevent excessive wasting of water at the watering point. Watering point piping should also be upgraded by installing an insulated arctic pipe arm with a flexible hose drop pipe to improve accessibility for vehicle haul. This alternative is itemized in Table 2. Due to budget considerations, a second alternative including only the addition of a coin operated dispensing system is presented in Table 3.

Figure 1 - Public Watering Point

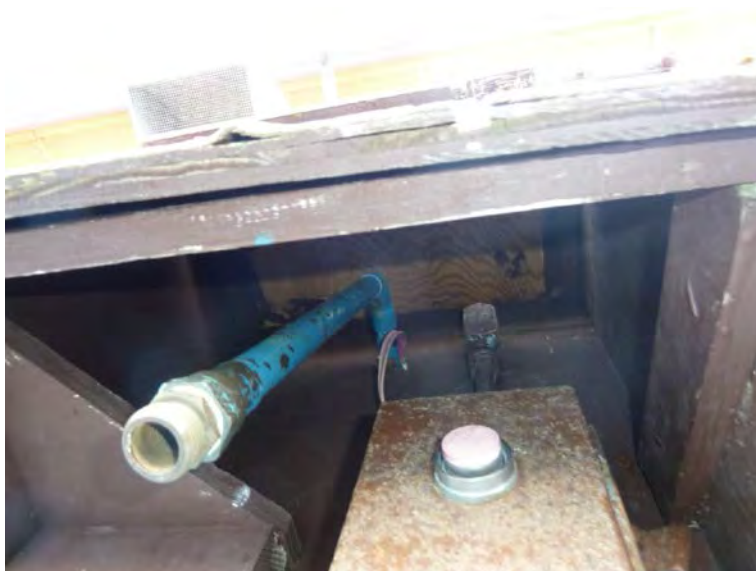
Figure 2 - Public Watering Point Piping and Actuator

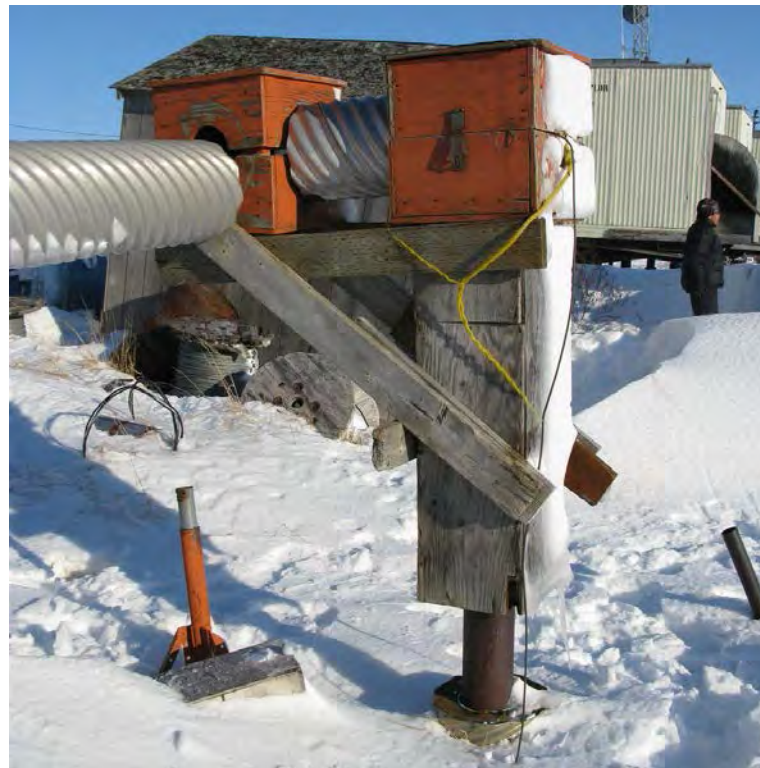
Figure 4 - Well Head

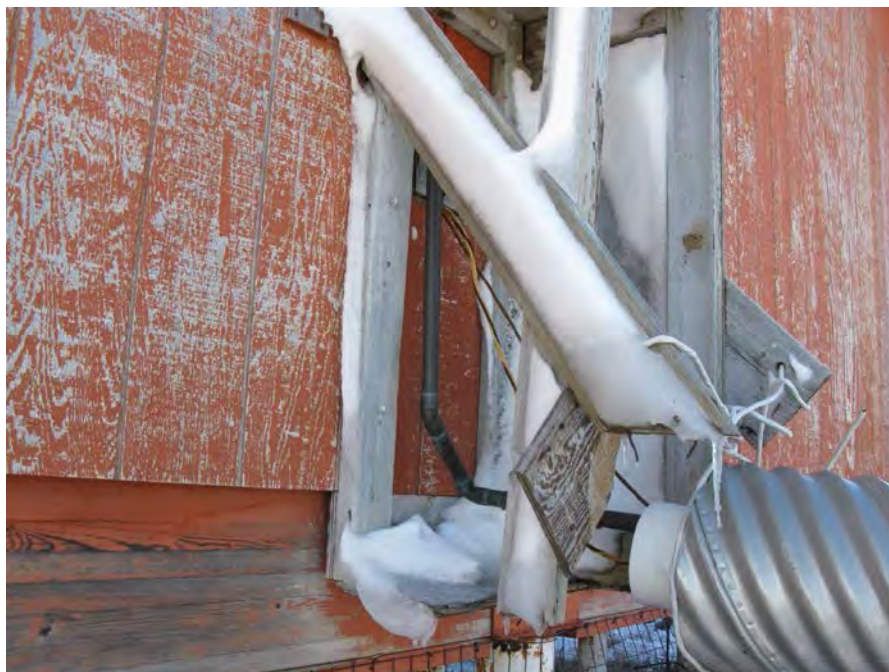
Figure 5 - Connection to WTP

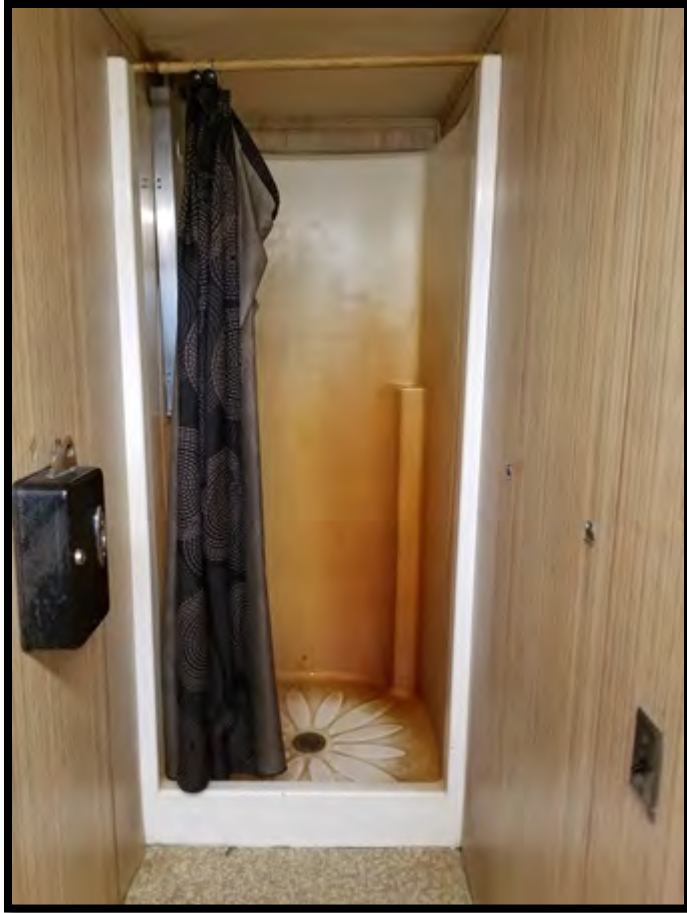
- Women's bathroom is in use, but only one out of two showers is operational.
- Men's bathroom and shower room are not in use. The council reports they haven't worked since before 2013. They are now used as storage. Tom was unsure what is wrong but knows that they have attempted to repair them several times.
- Women's bathroom is distressed with broken mirror and vanity. There have been several holes patched in the walls. The door is damaged.

- The women's shower area has only one fan working and the other needs to be replaced; water-damaged floor and baseboards; inoperable window; mold in showers; leaking shower heads; signs of corrosion, etc.

Figure 9: Women's only operable shower.

- The floor throughout the washeteria needs to be replaced. In several places the floor is worn down to structural floor boards.
- It is recommended that the entire washeteria interior needs to be replaced (e.g. windows, flooring, sheetrock, shower, bathrooms, etc.).

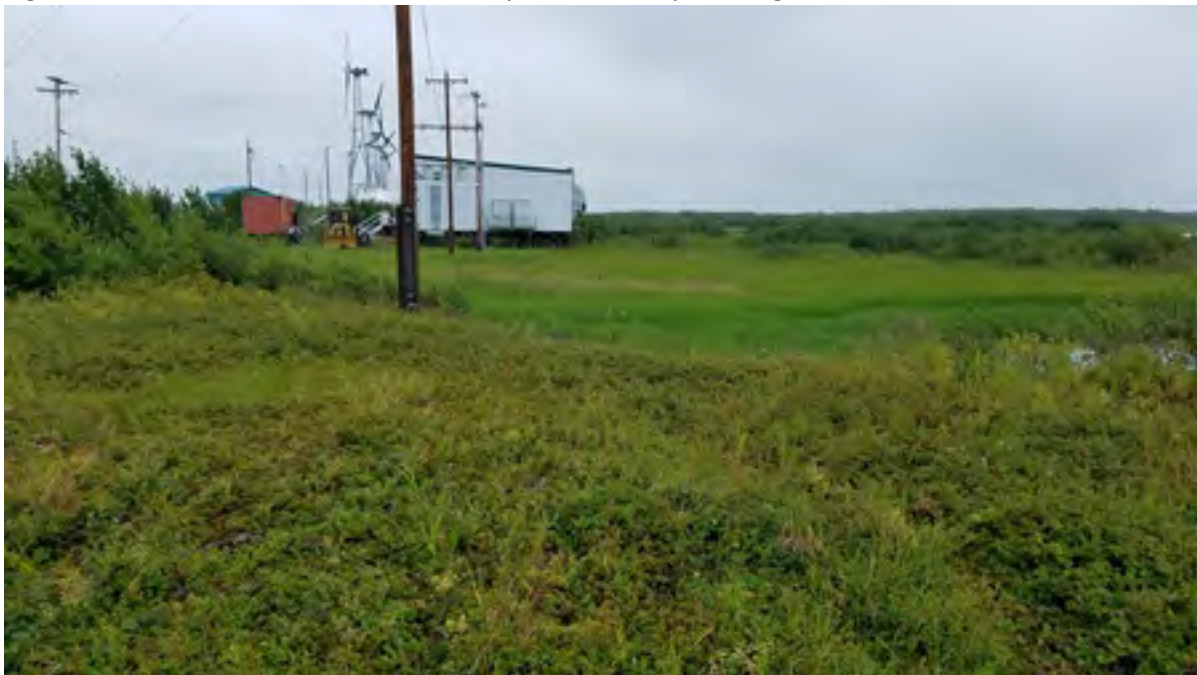
Figure 24: Potential new washeteria site by United Utility, looking west towards power plant.
