Prepared for: City of Ekwok P.O. Box 49 Ekwok, Alaska 99580

SECT	<u>PAGE</u>
1.0	INTRODUCTION
2.0	FIELD NARRATIVE
3.0	SEWER MAIN INSPECTION
4.0	WATER QUALITY TESTING9
5.0	SUNSHINE VIEW LEACHFIELDS
5.1	Karasti Property 15
5.2	Walcott Property 16
6.0	REFERENCES
	TABLES
Table 3	3.1 Sewer Main Inspection7
Table 4	4.1 Water Quality Testing (June 2009)9
Table 4	4.2 Water Quality Testing (September 2009)10
Table 4	1.3 Frank Nicholai – Additional Water Quality Testing (June 2009)11
Table 5	5.1 Leachfield Survey Results
Table 5	5.2 Percolation Test Results
Table 5	5.3 Sunshine View Groundwater Depths
	FIGURES
Figure	C1 Project Overview
Figure	C2 Sunshine View Subdivision On-Site Systems
Figure	C3 Sunshine View Subdivision On-Site Systems
Figure (C4 Existing and Proposed Sanitary Sewer System

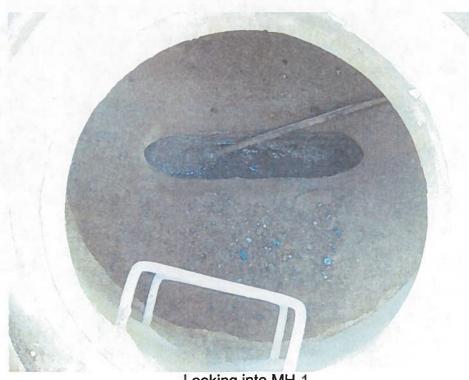
Looking into MH-1

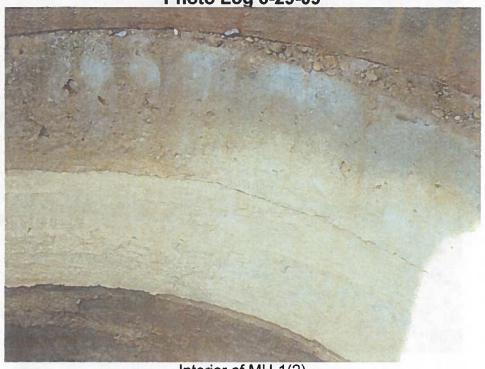
Interior of MH-1(2)

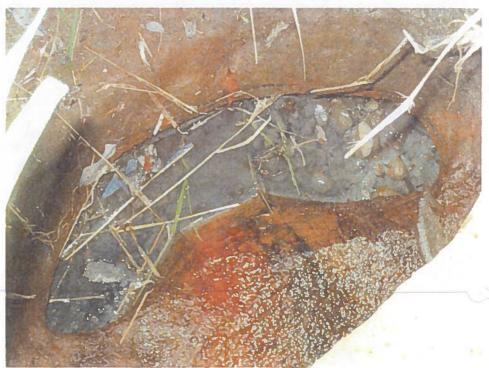
Closer view inside MH-2

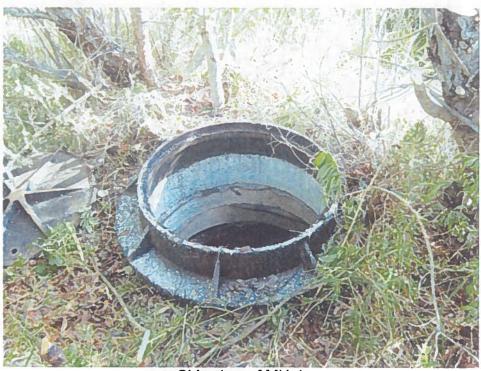
Side view of MH-4

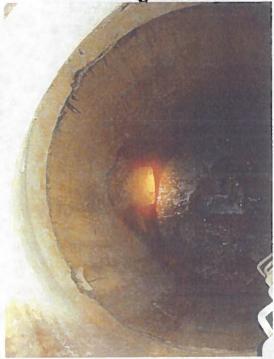
Looking down MH-5

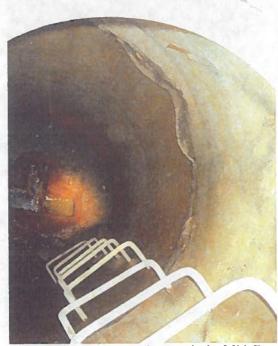
Looking down stair treads in MH-5

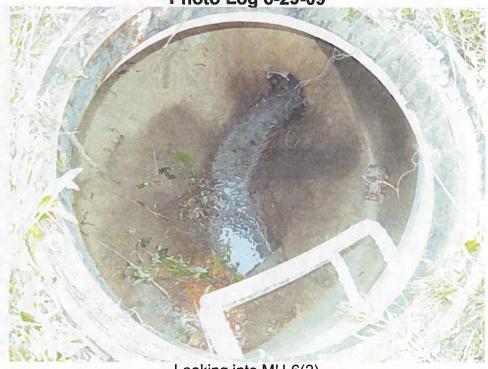
Looking into MH-6(2)

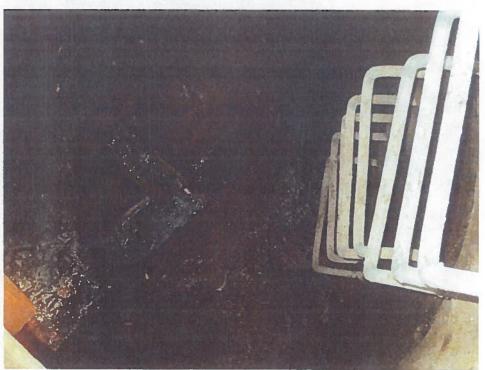
Looking down stair treads in MH-6

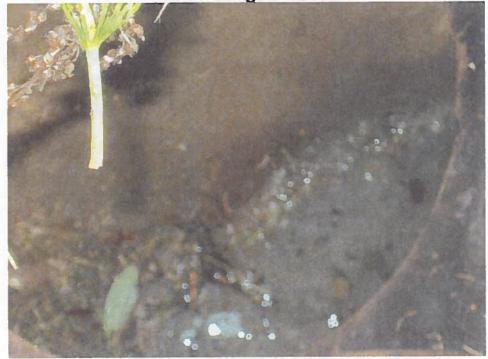
Close view of MH-6

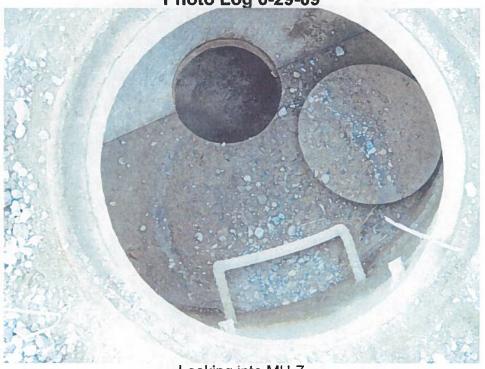
Looking into MH-7

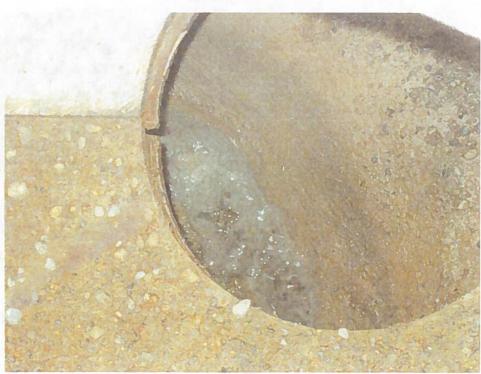
Looking into MH-7(2)

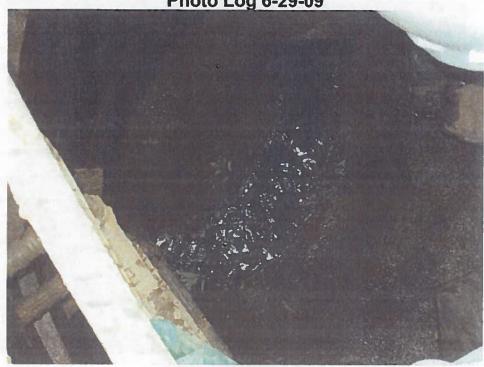
From stair treads of MH-9

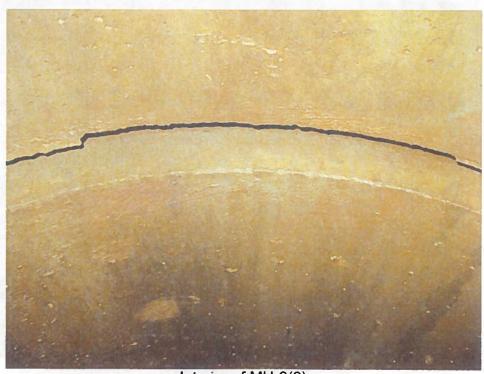
Interior of MH-9(2)

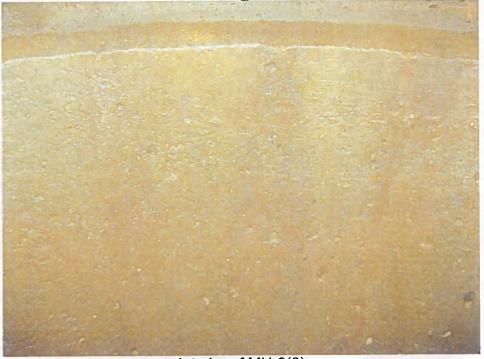
Interior of MH-9(3)

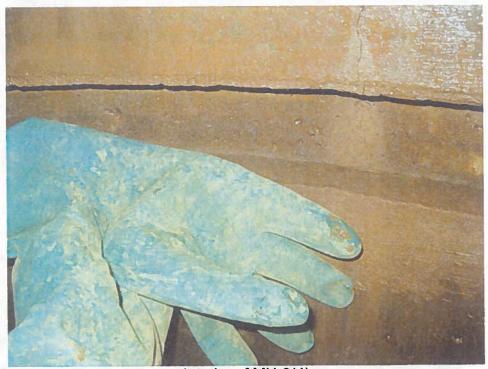
Interior of MH-9(4)

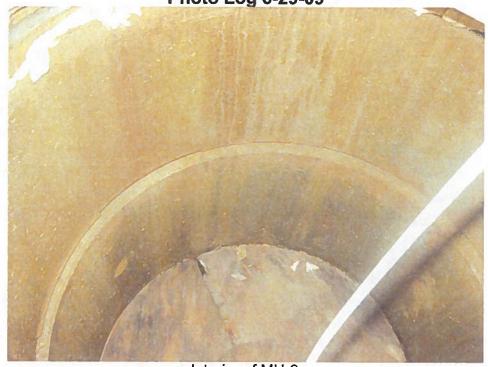
Interior of MH-9

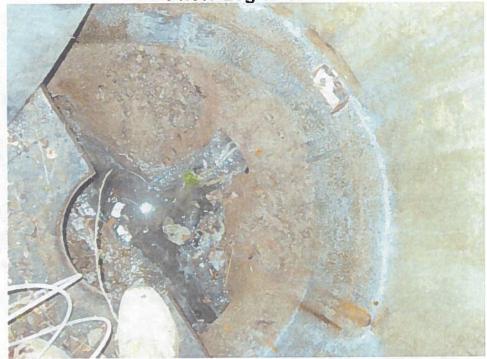
Close view of air quality test in MH-11

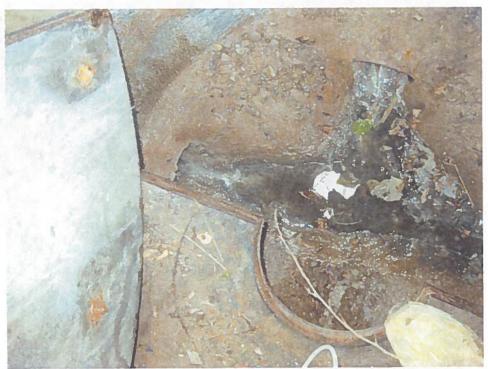
Close view of air quality test in MH-11(2)

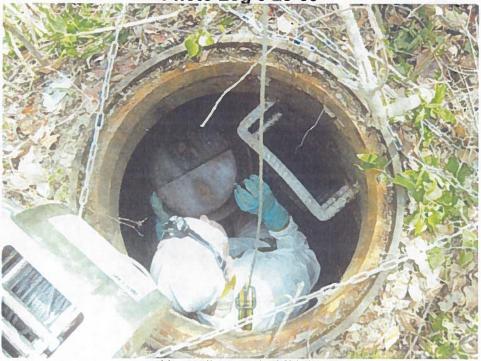
Air quality test in MH-11

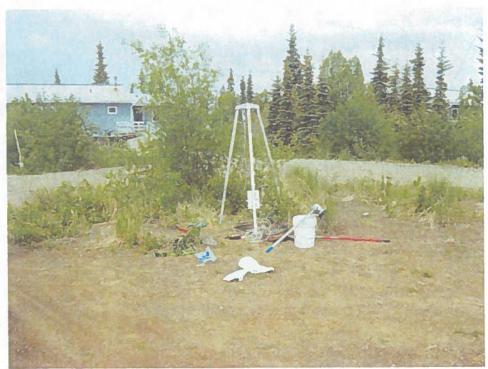
Pre-entry set-up of MH-13A

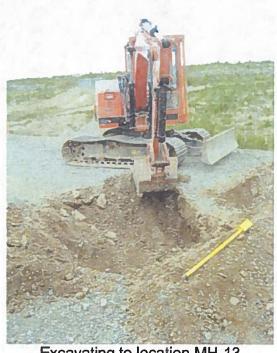
Excavating to location MH-13

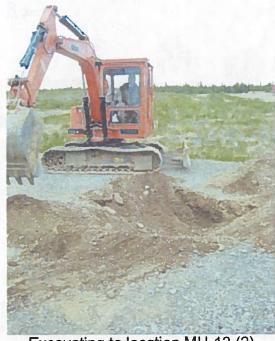
Excavating to location MH-13 (2)

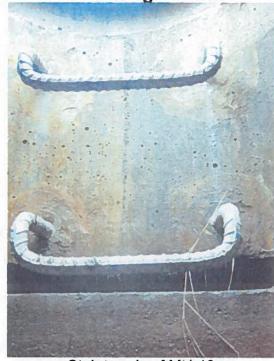
Stair treads of MH-13

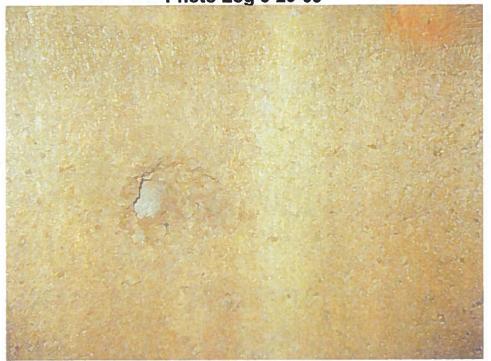
Hole from stair treads in MH-13

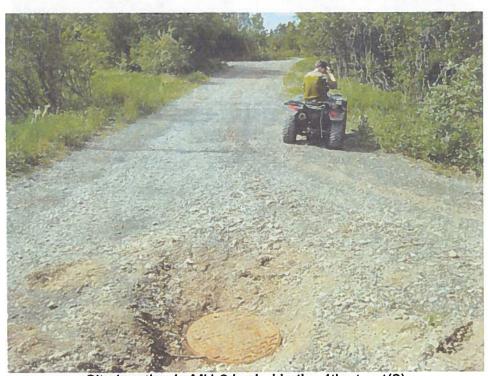
Site location in MH-3 buried in the 4th street(2)

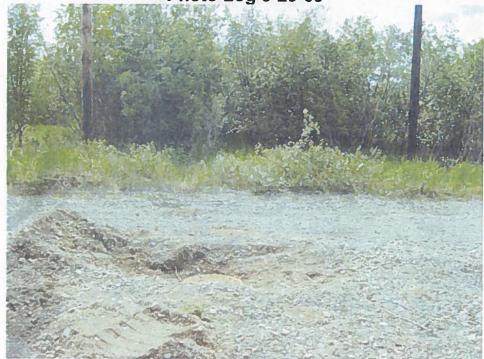
Site location of MH-3 buried in 4th street

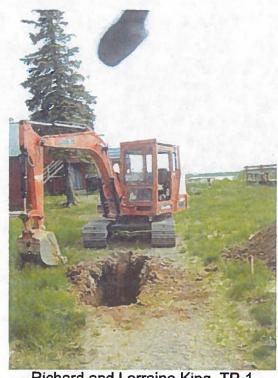
Richard and Lorraine King, TP-1

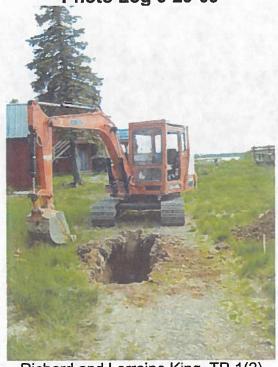
Richard and Lorraine King, TP-1(2)

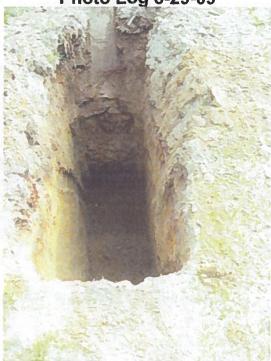
TP-1 soil matrix

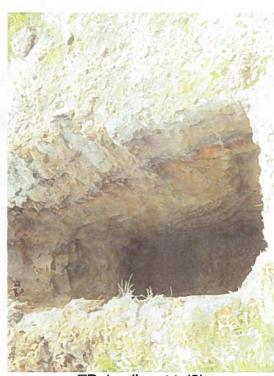
TP-1 soil matrix(2)

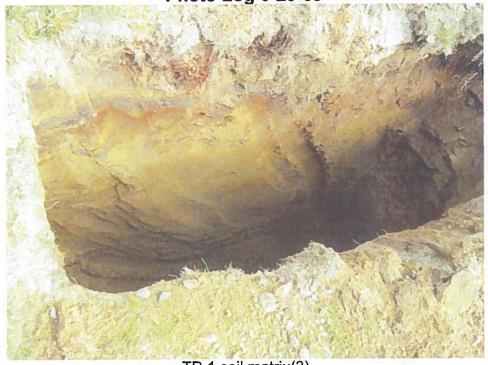
TP-1 soil matrix(3)

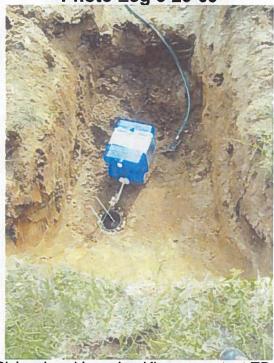
Richard and Lorraine King, perc. test TP-1

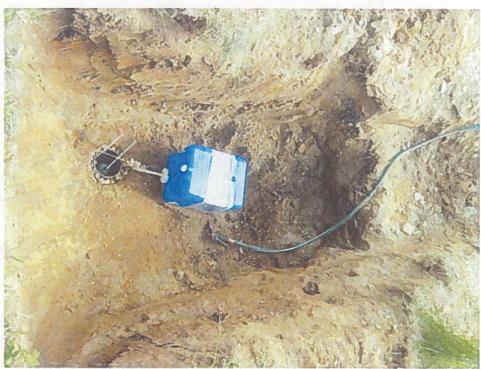
Richard and Lorraine, perc. test TP-1(2)

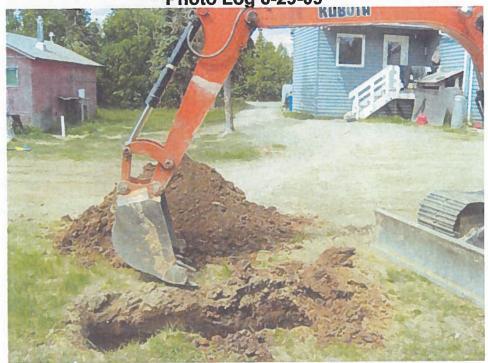
Peter Walcott TP-3

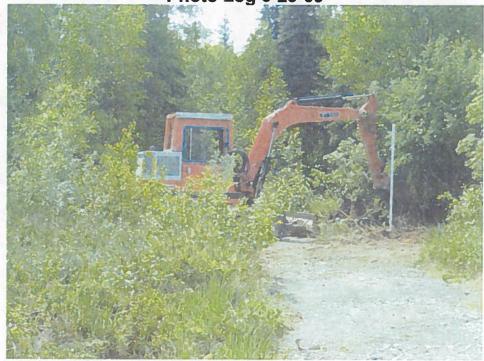
Peter Walcott, TP-4

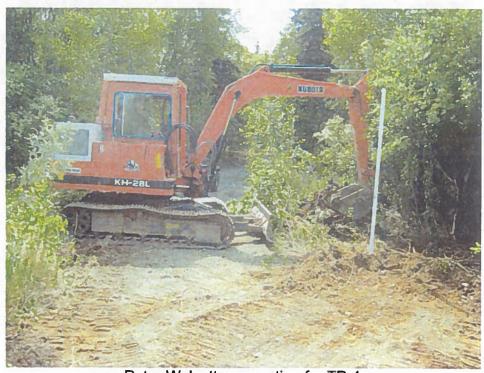
Peter Walcott, excavation for TP-4

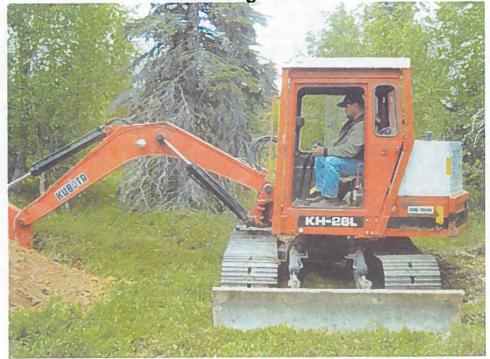
Julia and Billy Branden, excavation for TP-5

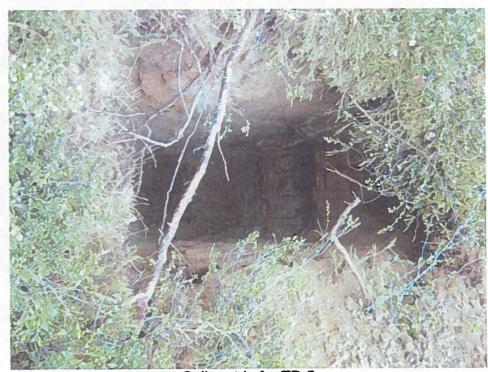
Soil matrix for TP-5

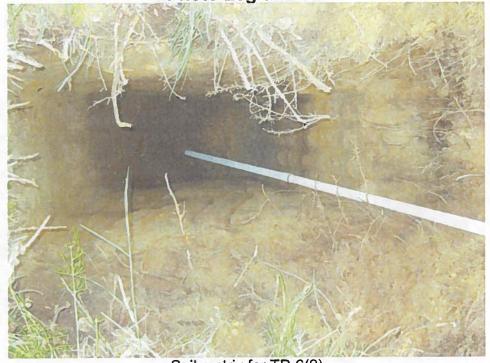
Soil matrix for TP-6(2)

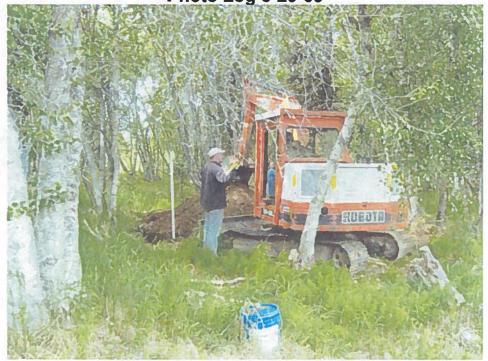
Sandra Stermer, excavation for TP-6

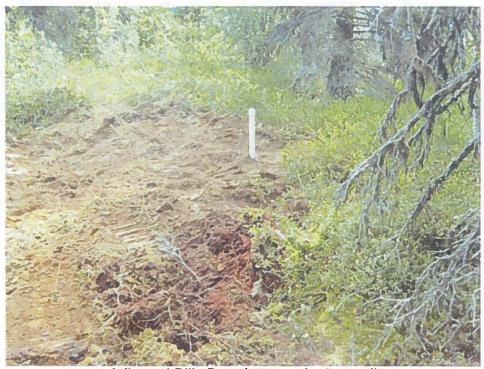
Julia and Billy Brandon, monitoring well

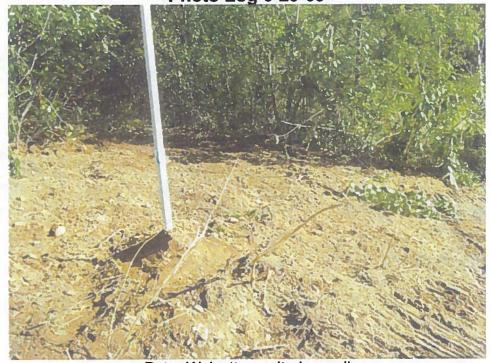
Peter Walcott, monitoring well

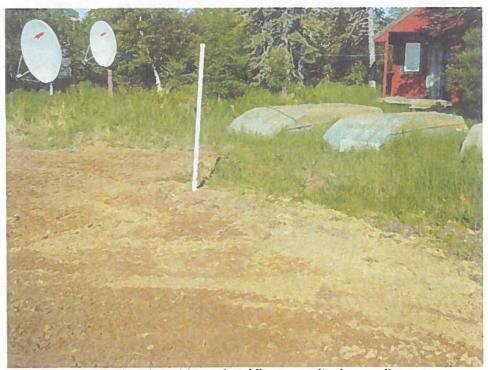
Richard and Lorraine King, monitoring well

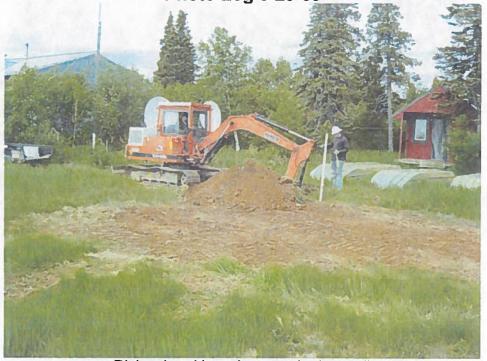
Richard and Lorraine, monitoring well

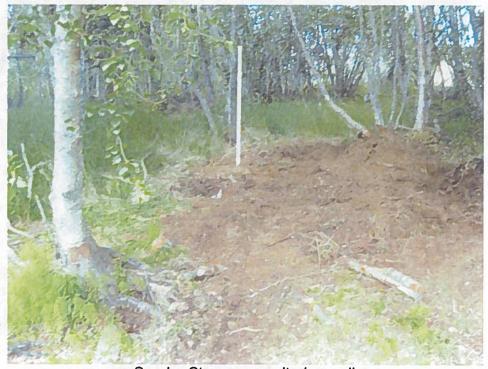
Sandra Stermer, monitoring well

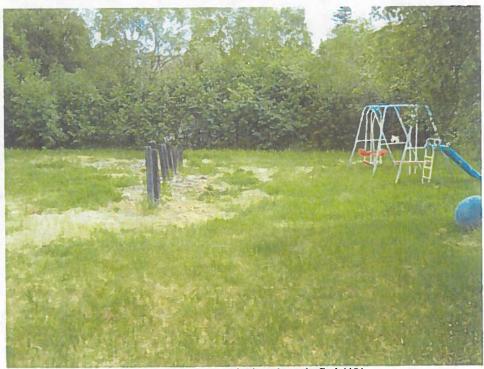
Peter Walcott existing leach field(2)

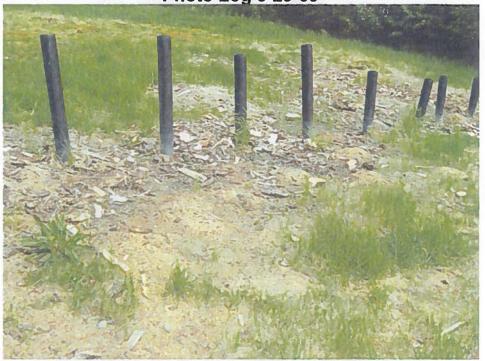
Peter Walcott leach field with surface sewage present

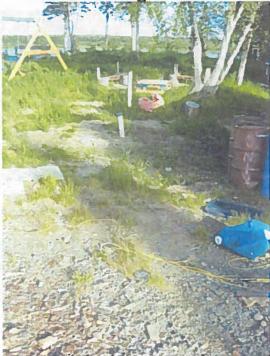
Richard and Lorraine King's existing leach field

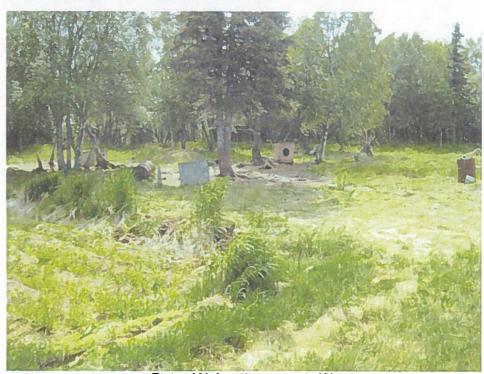
Peter Walcott's property(2)

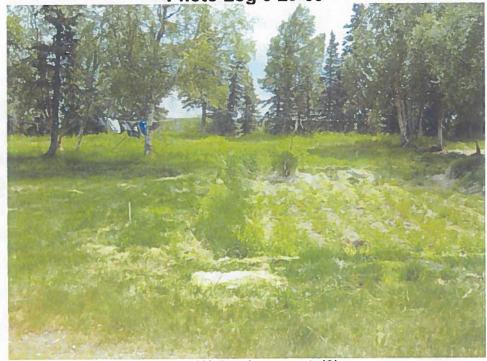
Peter Walcott's property(3)
