January 2013 Reports

Tuluksak Water Treatment Plant Structural Condition Survey, Reid Middletoon, Jan 2013

Tuluksak Water Treatment Plant Mechanical Condition Survey, EDC Engineers, Jan 2013

Tuluksak Water Treatment Plant Structural Condition Survey Report

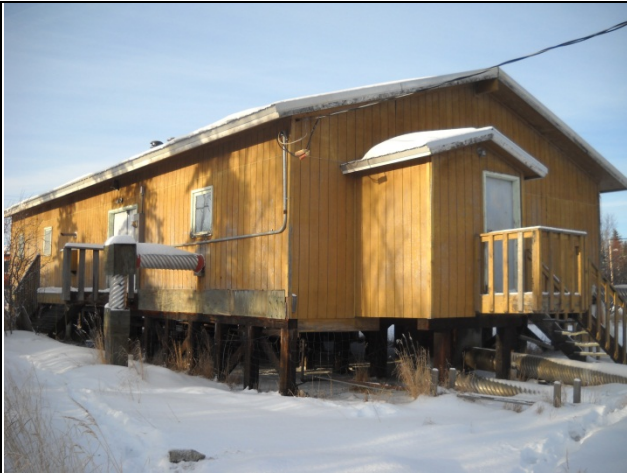
WTP/W Bldg (SE corner, notice insulated well head & piping)

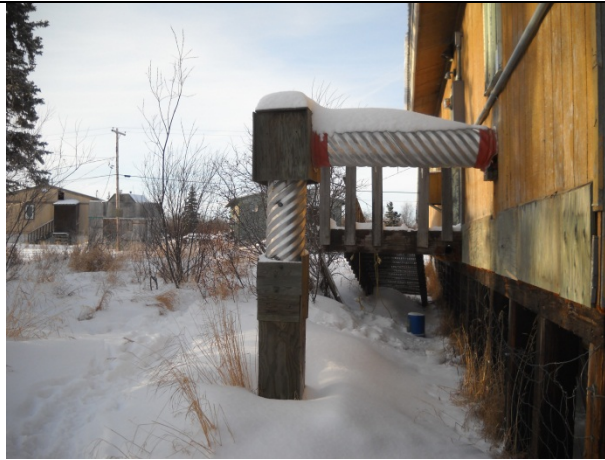
Insulated well head & piping

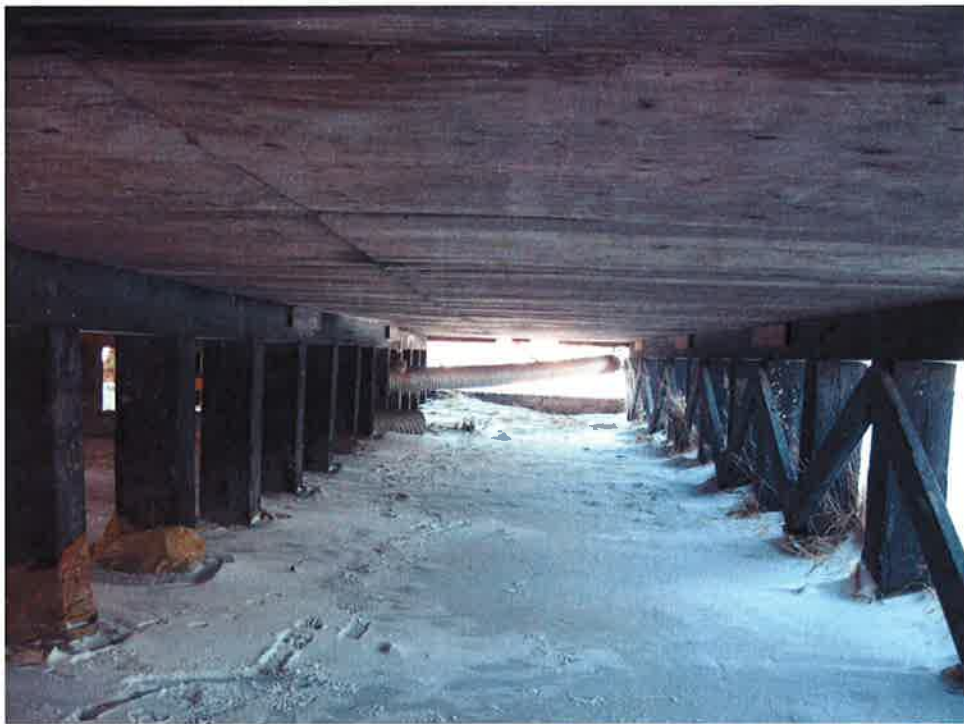
Photo No. 9: Post and Beam Foundation

The foundation system consists of 10x12 treated posts spaced four feet on center along each of the four bents. The posts extend approximately 3 feet below grade and are supported on a treated timber strip footing. Each 10x12 post bears on a 10x12 cross-beam that distributes the loads across the strip footing that consists of treated 4x12s that run the length of the building. The width of the strip footing varies. Under the interior bent supporting the water tanks, the footing is (4) 4x12 planks wide. The other strip footings are two or three 4x12s wide. See sheet 6 for a 3-D perspective of the foundation system.

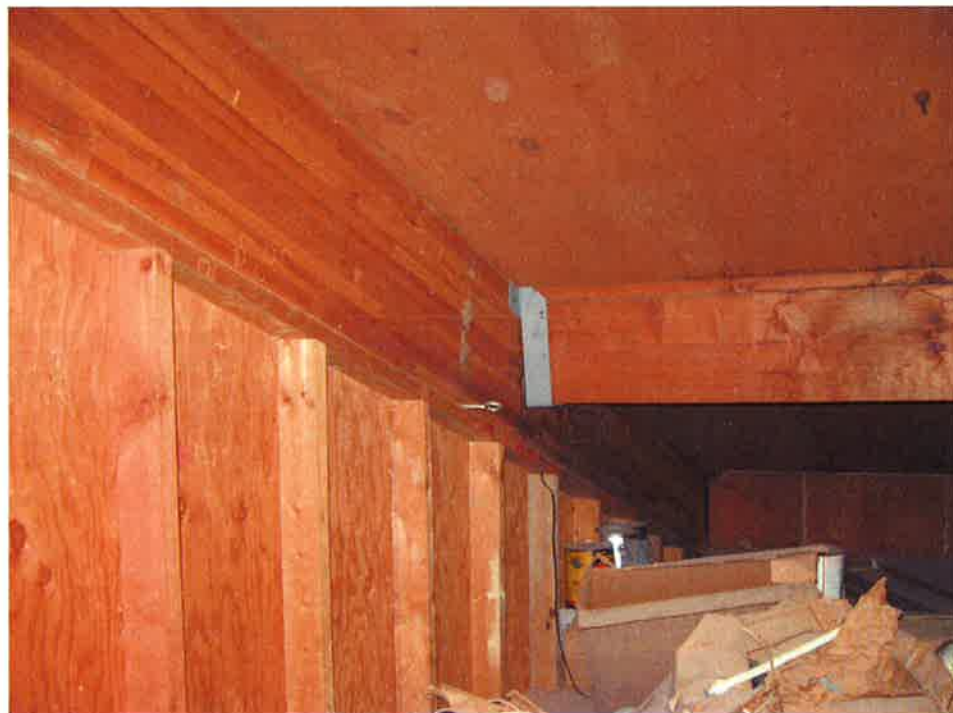
Photo No. 10: Typical Roof Framing

We observed no structural issues with the roof framing. Water stains were noticed on several of the roof beams (Photos 10 and 12), but no rot was observed in the roof framing members. Where glued-laminated beams framed into columns, it appears that the steel hanger connections were too short and the beams were notched to allow for installation (Photo No. 11). This is not a recommended detail as it can lead to splitting of the bottom of the beam at the notch. However, the beams are performing adequately with no splitting. No action is required.

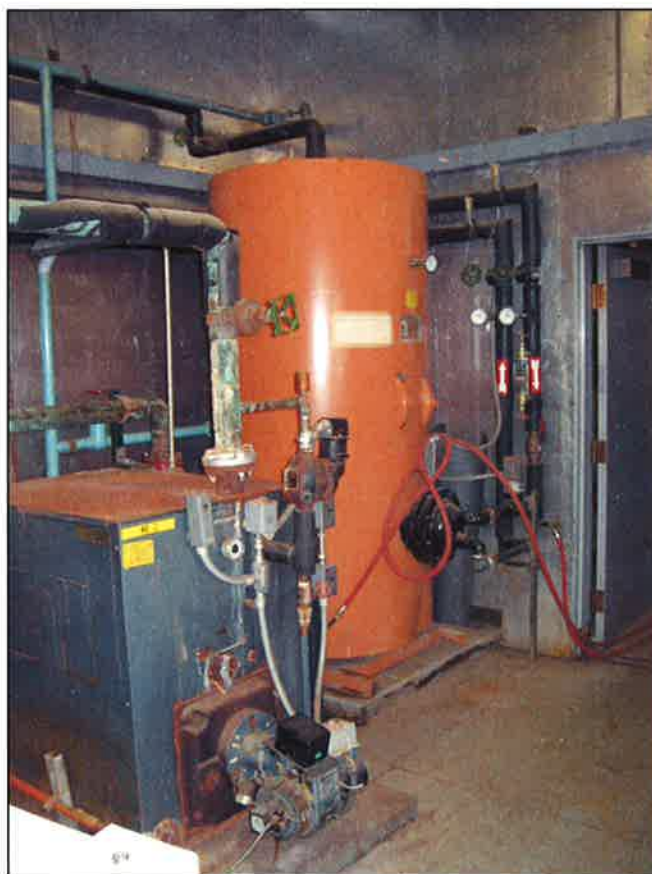
Photo No. 15: Boiler Room – Hot Water Generator

3. Northeast corner of the boiler room, equipment pad for hot water generator (Photo 15 and 16): The hot water tank is supported on a raised equipment pad that is wood framed, not concrete. The front edge of the pad is rotten (see Photo 16 showing knife penetration into wood platform).

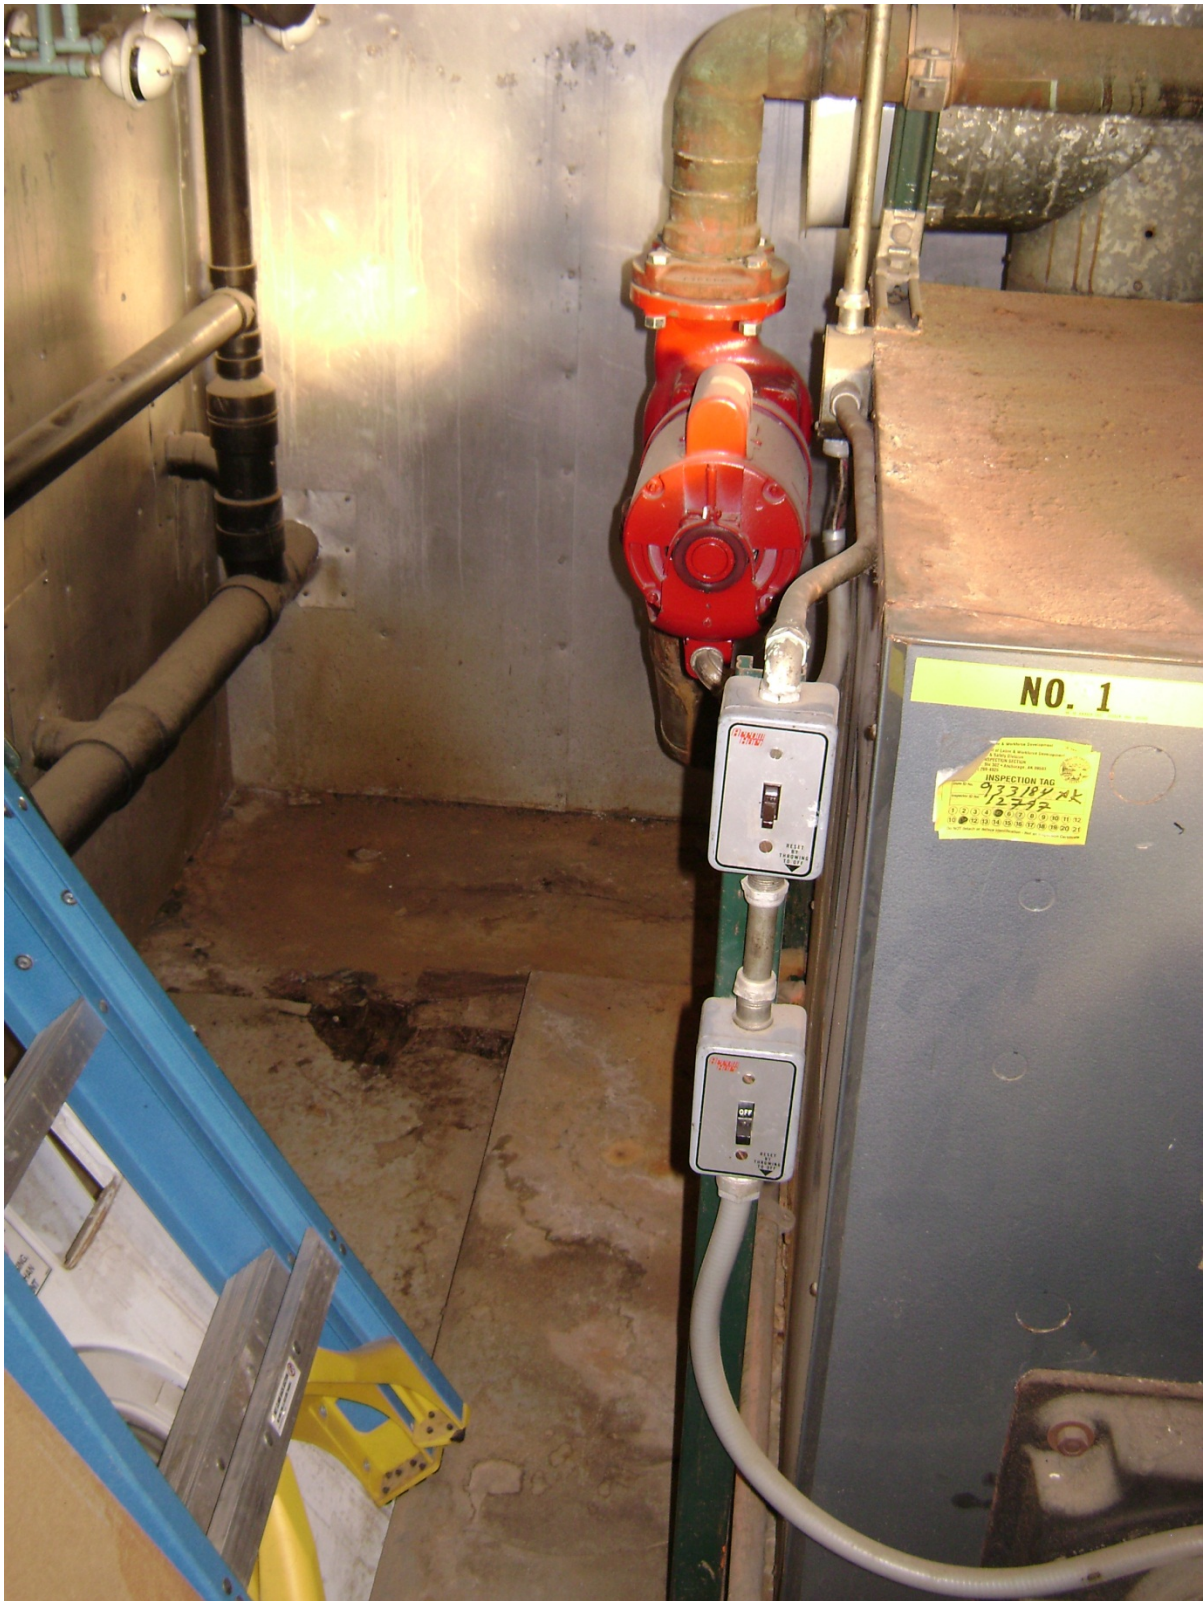
Boiler and Circulation Pump

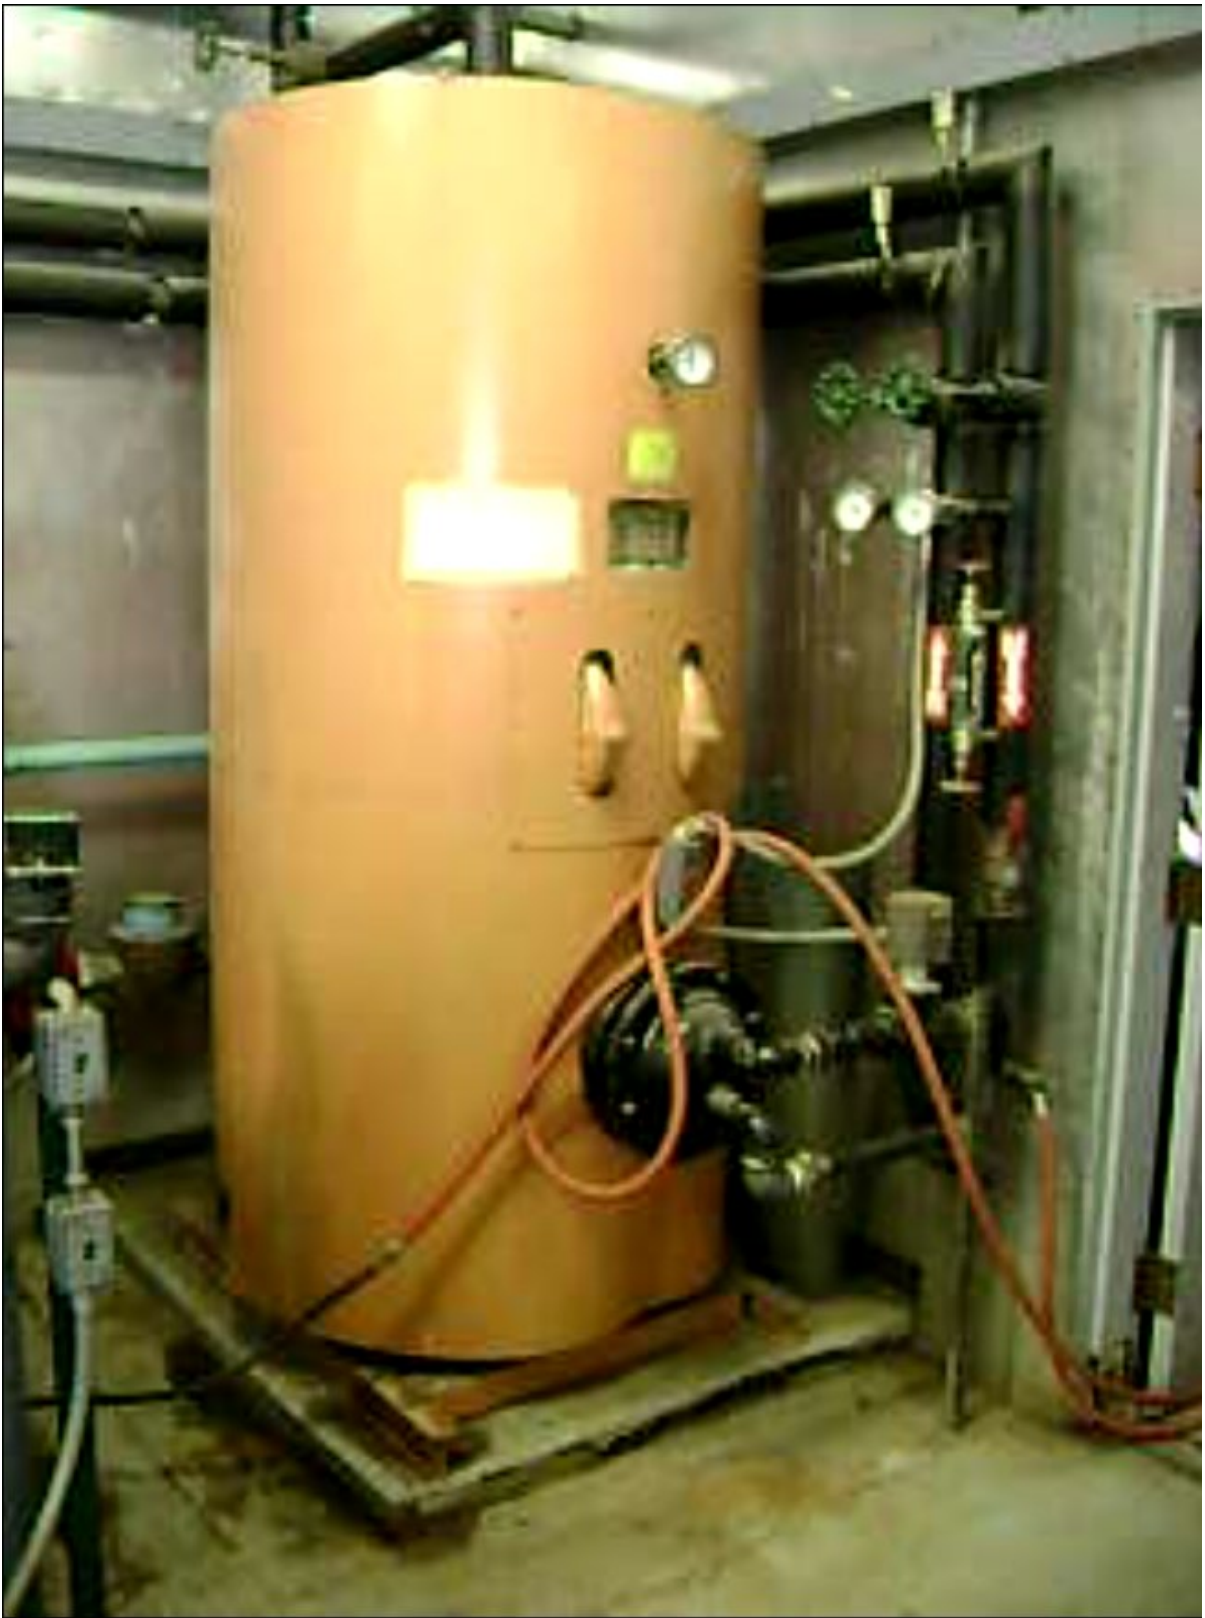
Domestic Water heater with original single wall heat exchanger bundle.

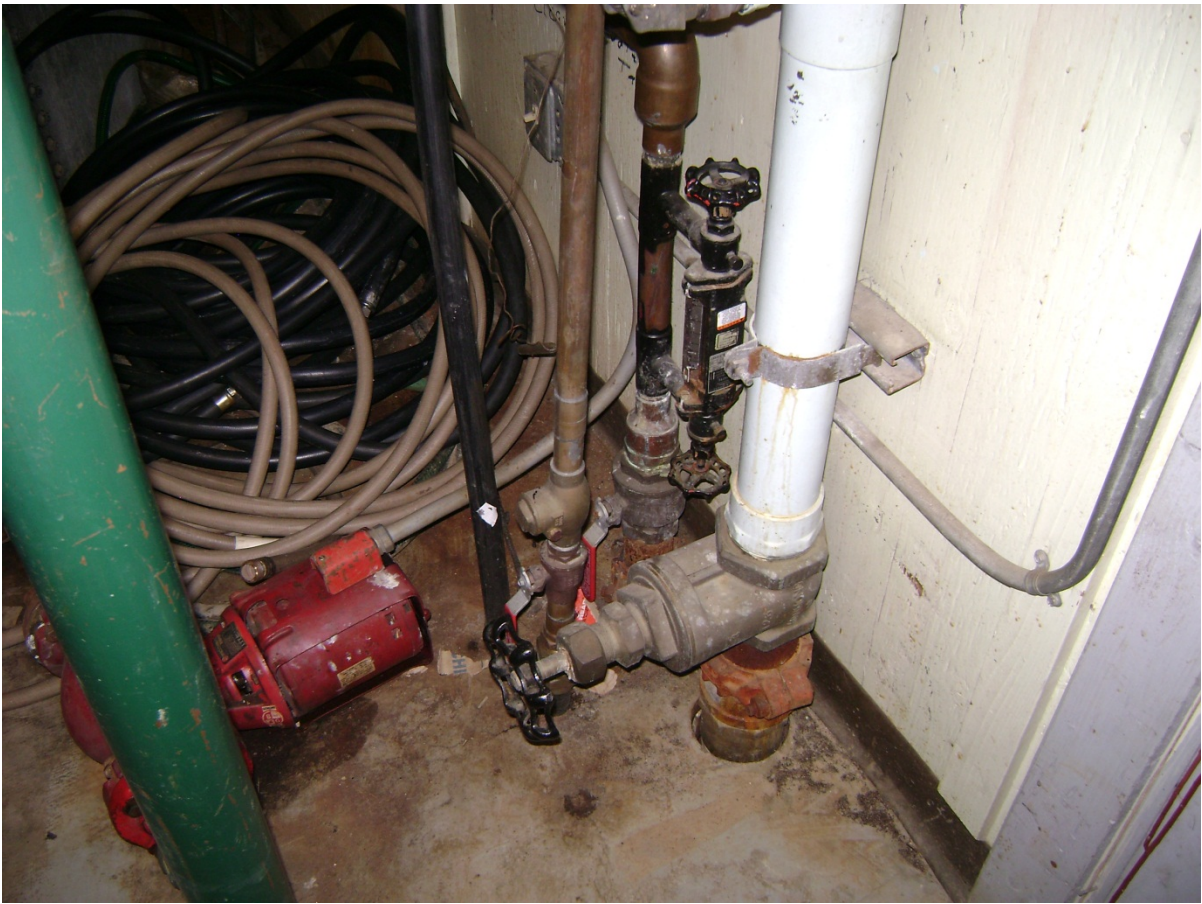
School and Camp Supply Line Heat Exchanger: Operational, although piping arrangement of the camp circulation pumps causes school water meter to turn backward. Heat exchanger is single wall.

School and Work Camp (smaller) water lines thru floor. Raw water tank drain line pump at left.

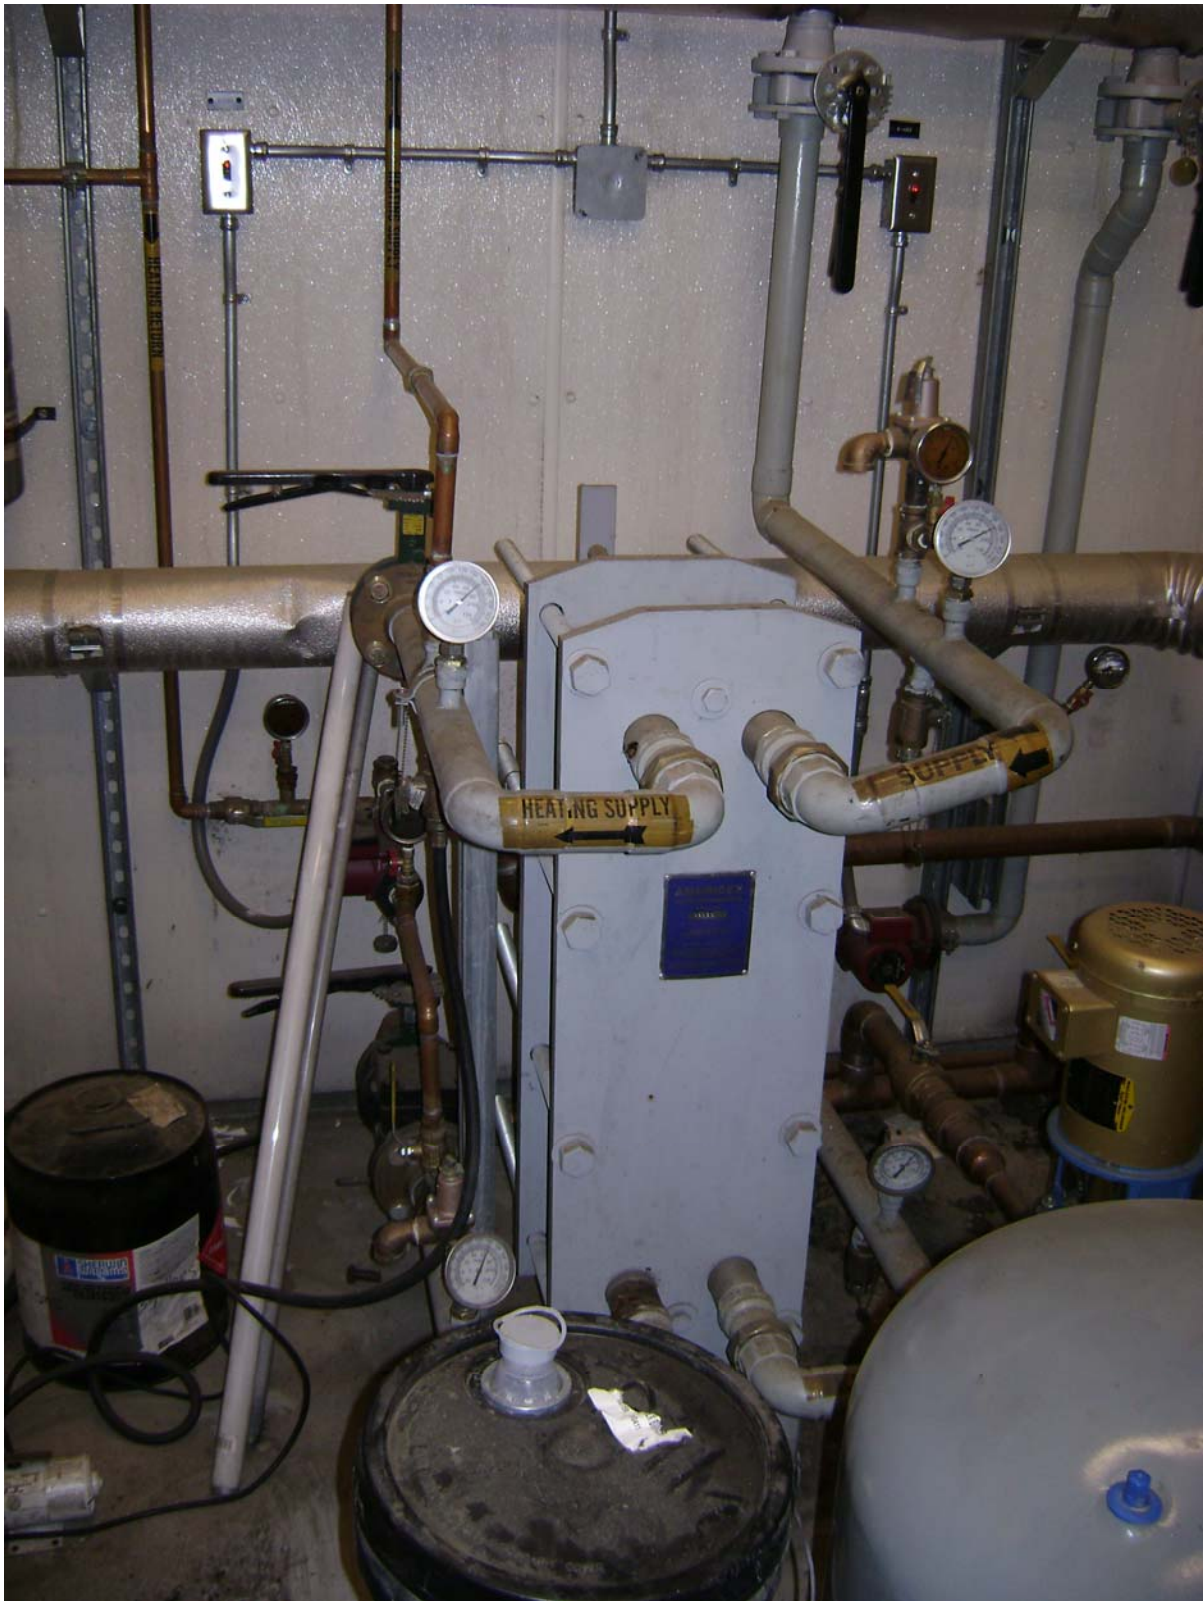
AVEC Waste Heat equipment

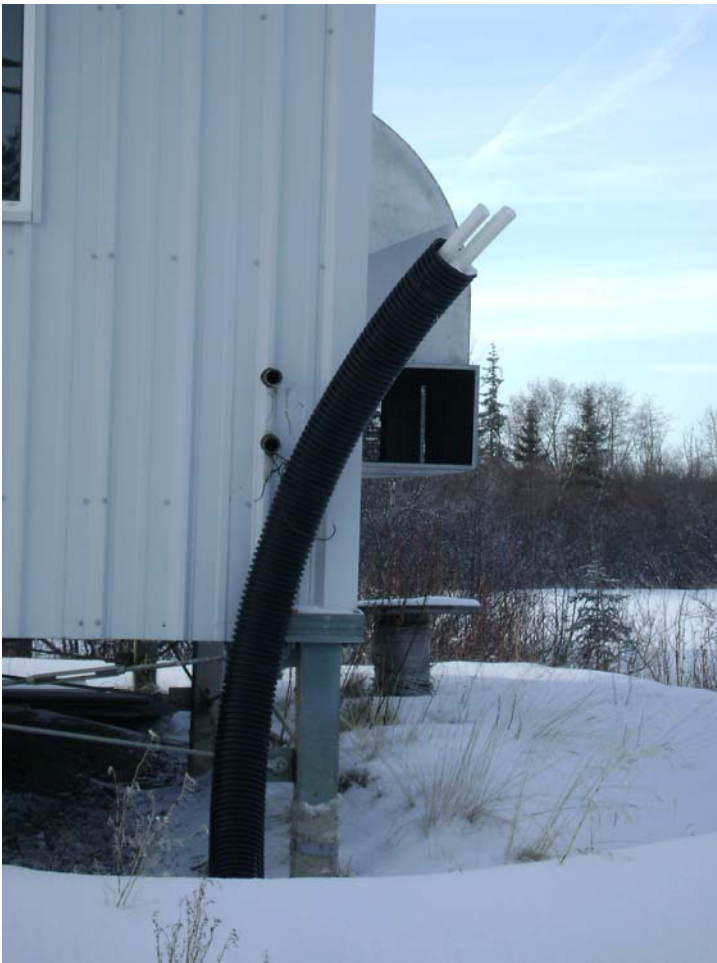
Waste Heat Piping conduit at exterior of power plant.

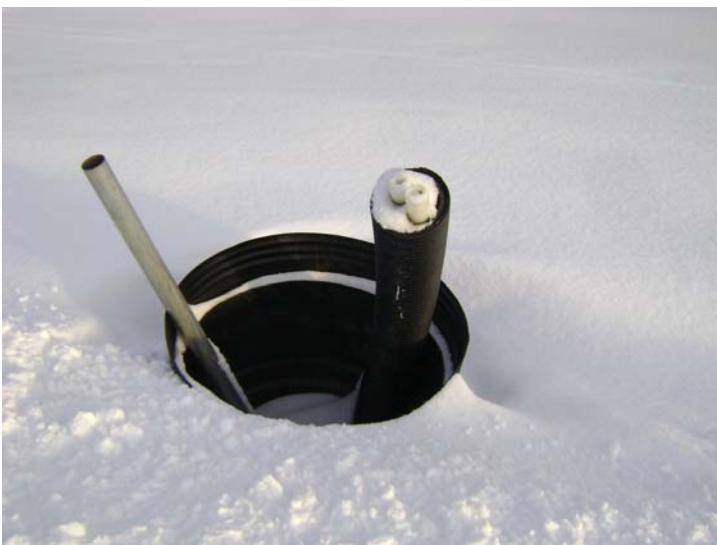
Waste Heat Piping conduit on opposite side of road from power plant.
