# Washeteria Replacement

## Preliminary Engineering Report

### Beaver, Alaska

**FINAL REPORT**  
**May 21, 2019**

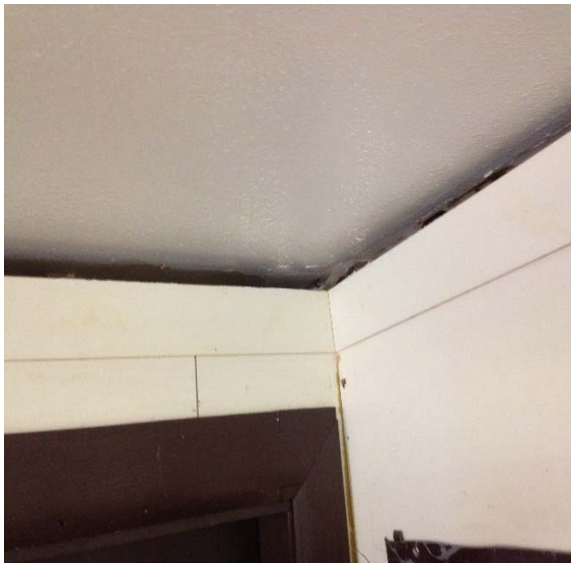
The building now has severe settlement damage. The building has settled approximately four to five inches on one side. There are one- to two-inch gaps along the internal walls where the ceiling has pulled away from the walls. Winter 2017/2018, daylight was visible inside the building due to the gaps. Summer 2018, the building settlement was so great the sewer service broke. Maintenance staff had to cut off several inches of the pipe to reconnect it because the building had settled so much. The community was without access to the washeteria for approximately two days. Interior plumbing also had to be adjusted.

Walls separating from ceiling.

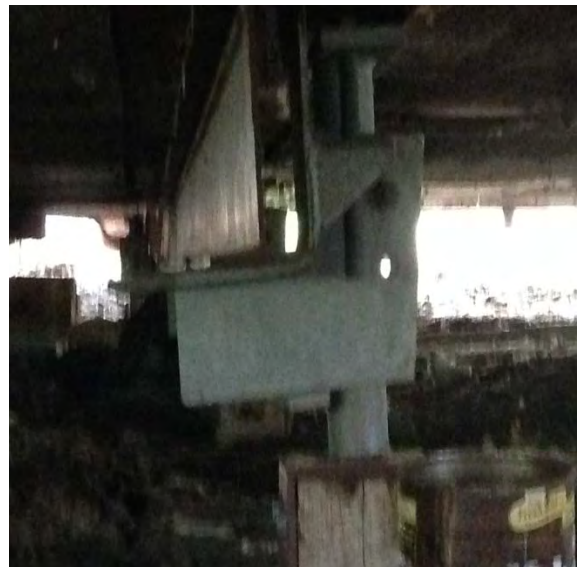
Adjustable Foundation Retrofit.

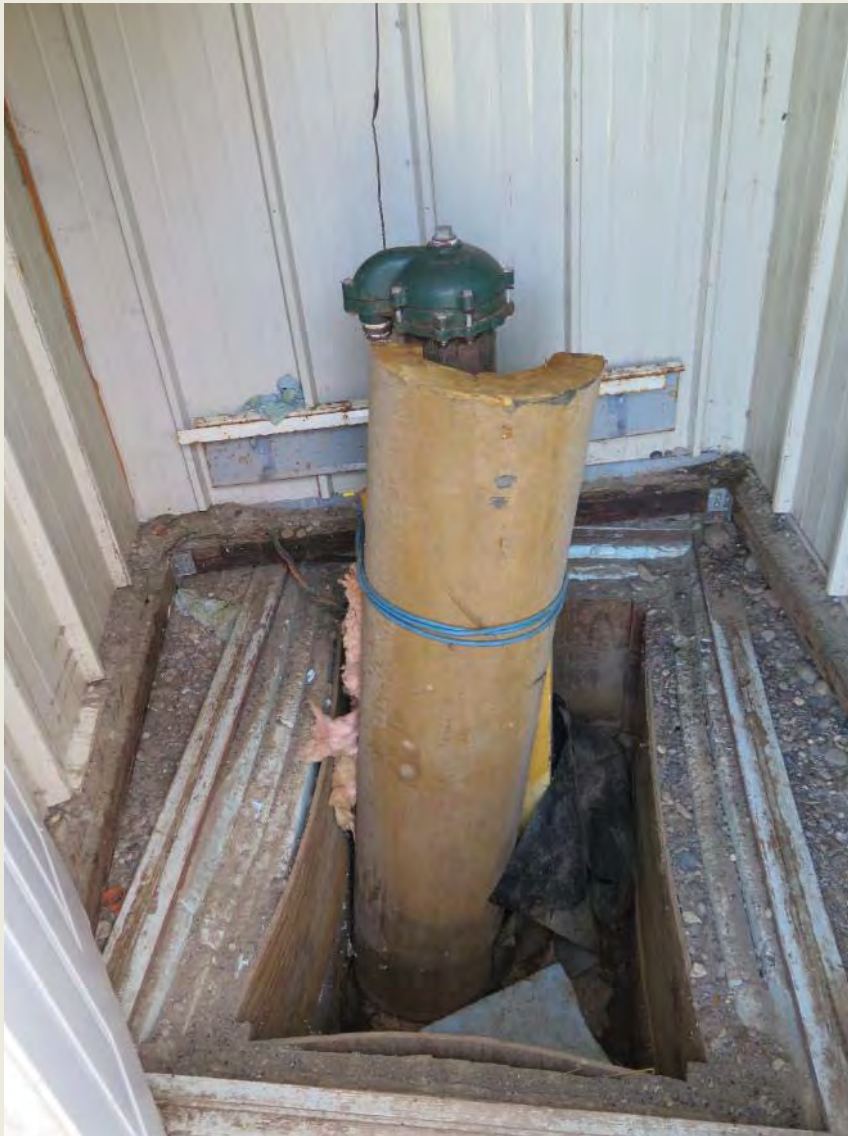
1. The well log does not indicate whether or not the well was grouted and it is located in a pit which is prohibited under drinking water regulation 18 AAC 80.015. The surveyor noted that this pit was previously filled, but fill was removed to facilitate installation of heat trace plumbing and never backfilled. The pit and surrounding well house floor must be backfilled with a low permeability material (eg: bentonite/soil mixture) and sloped to drain away from the well in all directions. The top layer of the fill may be a material that is more suitable for foot traffic.
2. The downturned electrical access point on the well that also serves as a vent was not screened (photo log page 3, photo 3). A screen must be installed to help prevent potential sources of contamination from impacting the source.

Photo 2: Well WL001, showing pit left when gravel fill was removed to install glycol heat trace piping

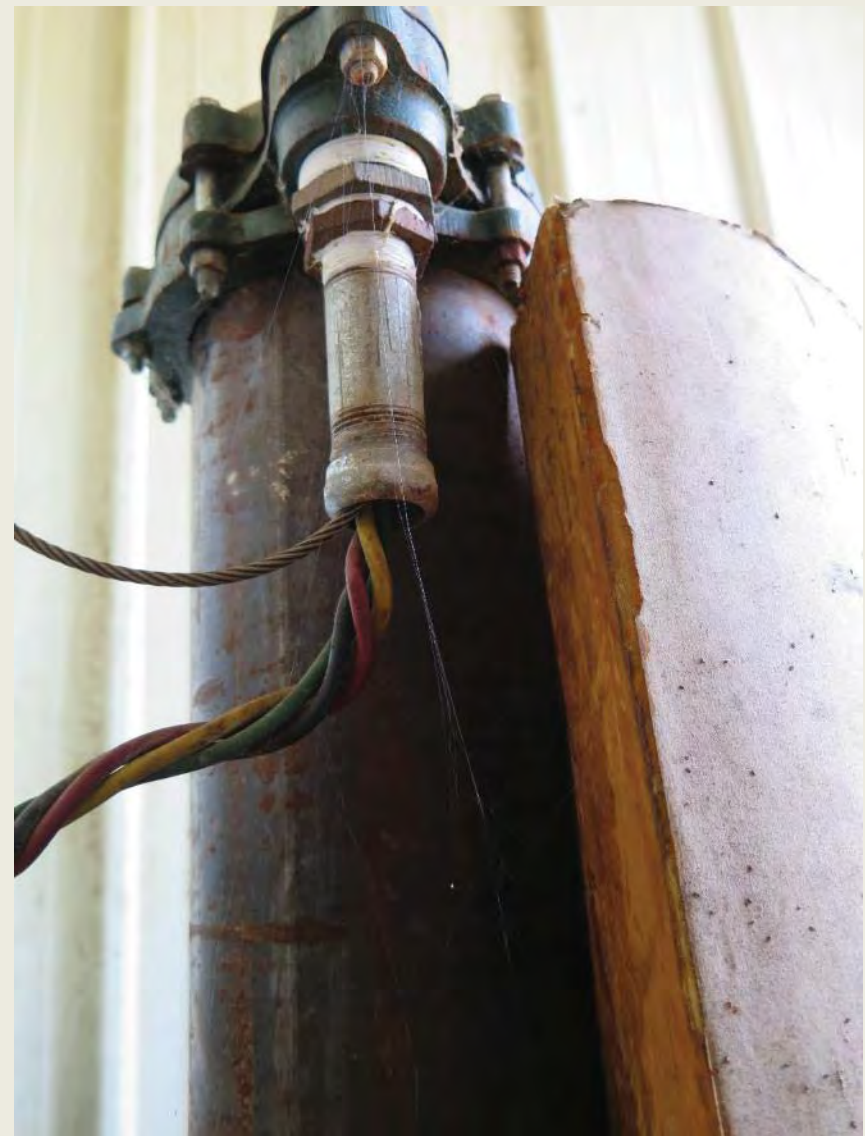
Photo 3: Well WL001, electrical power cables and conduit

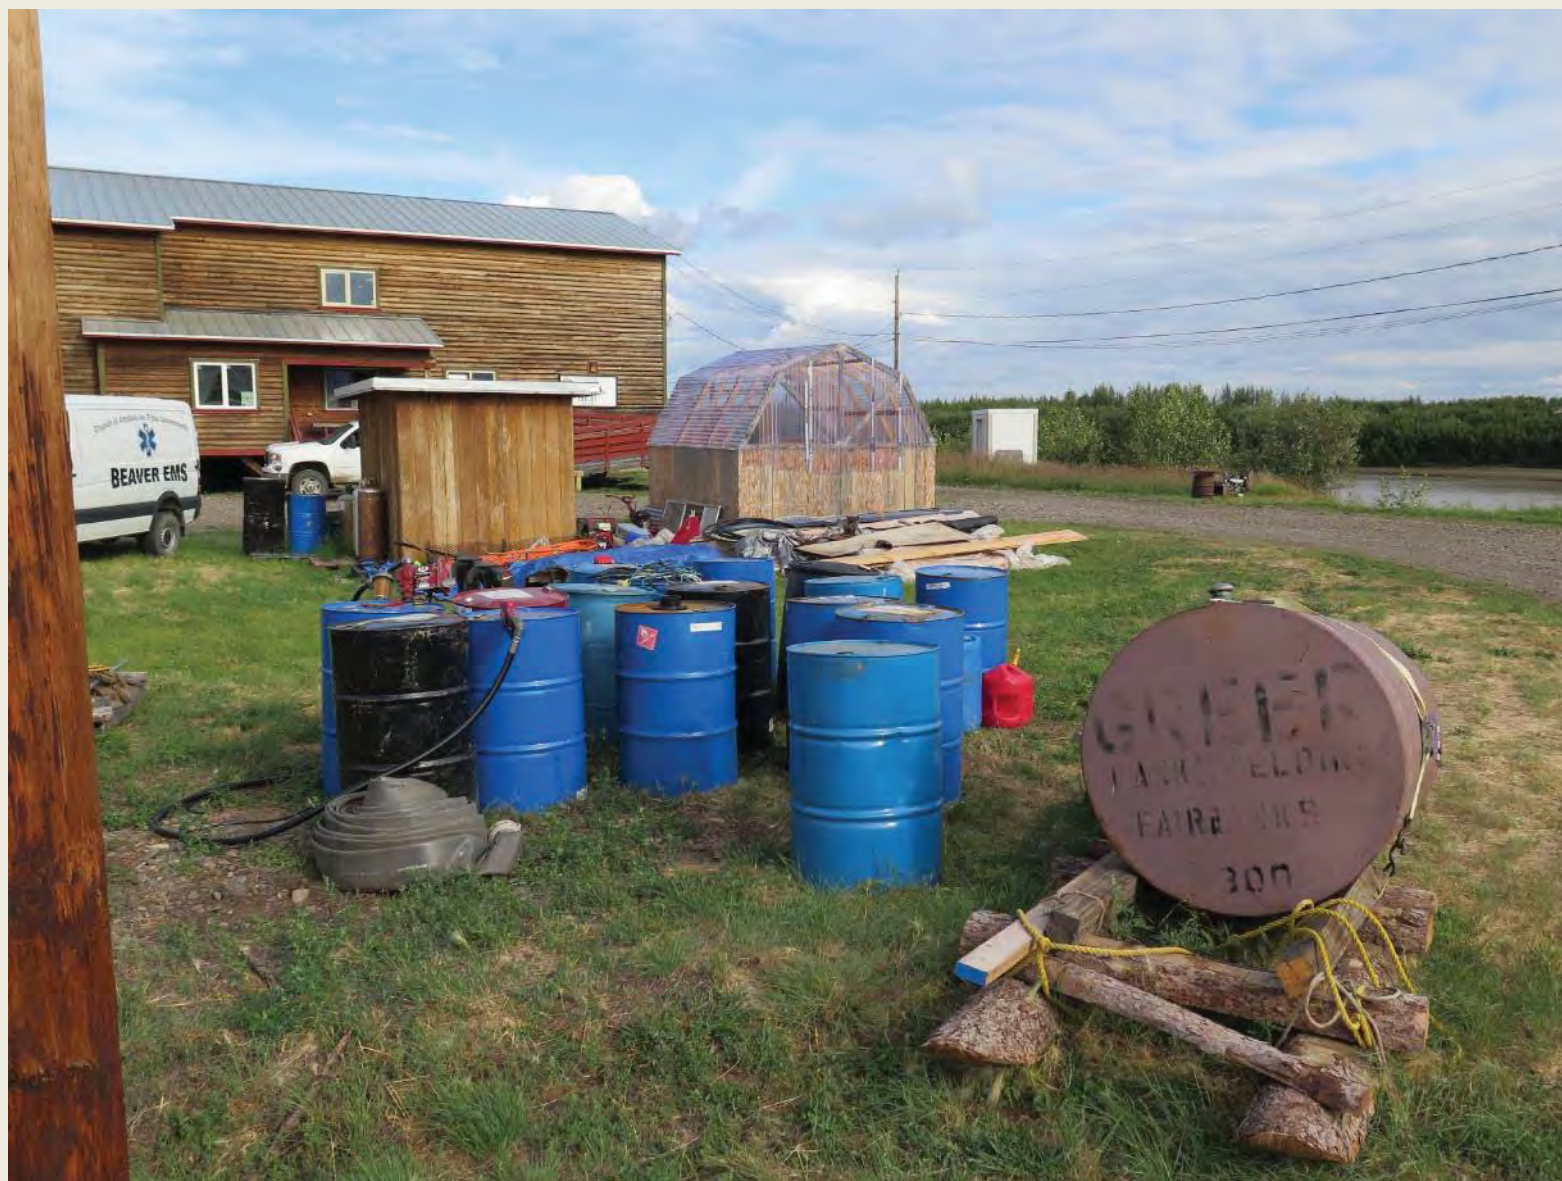
Photo 7: Unlined gasoline and lubricant filling station and storage near Well WL001 (seen in background)

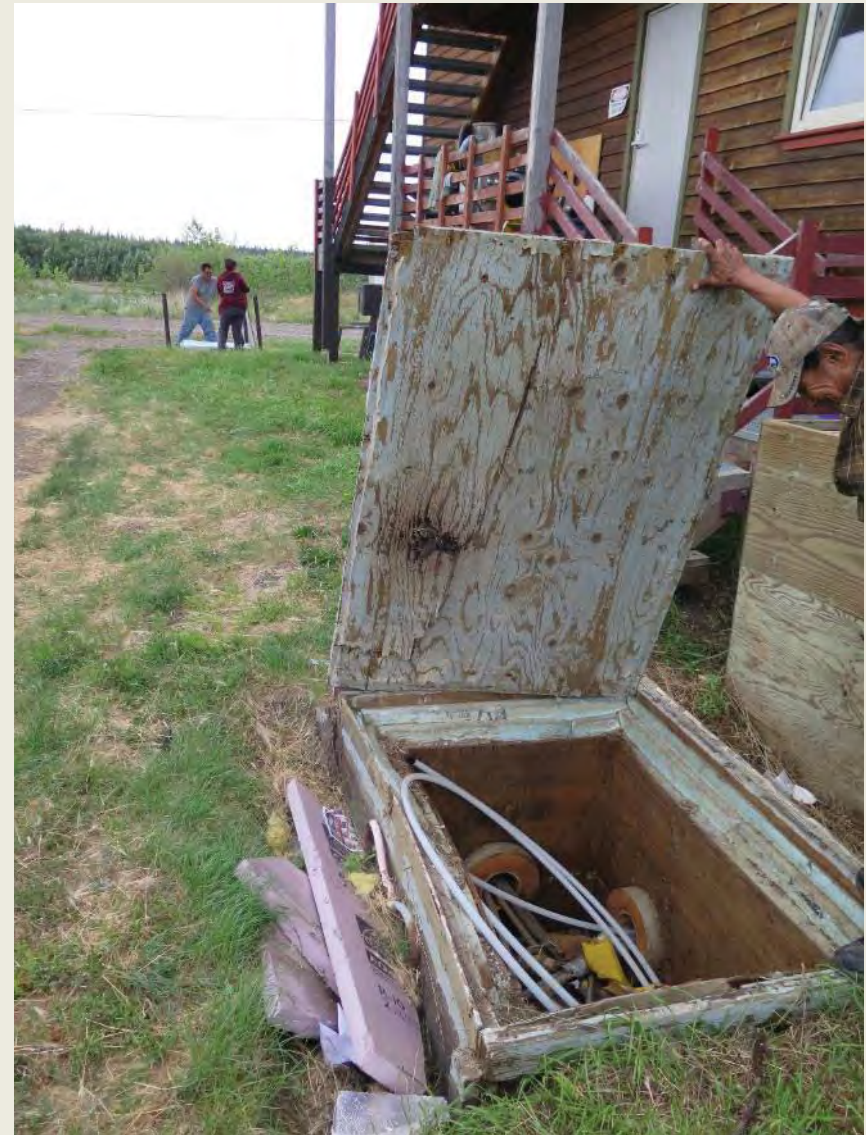
Photo 9: Second manhole on raw water transmission line, where it joins treated water and sewer utilidor behind multi-purpose building (first manhole in background). New PEX tubing (white) for in-progress service line project visible.

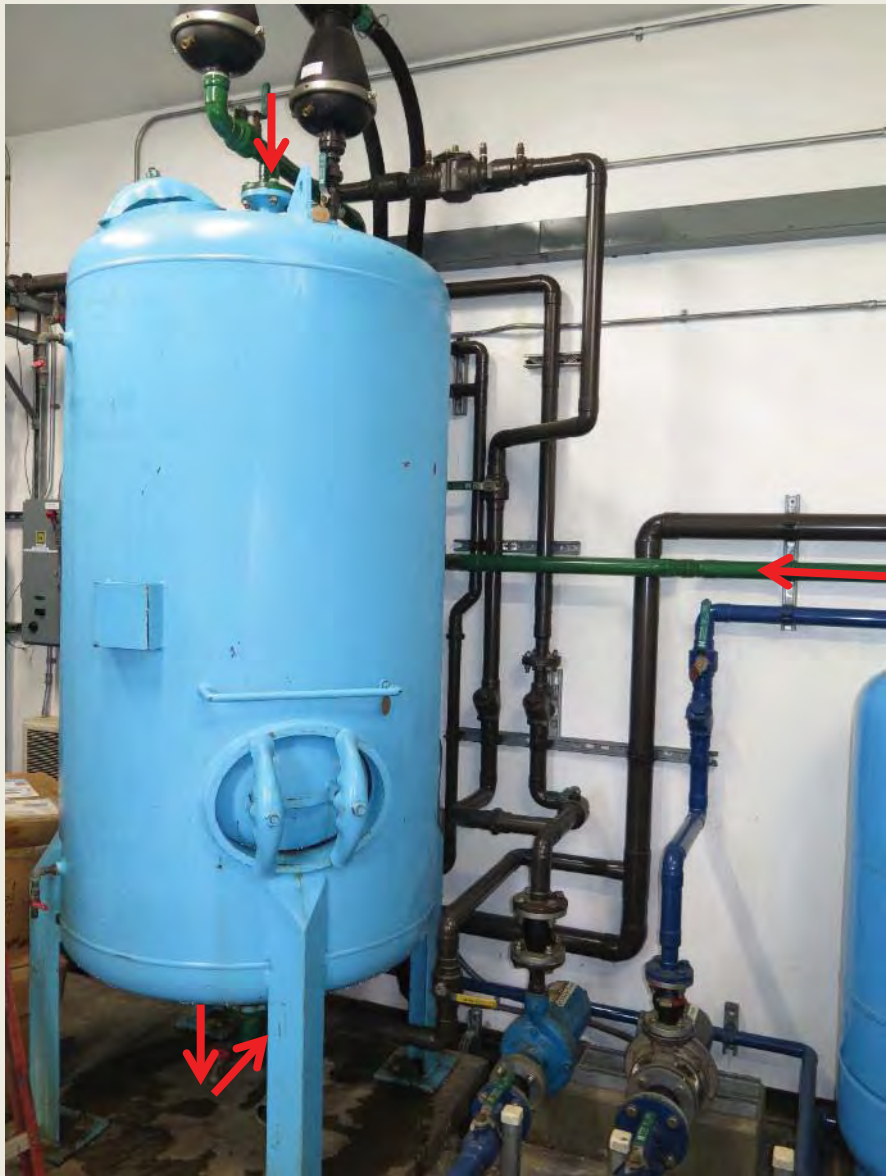
Photo 14: Raw water detention tank, intended to provide contact/reaction time for oxidation of iron and manganese.

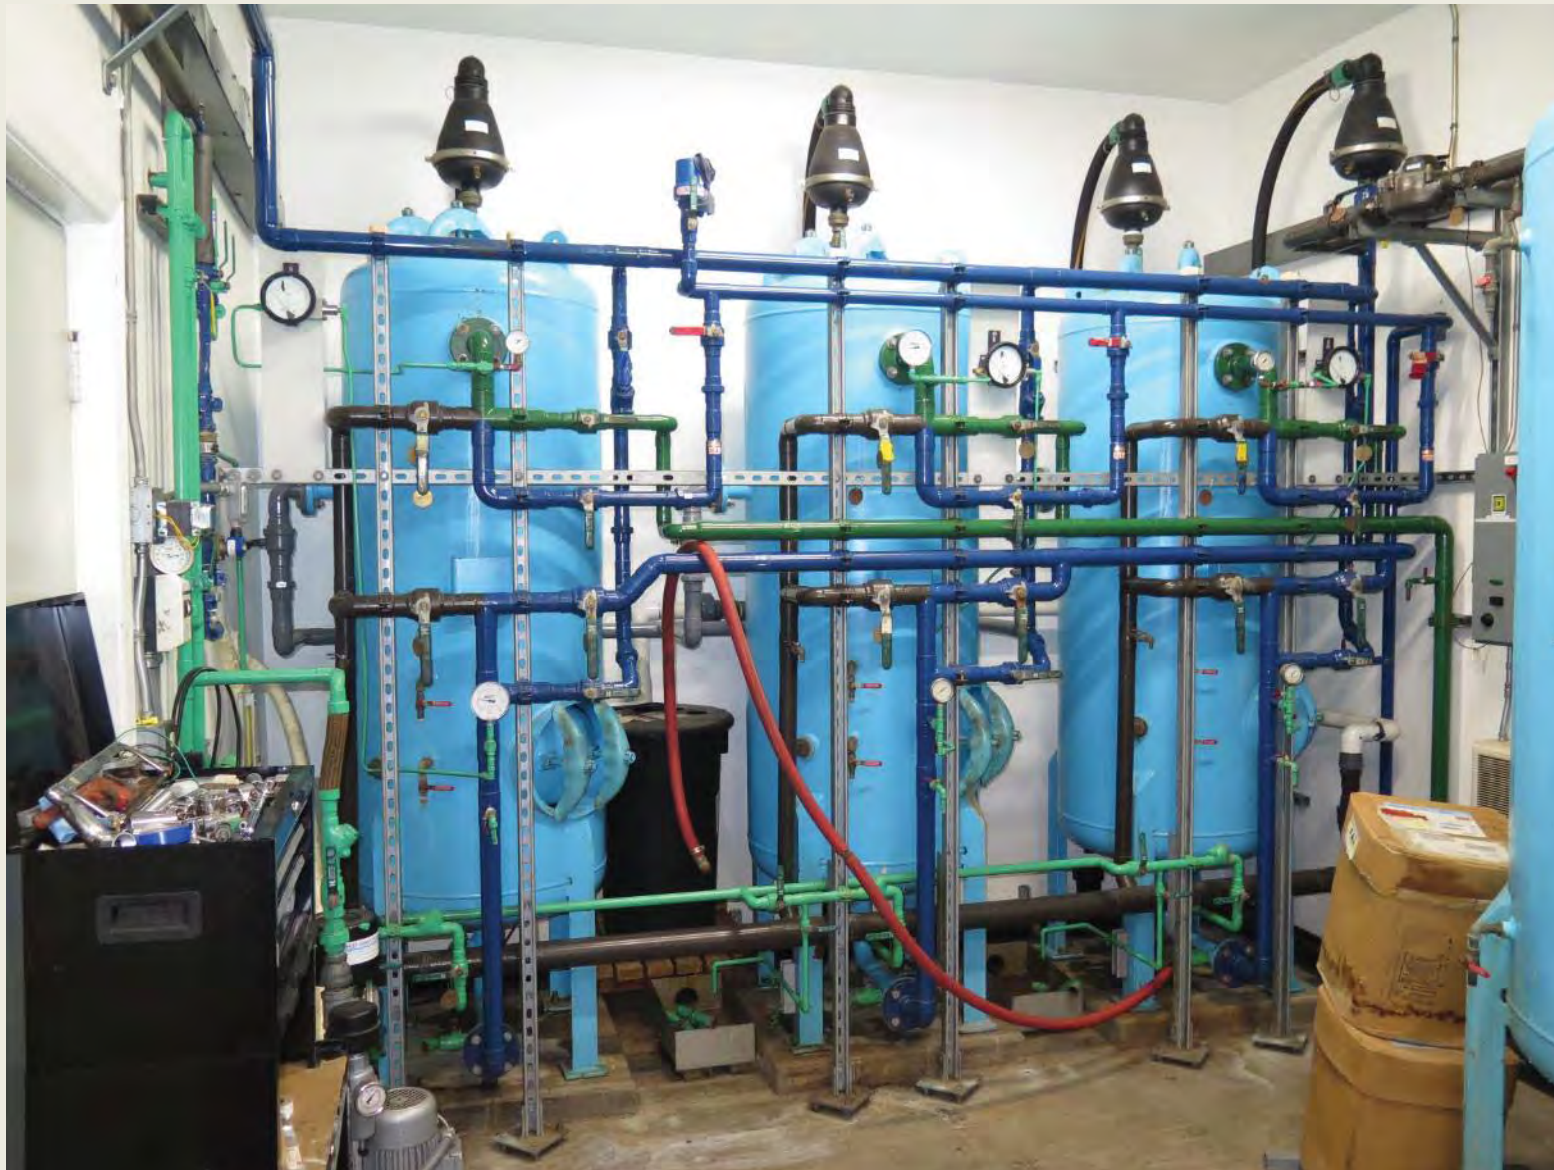
Photo 16: Greensand filters. Raw water piping in green; filter effluent in blue, backwash dark brown piping. Air scour piping in light green.

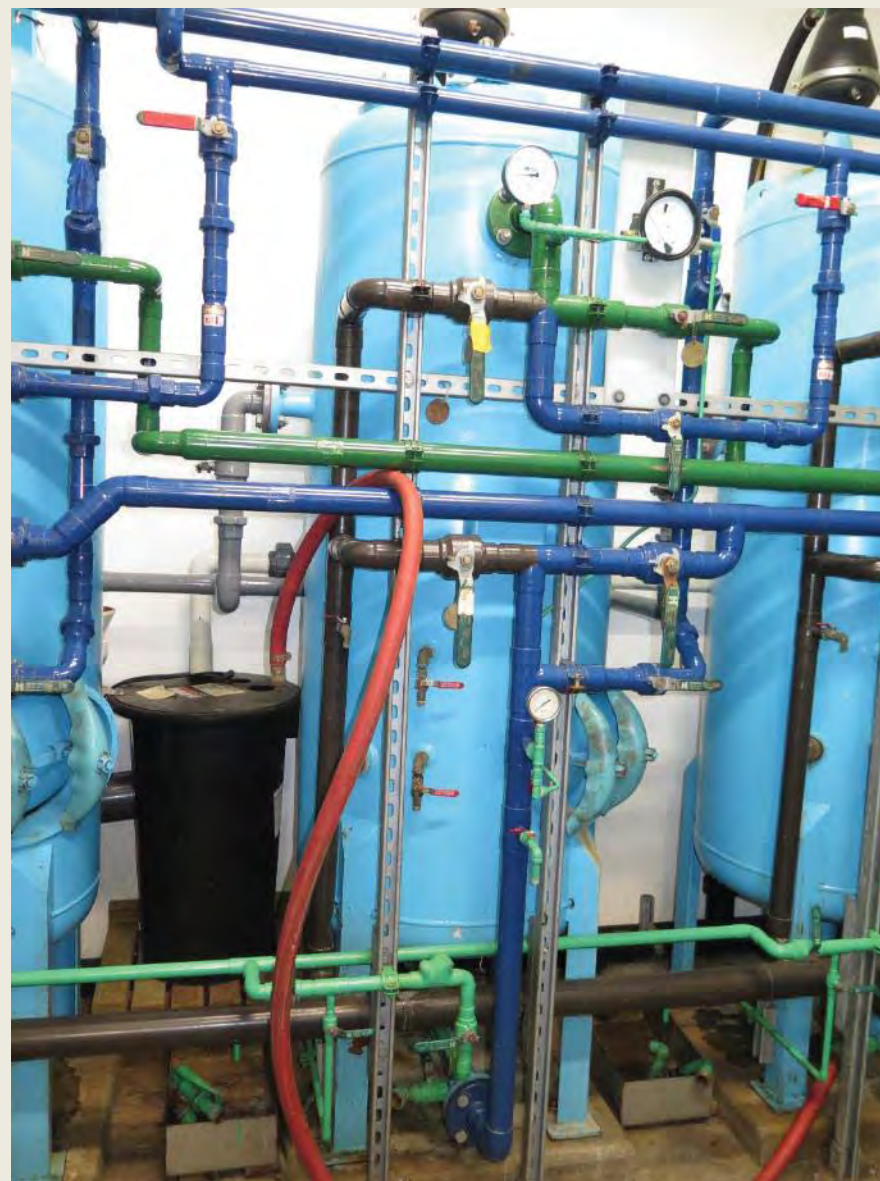
Photo 18: Filter vessel piping and sump tank, used to collect and pump freeboard drain effluent to backwash tank.

3. The hose used to drain the filter vessel freeboard effluent before backwashing must have and maintain an air-gap that is at least two times the diameter of the drain hose above the backwash tank where it discharges (photo log page 14, photo 18).

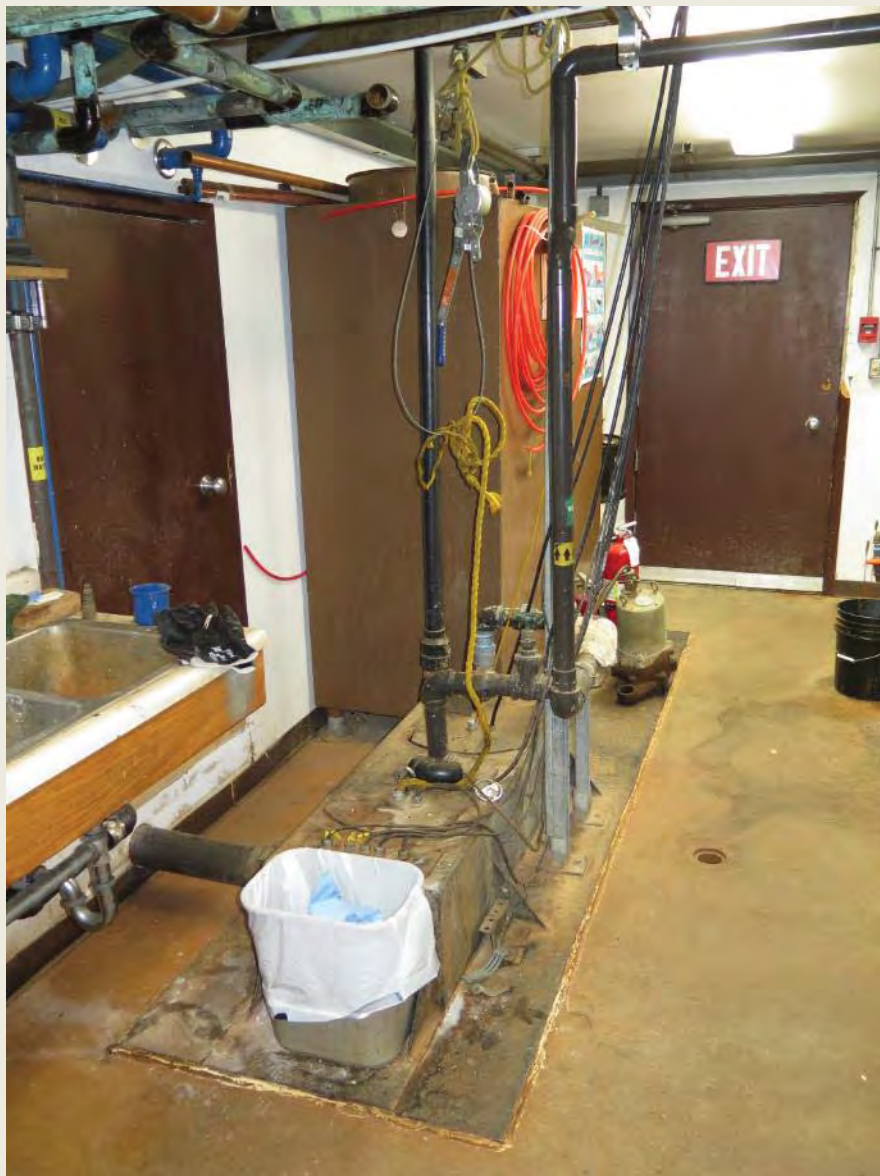
Photo 19: Washeteria lift station, with backwash detention tank in background..

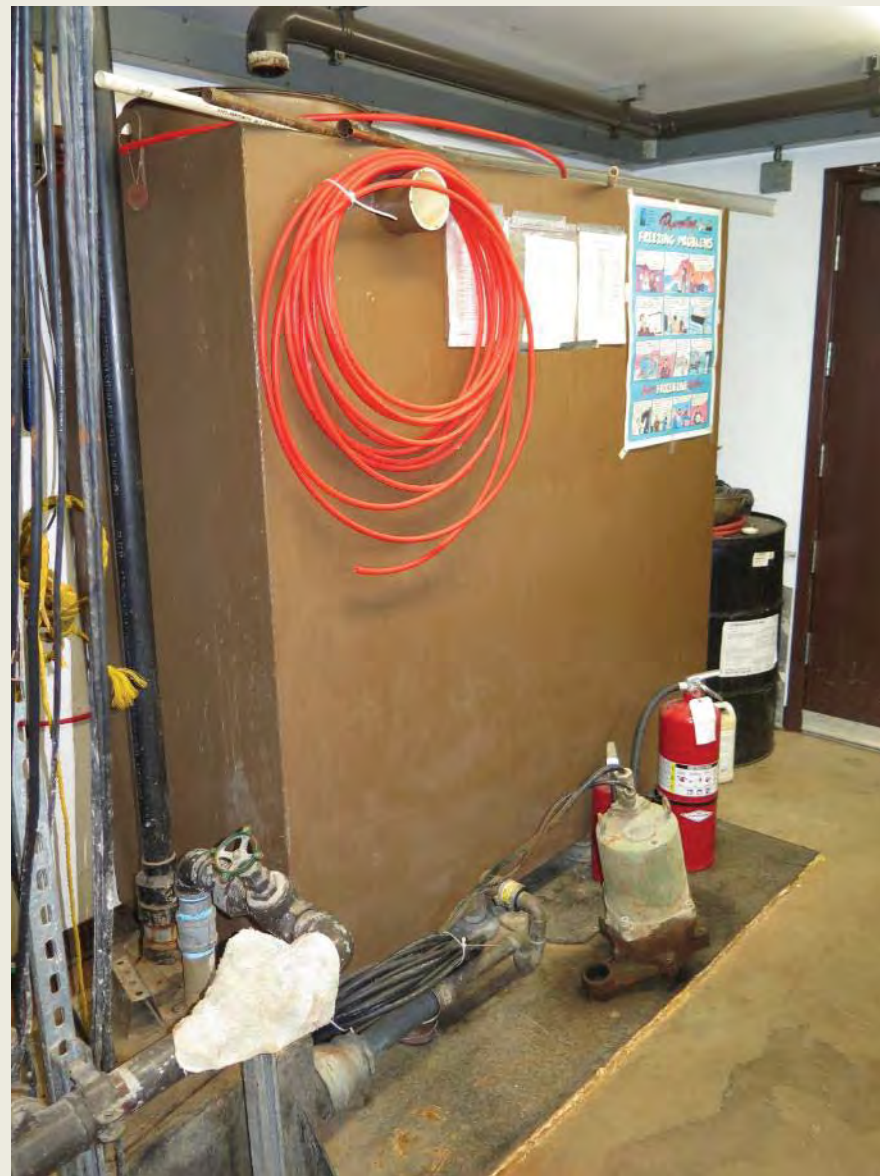
Photo 20: Backwash detention tank, hard-piped to lift station at bottom, air gap at top.

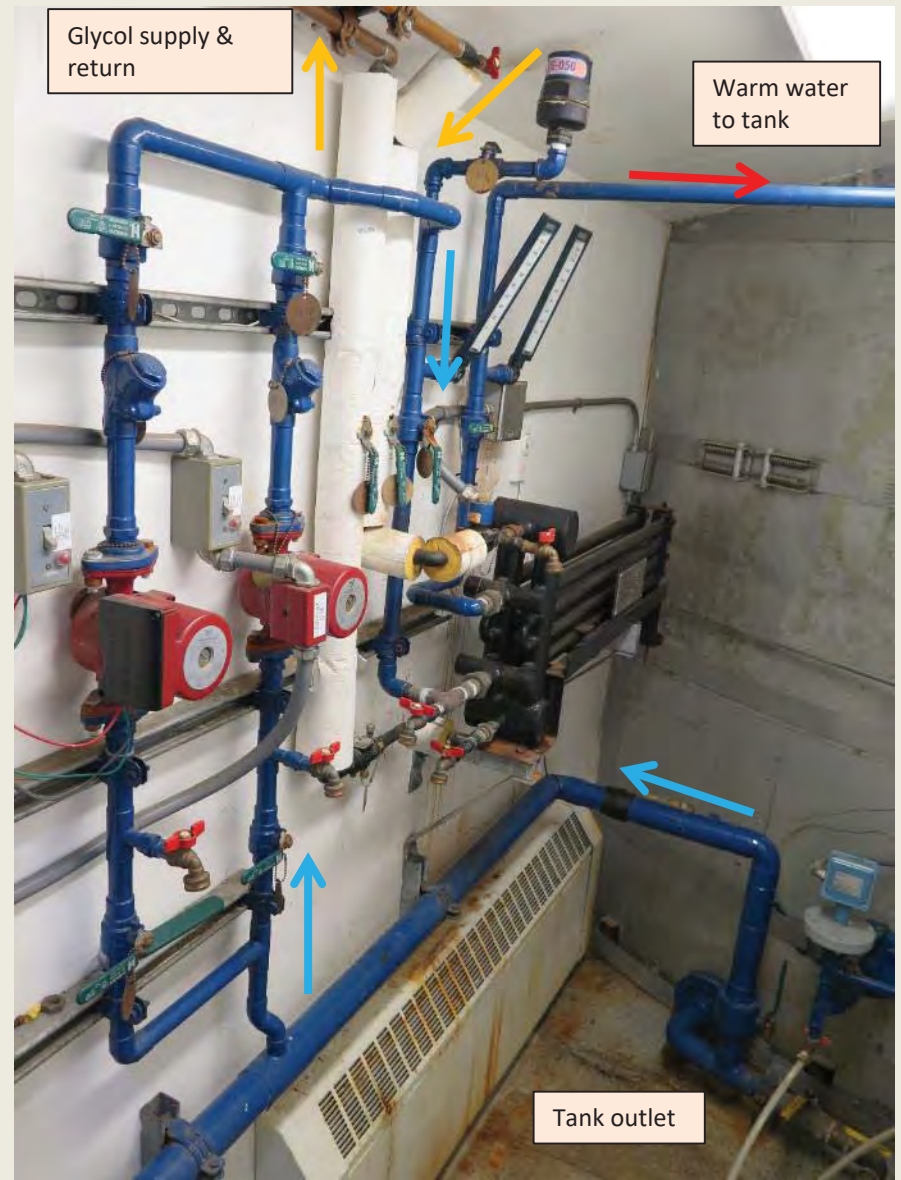
| | Notes: <div style="border: 1px solid black; padding: 5px; display: inline-block;">The water storage tank add heat system is inoperable due to a failed heat exchanger. This leaves the water storage tank vulnerable to freezing. The remainder of the distribution system is protected and suffered no freeze-ups during the cold winter of 2016</div> | |

Photo 22: Storage tank finished water outlet & tank add heat system (heat exchanger not functional)

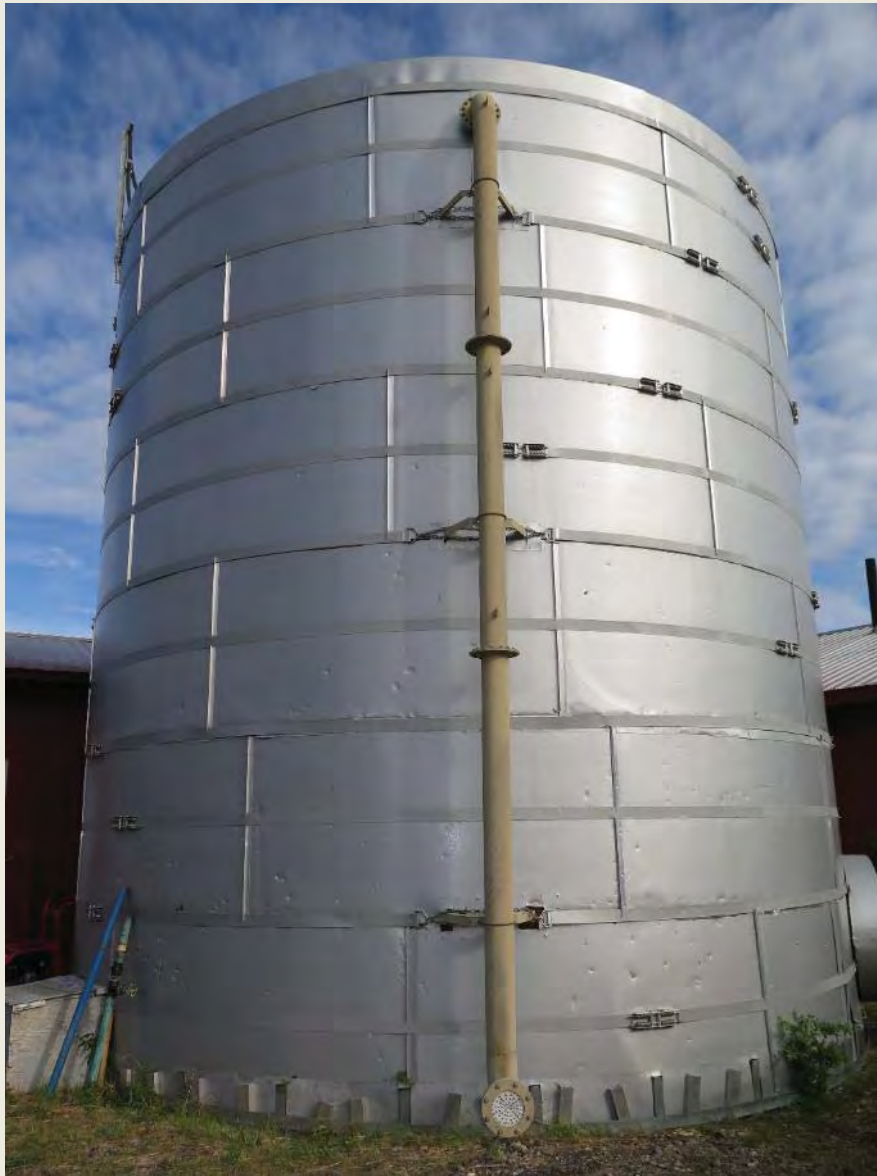
Photo 25: Water storage tank, showing overflow pipe with perforated screen.

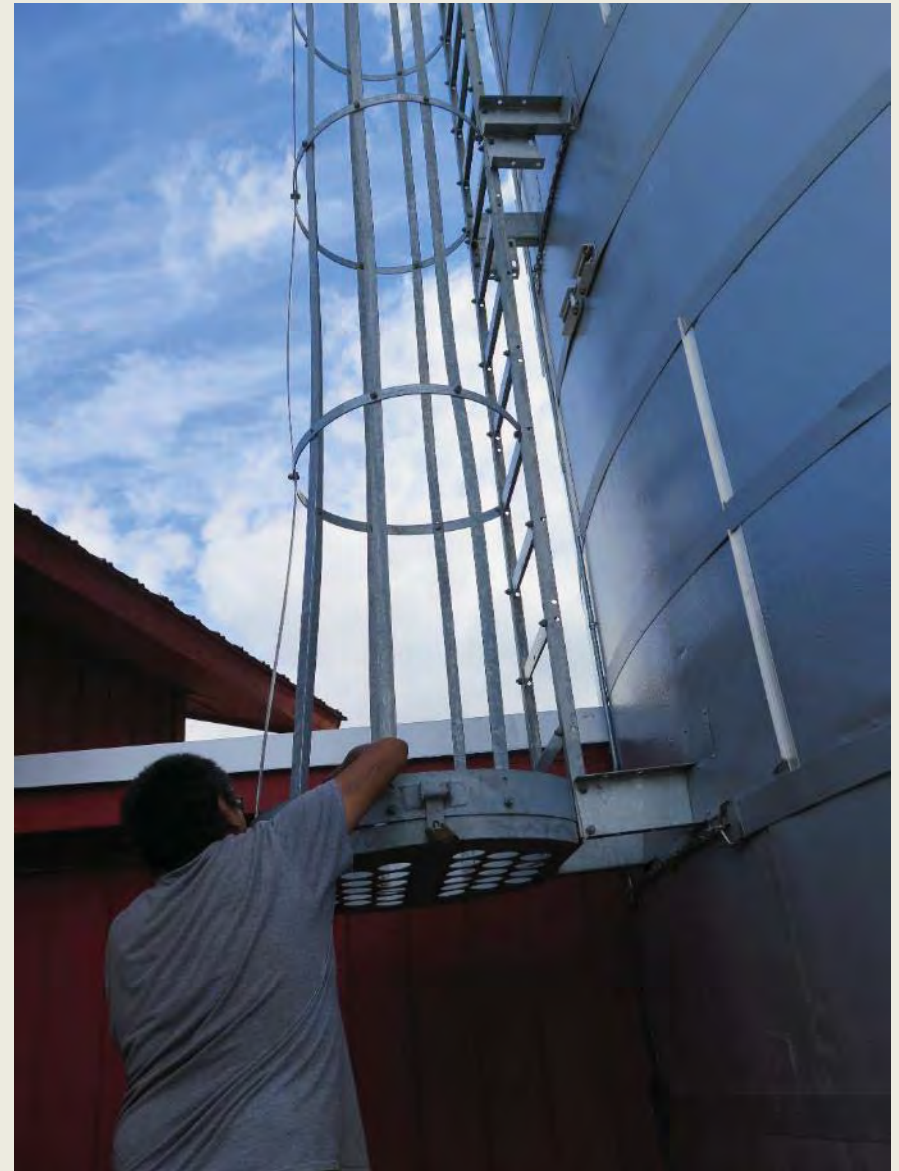
Photo 26: Tank access ladder.

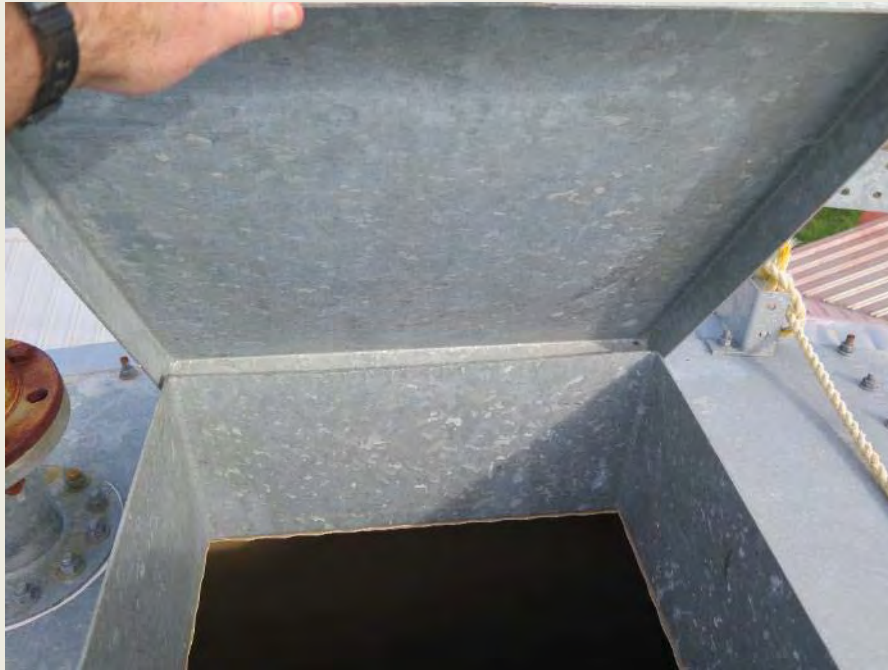
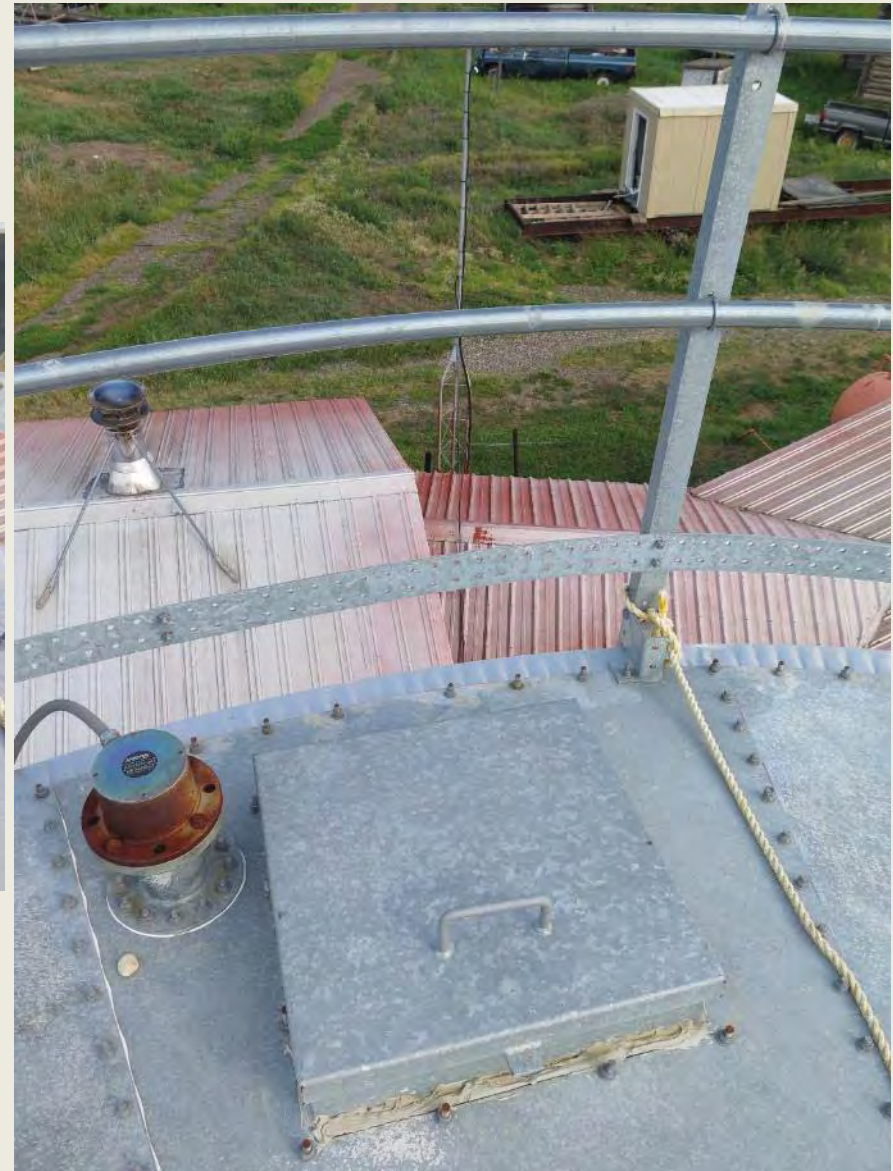
Photo 27: Tank cover.

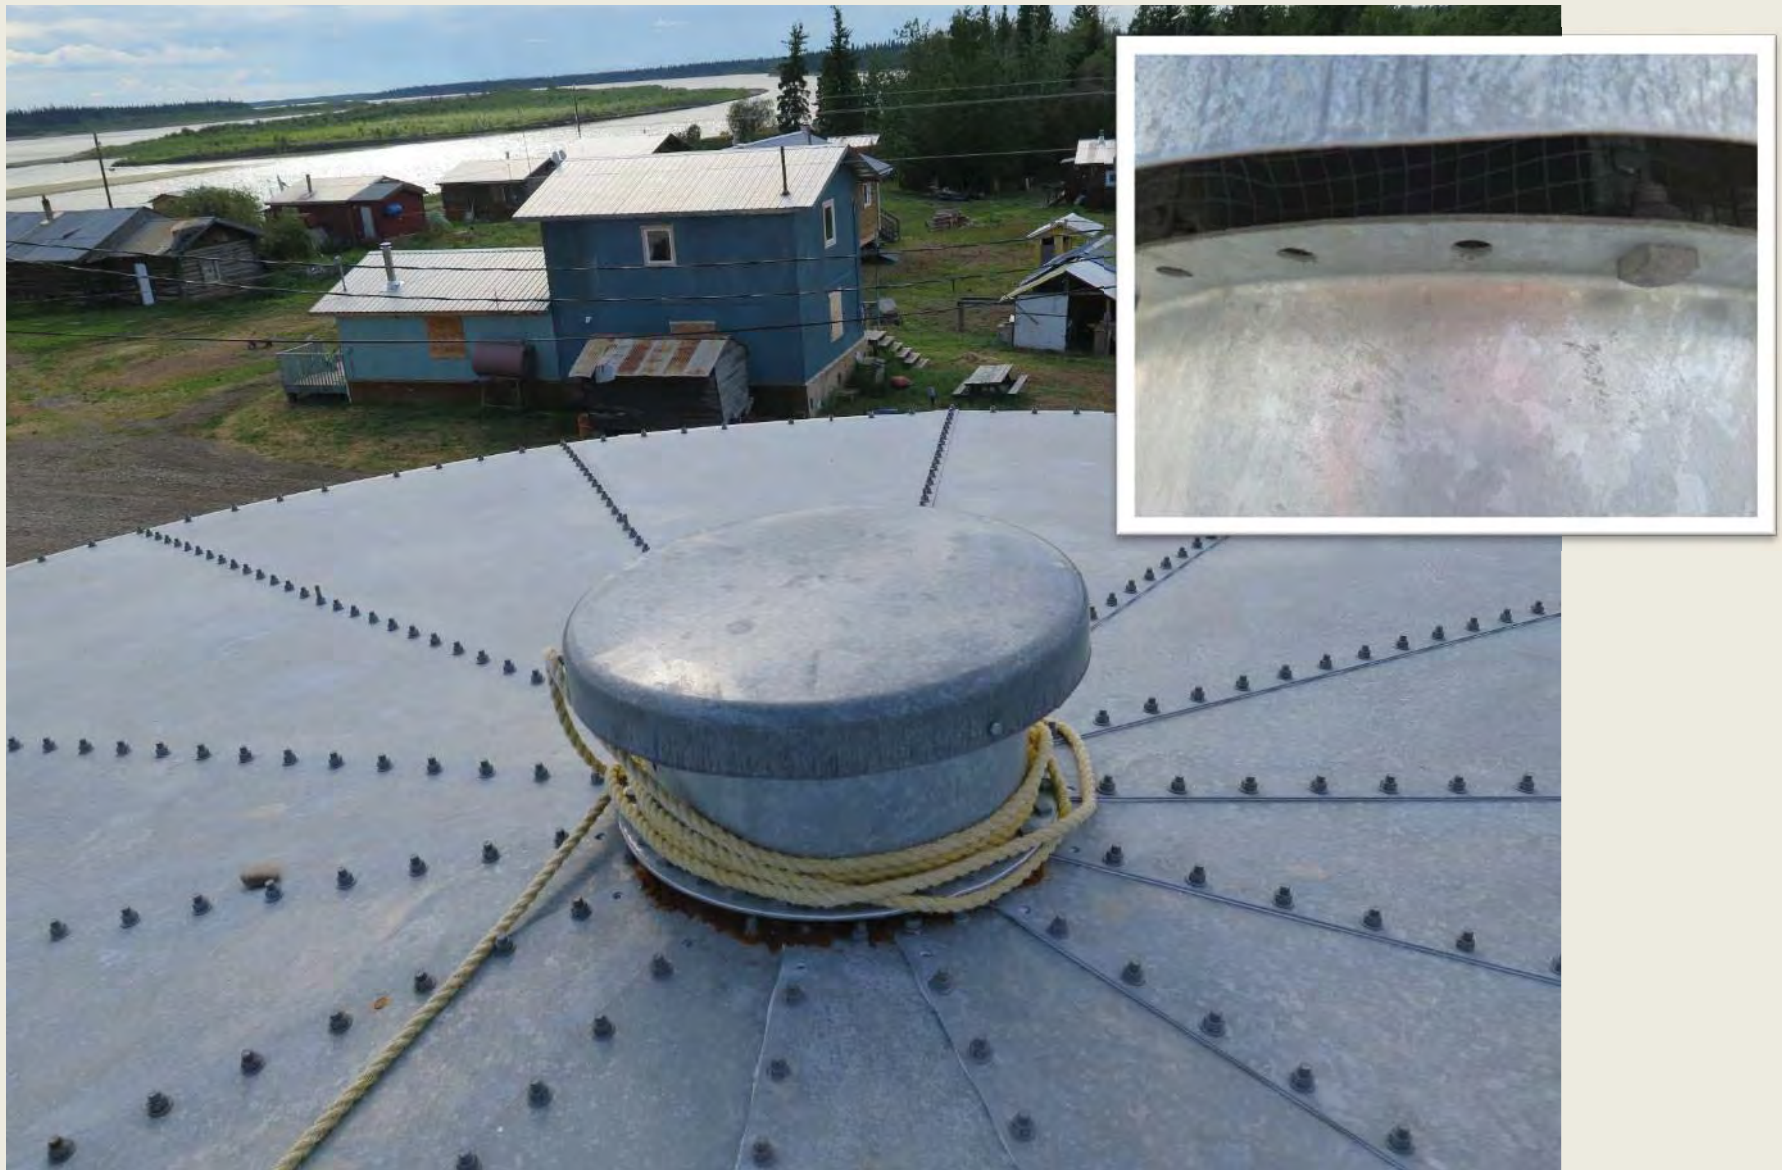
Photo 28: Tank vent & screened opening

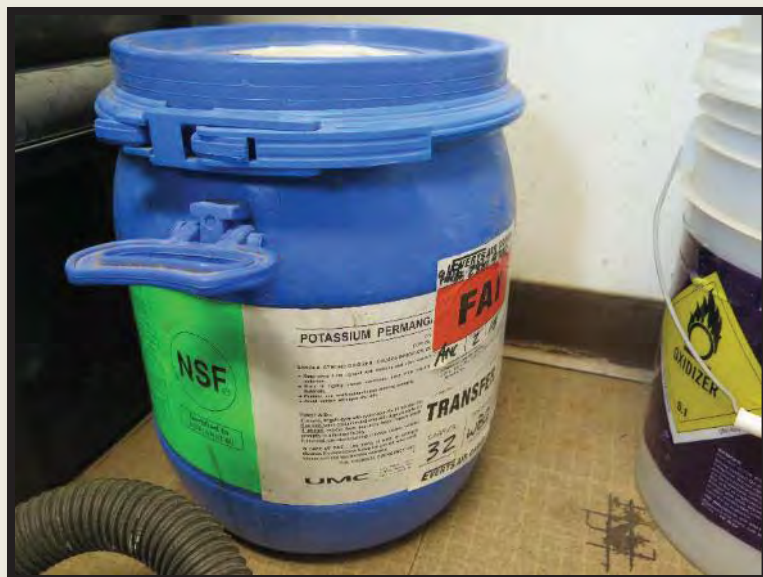
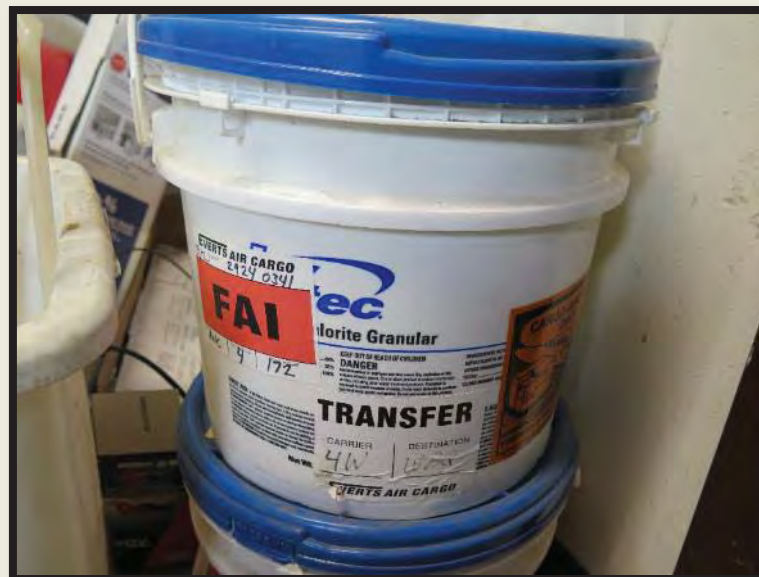
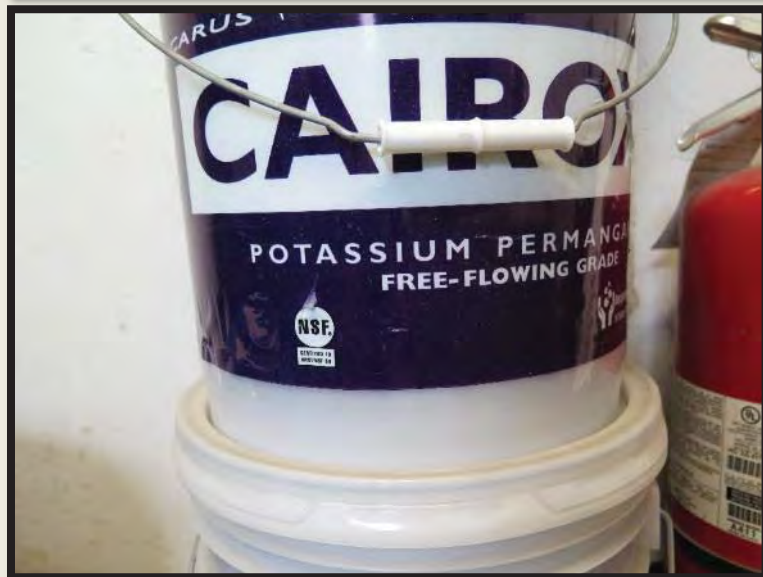
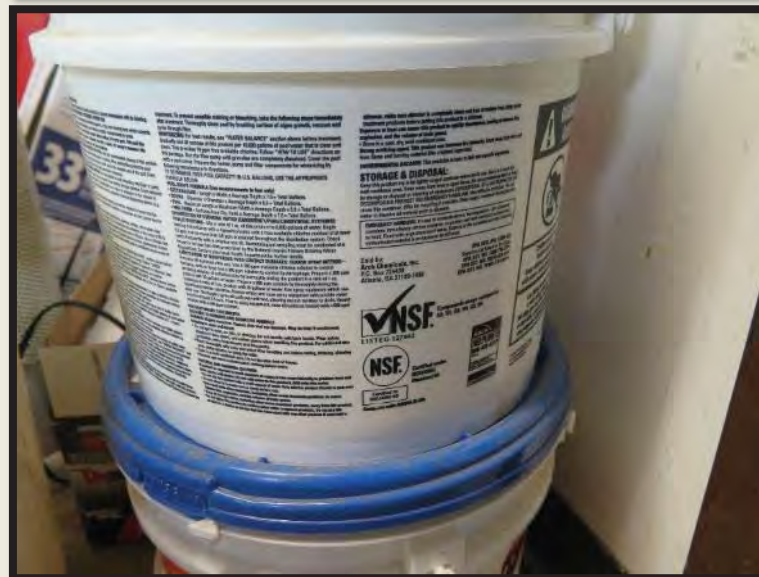
Photo 33: Potassium permanganate (2 manufacturers) and calcium hypochlorite storage.

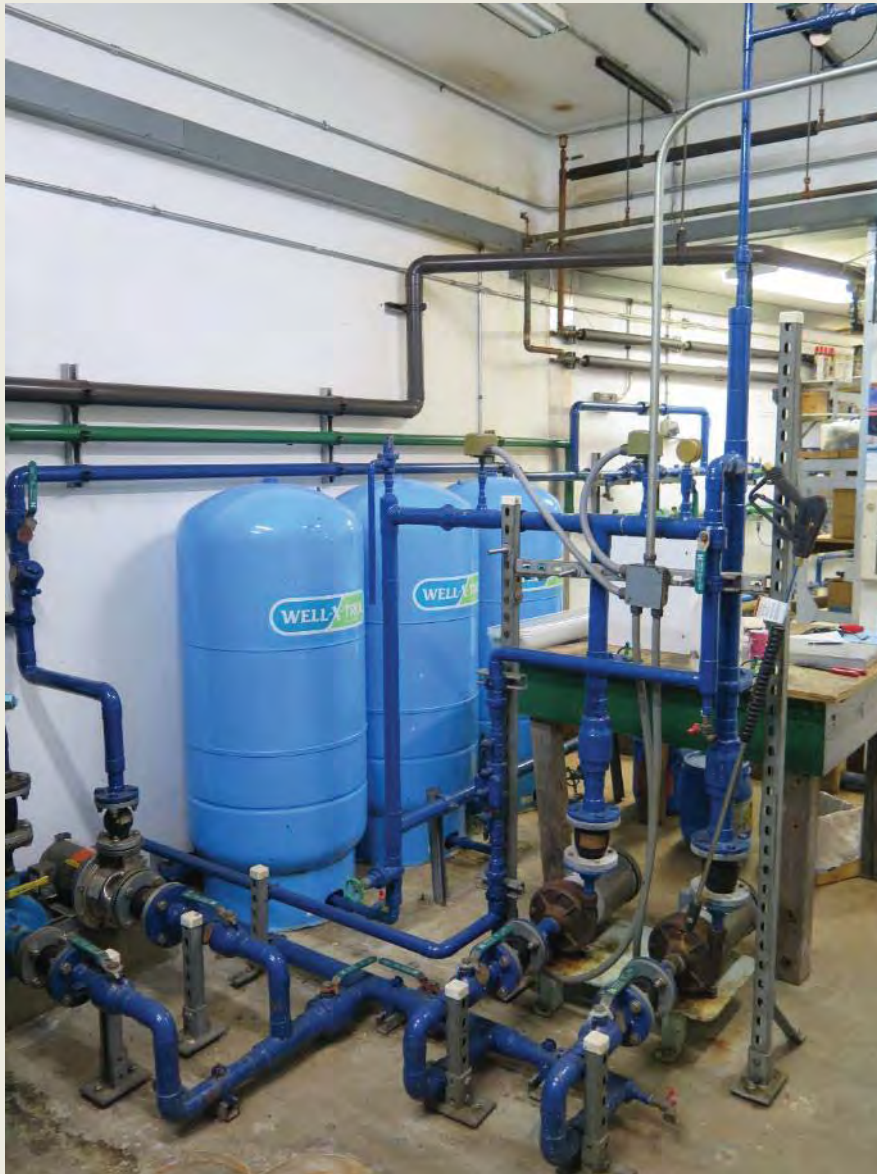
Photo 34: Distribution system pressure pumps & pressure tanks

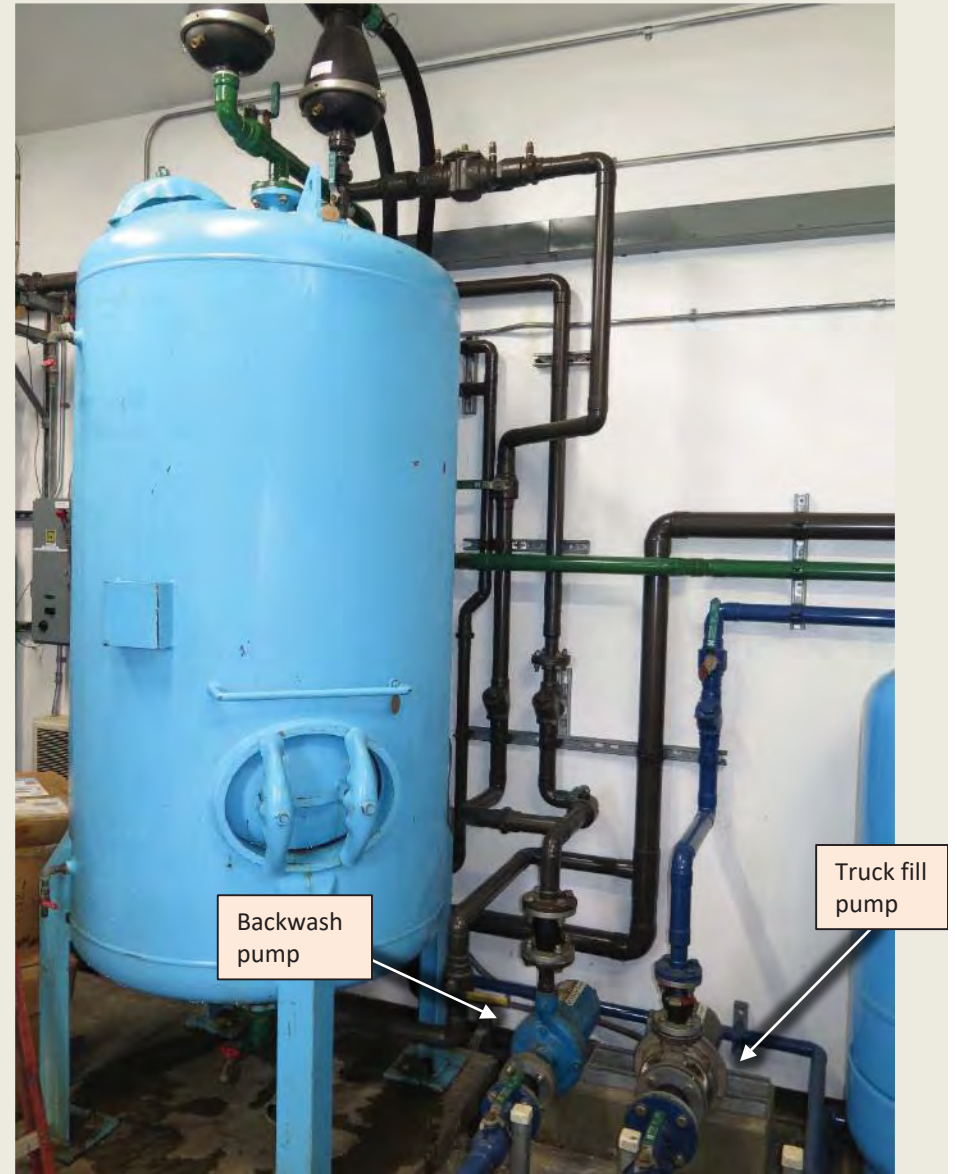
Photo 35: Truck fill & backwash pumps
