# Washeteria Replacement

## Preliminary Engineering Report

### Beaver, Alaska

**FINAL REPORT**  
**May 21, 2019**

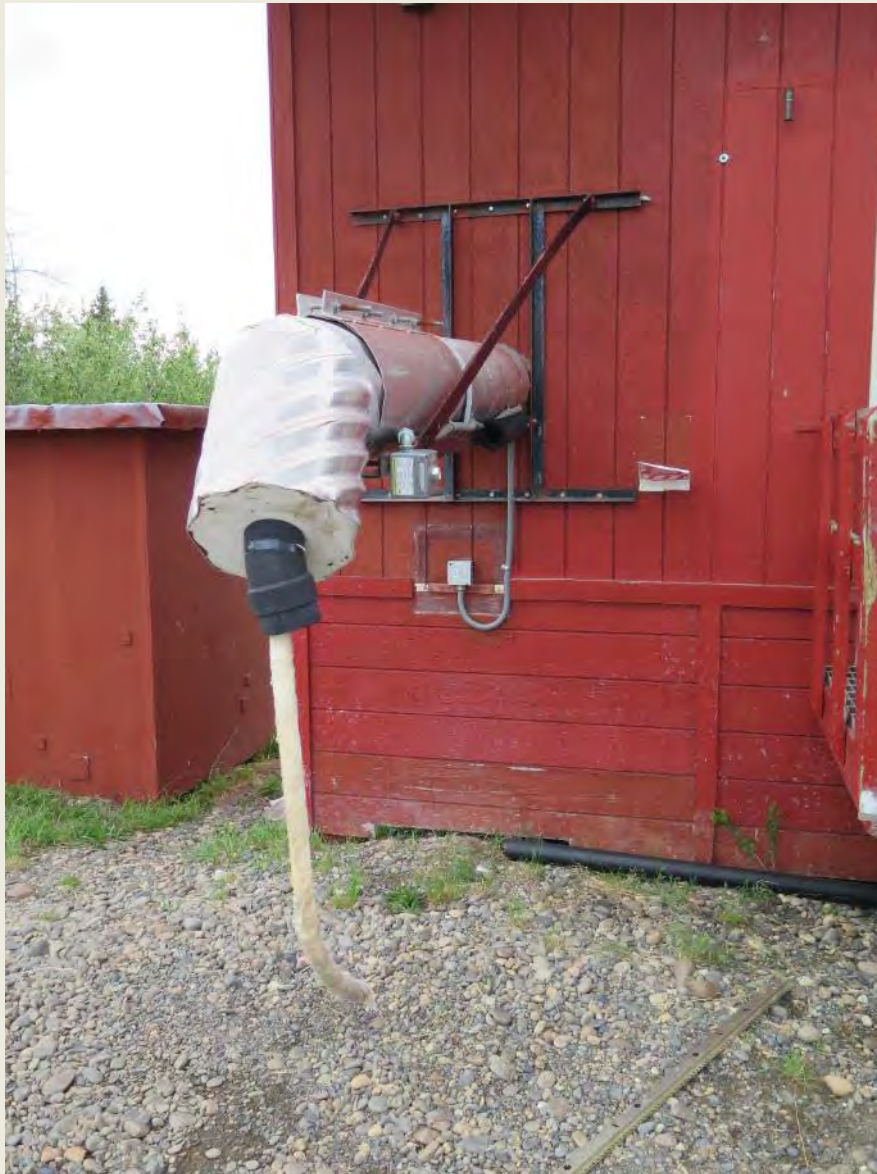
Photo 36: Watering point

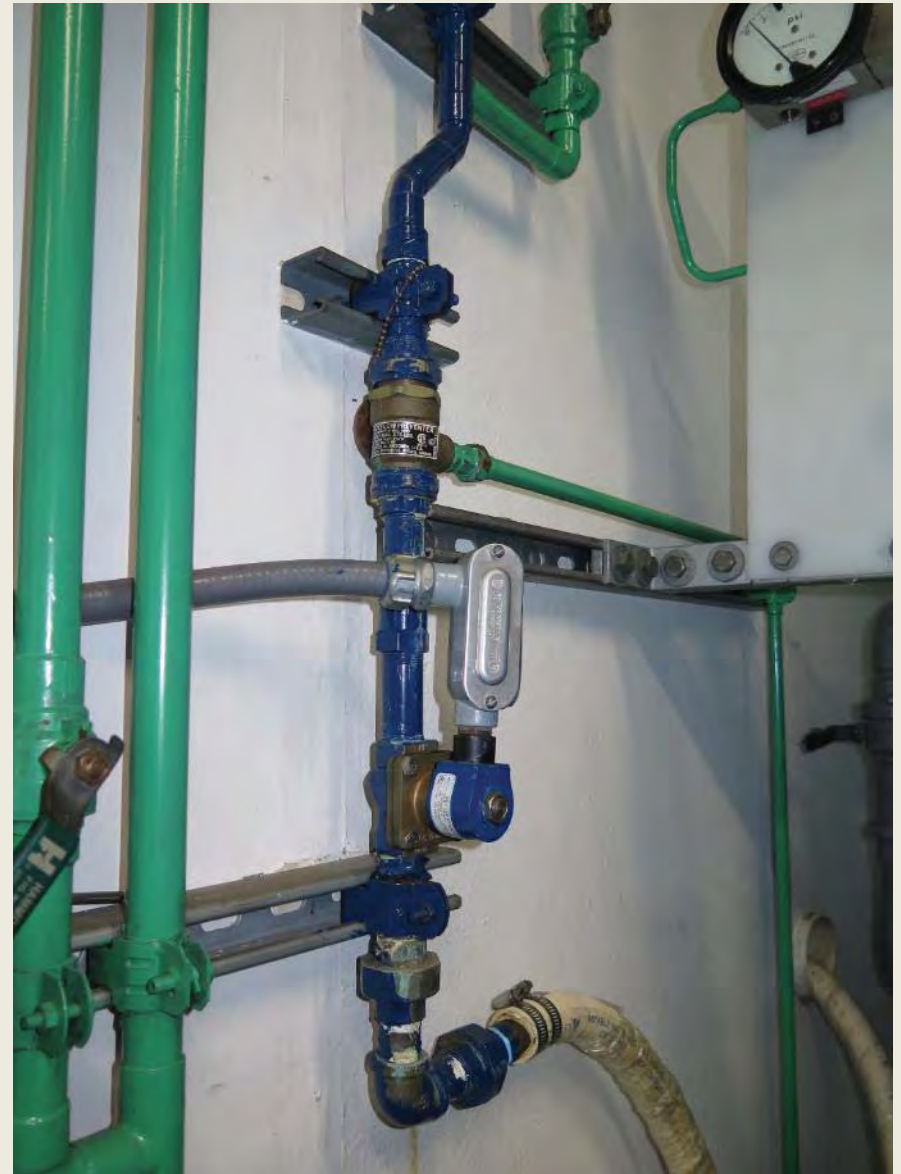
Photo 37: Watering point interior plumbing showing Watts 9D-M2 dual check valve with intermediate atmospheric vent (drains to green pipe). This model check valve is not rated for potable water use, and not certified lead-free.

7. The backflow preventer on the watering point is a dual check valve that is not certified to drinking water standards (photo log page 27, photo 37). This device must be replaced with a double check valve assembly that is certified to ANSI/NSF standard 61.
8. The unused storage tank and pressure pump system for the school is currently valved off from the distribution system. It must be physically disconnected.
9. Backflow prevention assemblies in the water system are not being routinely tested. All testable backflow prevention assemblies are required to be tested upon installation, and annually thereafter, per Plumbing Code requirements. A routine testing schedule must be developed and adhered to.

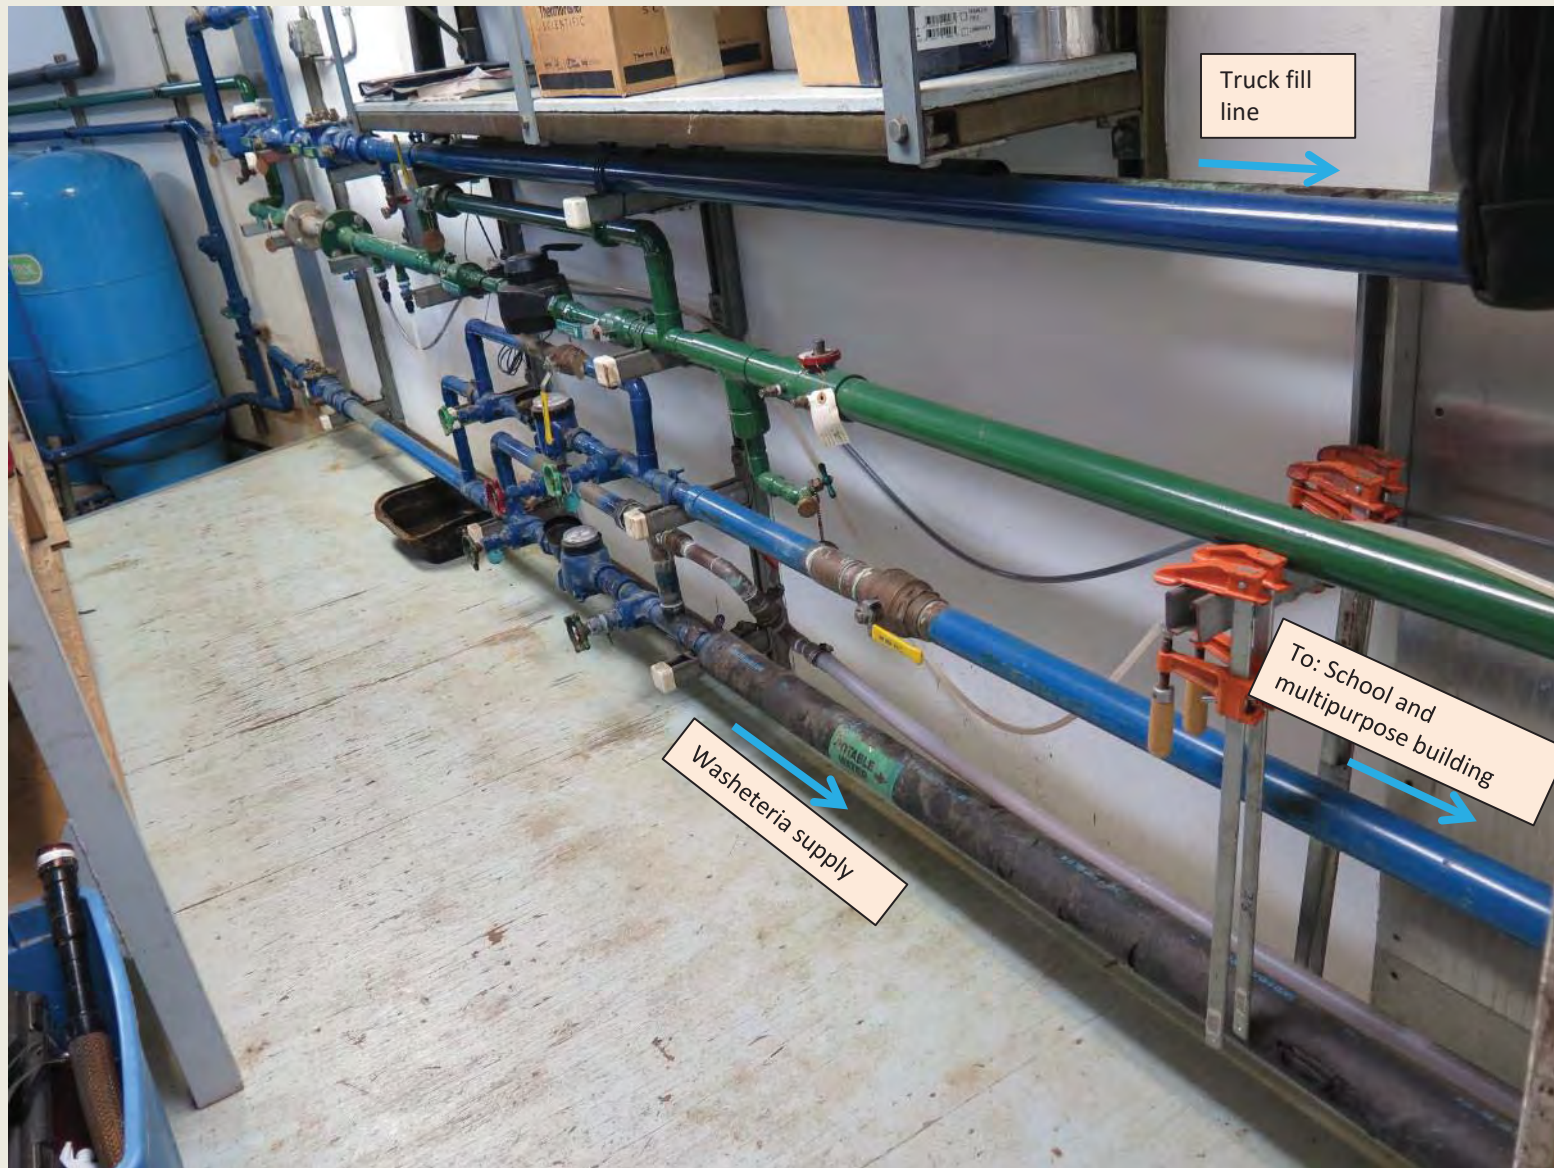
Photo 38: distribution system piping, with separate metering of individual service lines

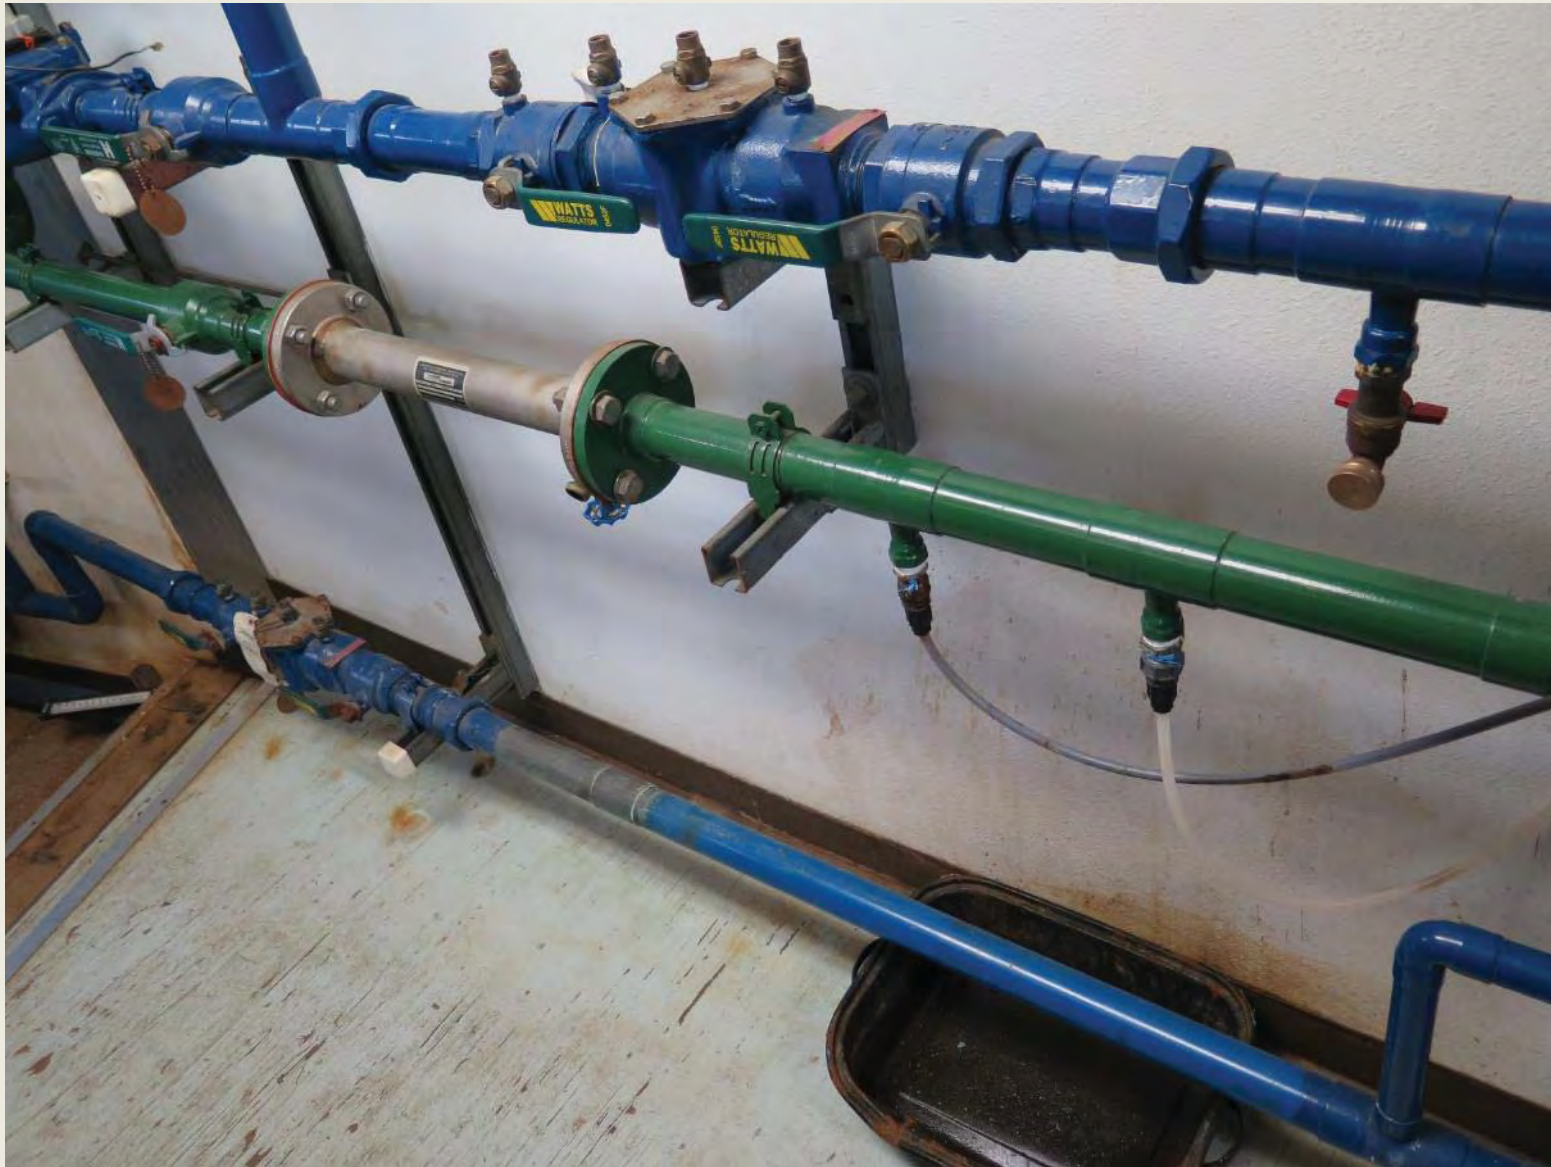
Photo 39: distribution system piping, showing backflow preventers on all lines (truck fill line backflow preventer on top; combined washeteria/school/multipurpose building lines at bottom)

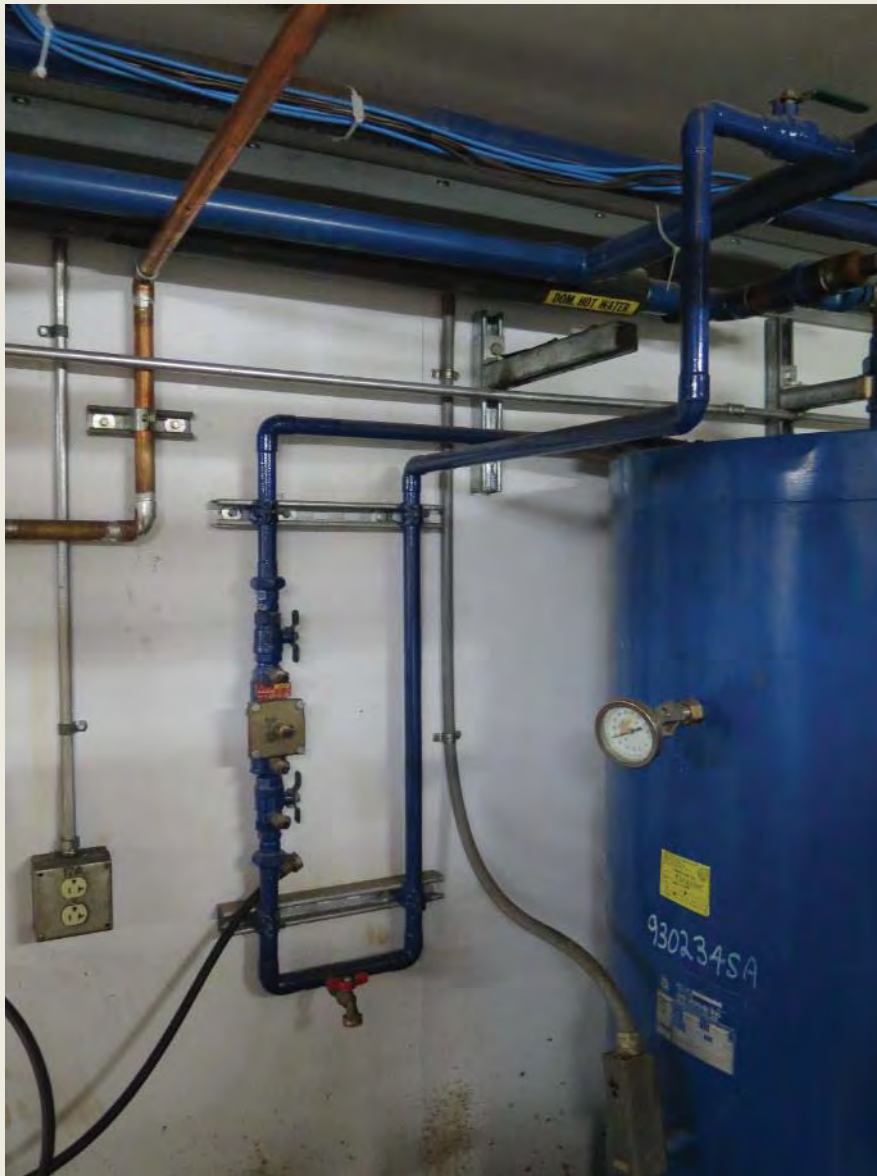
Photo 40: Backflow preventer on potable water supply to hot water generator.

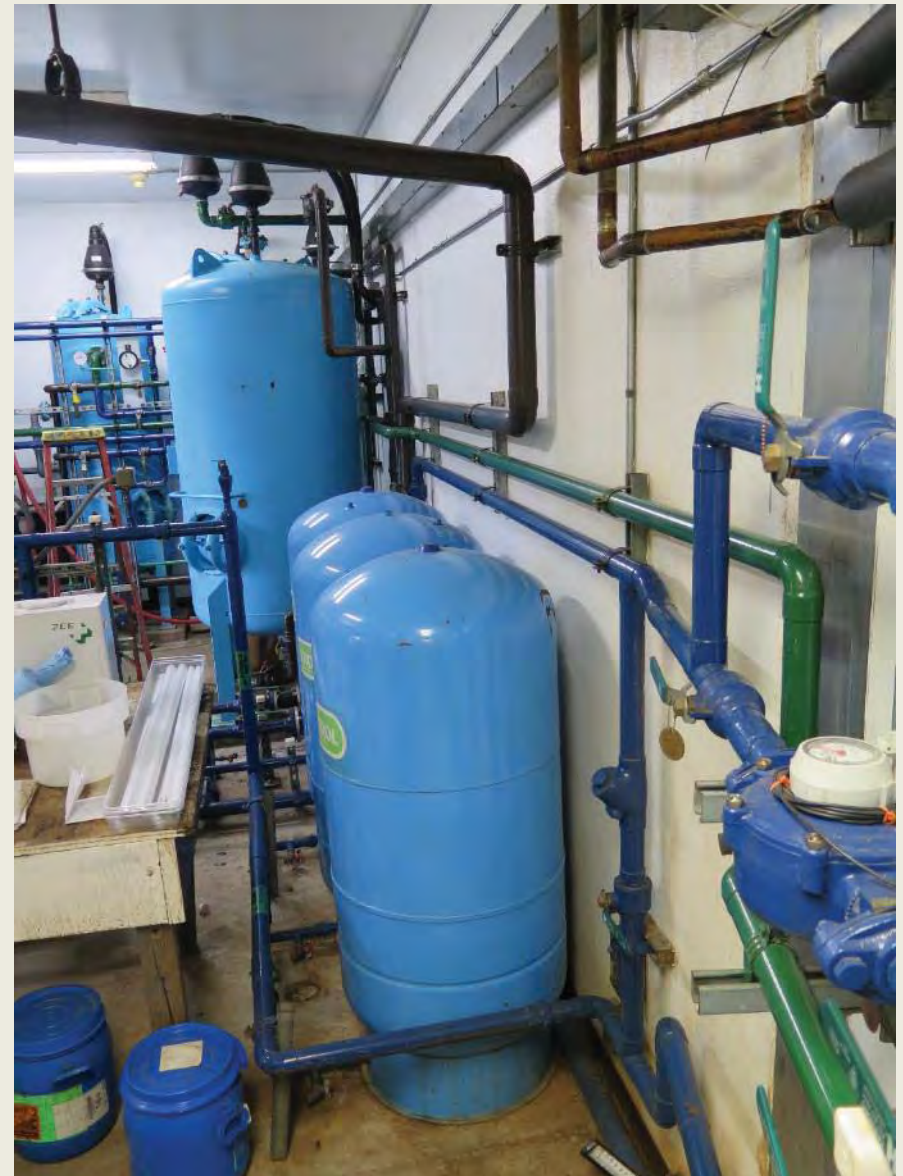
There is a dent in one of the tanks, which was reported in the previous sanitary survey, but otherwise the tanks are in very good condition.
- 4 Are the hydropneumatic tanks in a condition that represents an immediate threat to health or safety, or are in danger of failure? (Describe in notes.) ☐ Yes  
☒ No  
☐ NA

Photo 41: Pressure tanks, showing dent called out in previous sanitary survey.

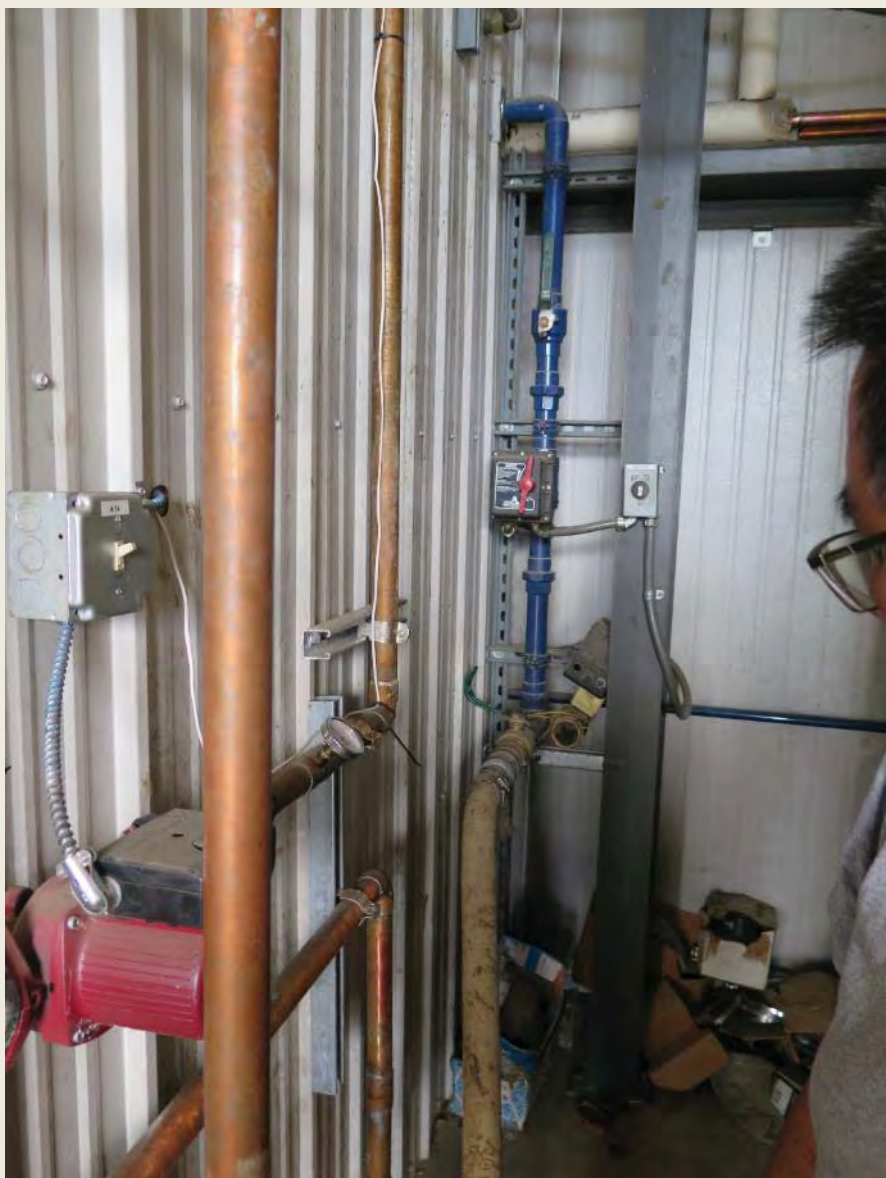
Photo 42: Truck fill piping (blue) and hose, in haul truck garage.

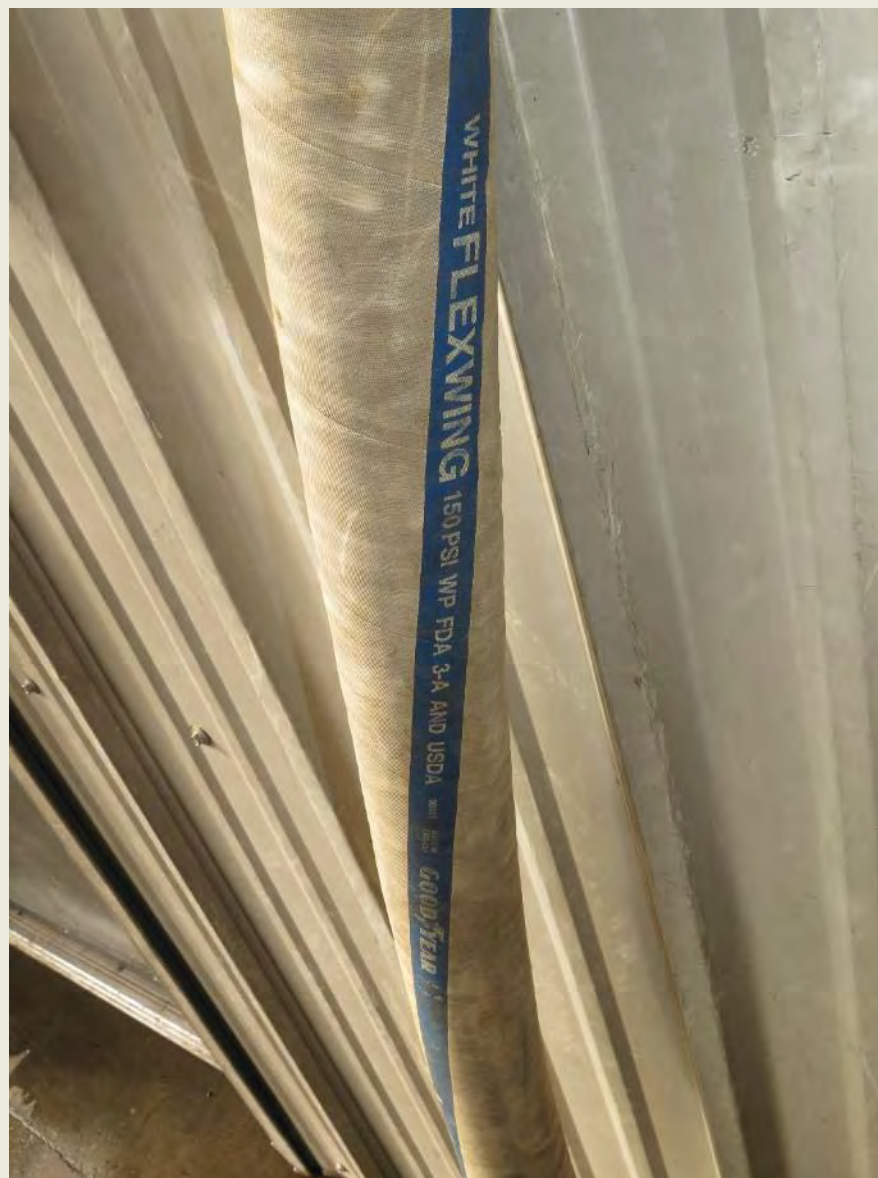
Photo 43: Truck fill hose, Goodyear brand.

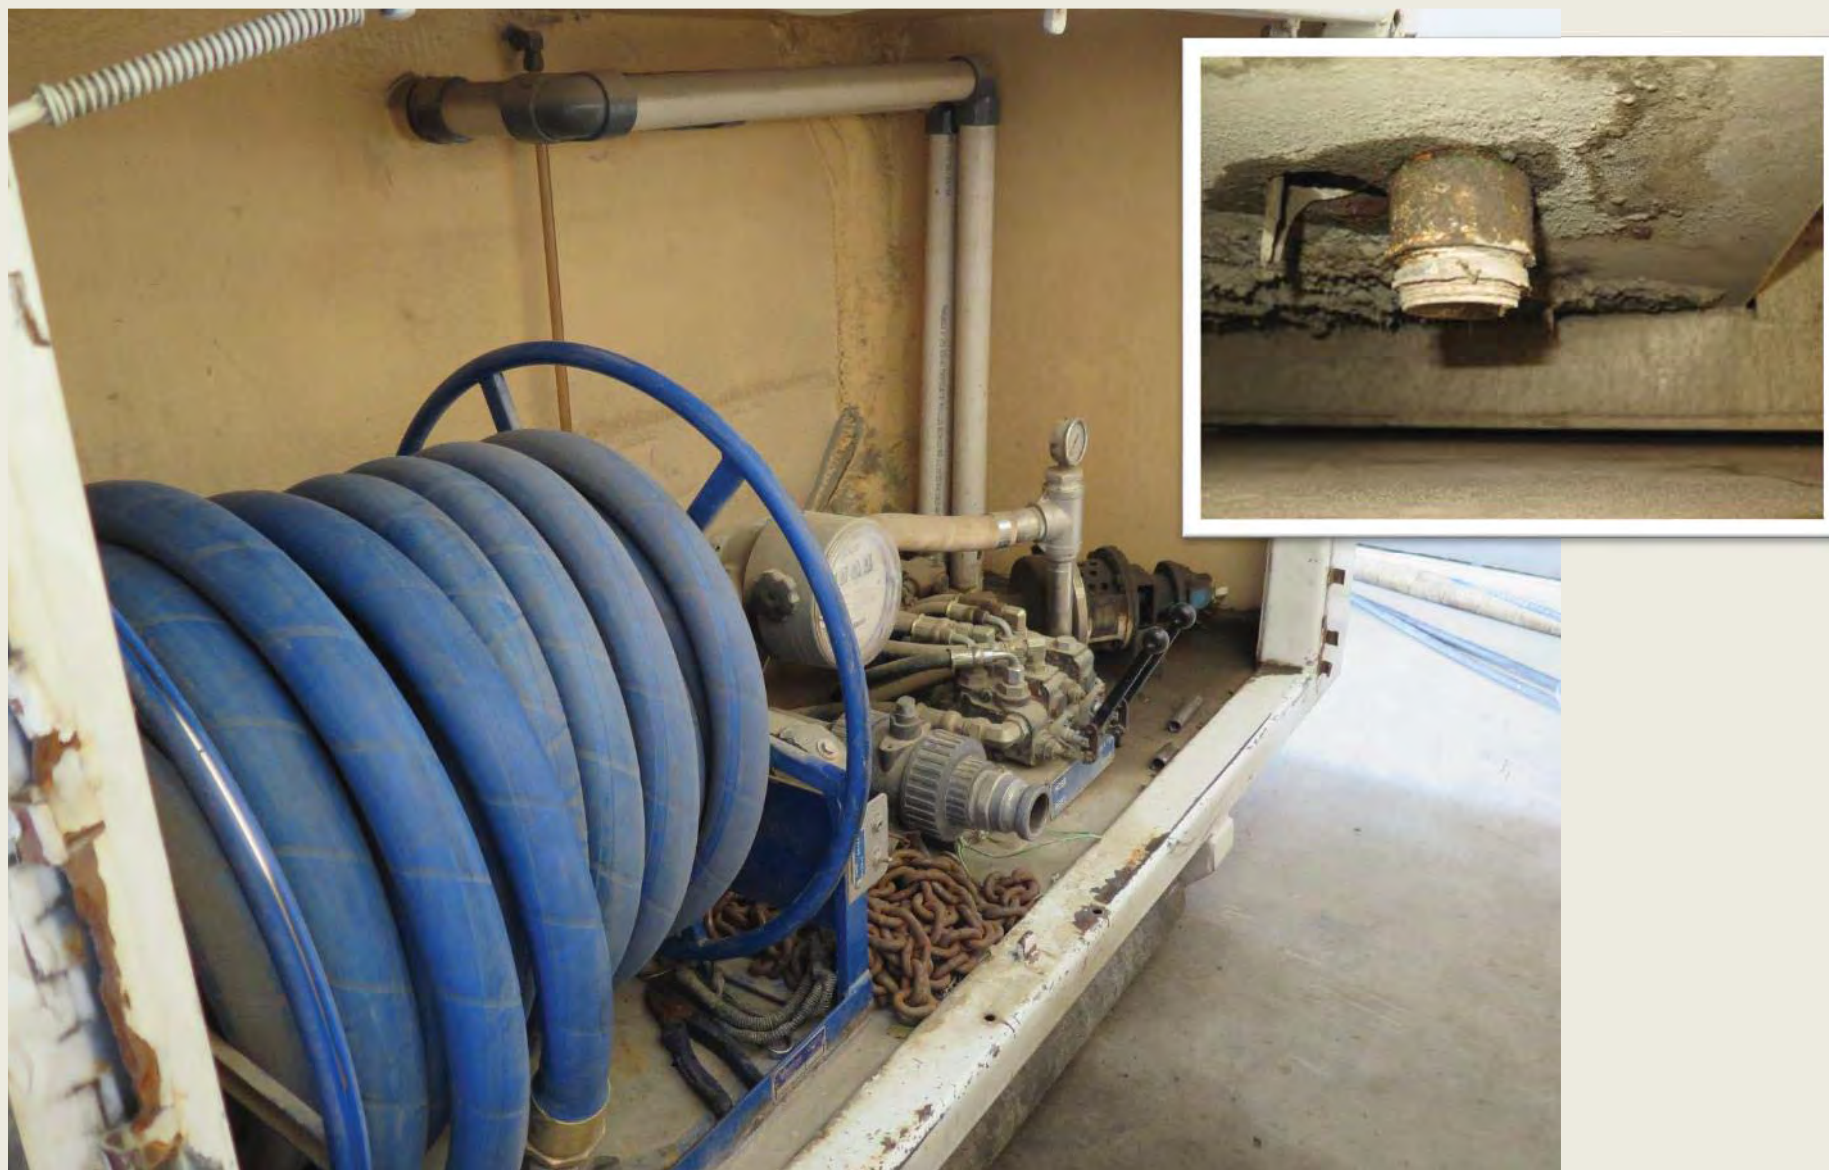
Photo 45: Water haul tank pump, meter, and fill hose. Tank overflow/vent piping coming from top (outlets shown in inset image)

11. The truck water haul tank overflow line must be appropriately screened to help avoid potential contamination of the storage tank (photo log page 33, photo 45). Due to the extreme winter conditions in interior Alaska, the addition of a screen may cause freeze-up issues during the winter months. Therefore, a screen is only required during summer operation when freeze issues are not a concern (approximately May – September, weather dependent).

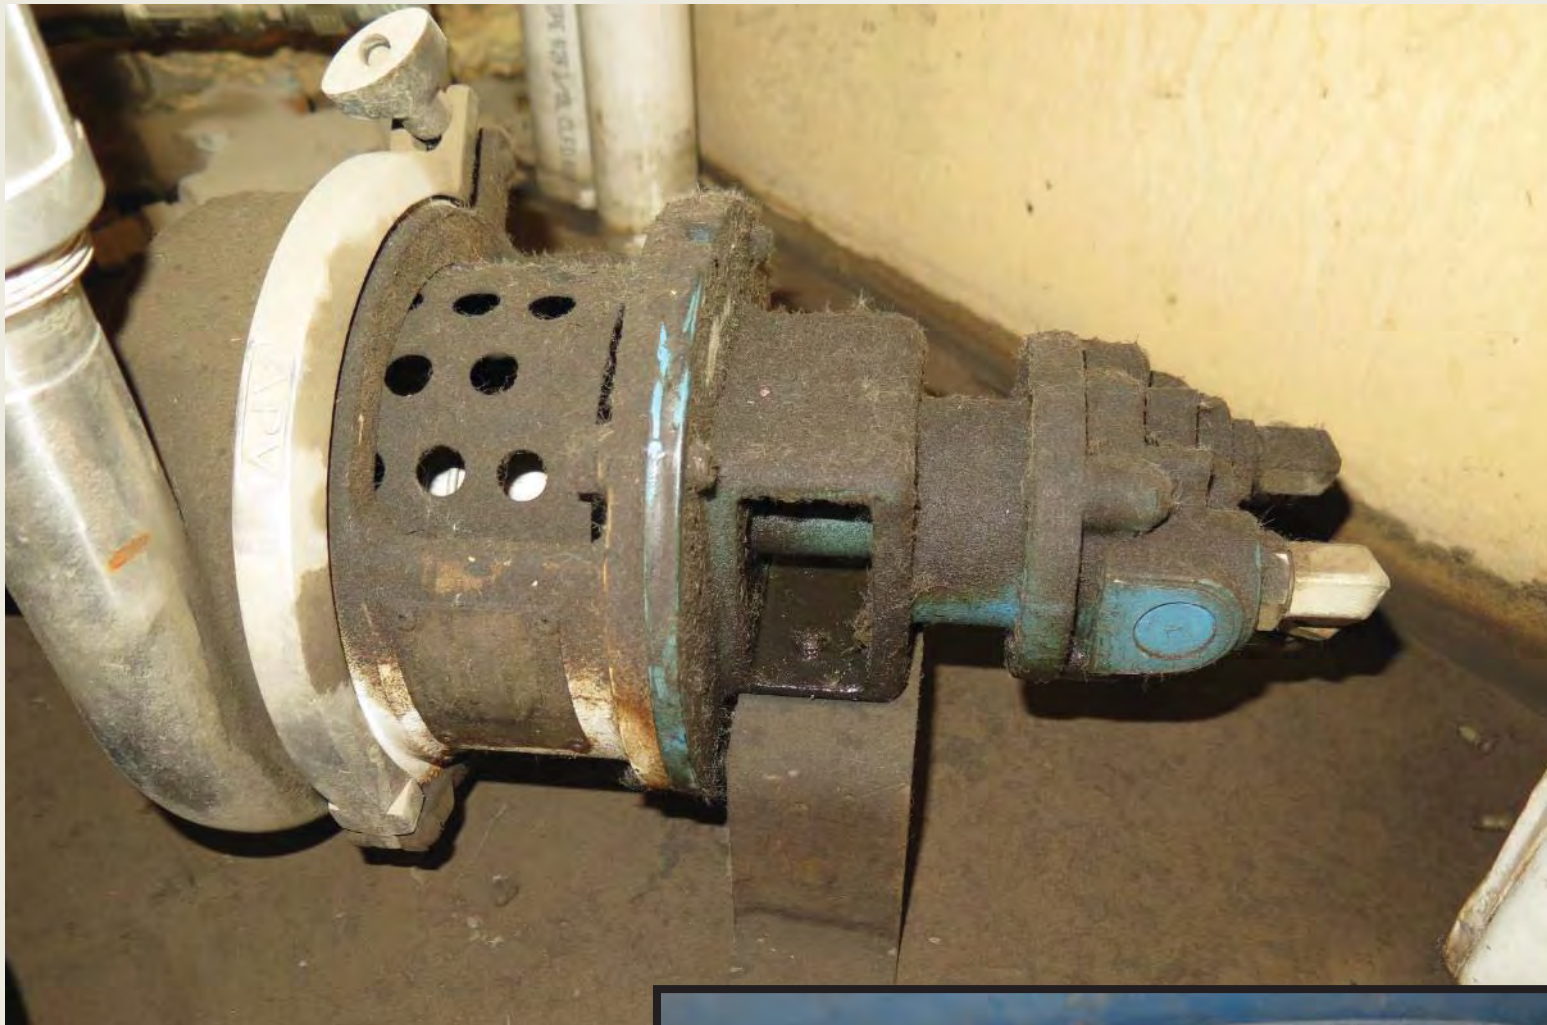
Photos 46 & 47: Water haul tank pump and Goodyear brand fill hose.

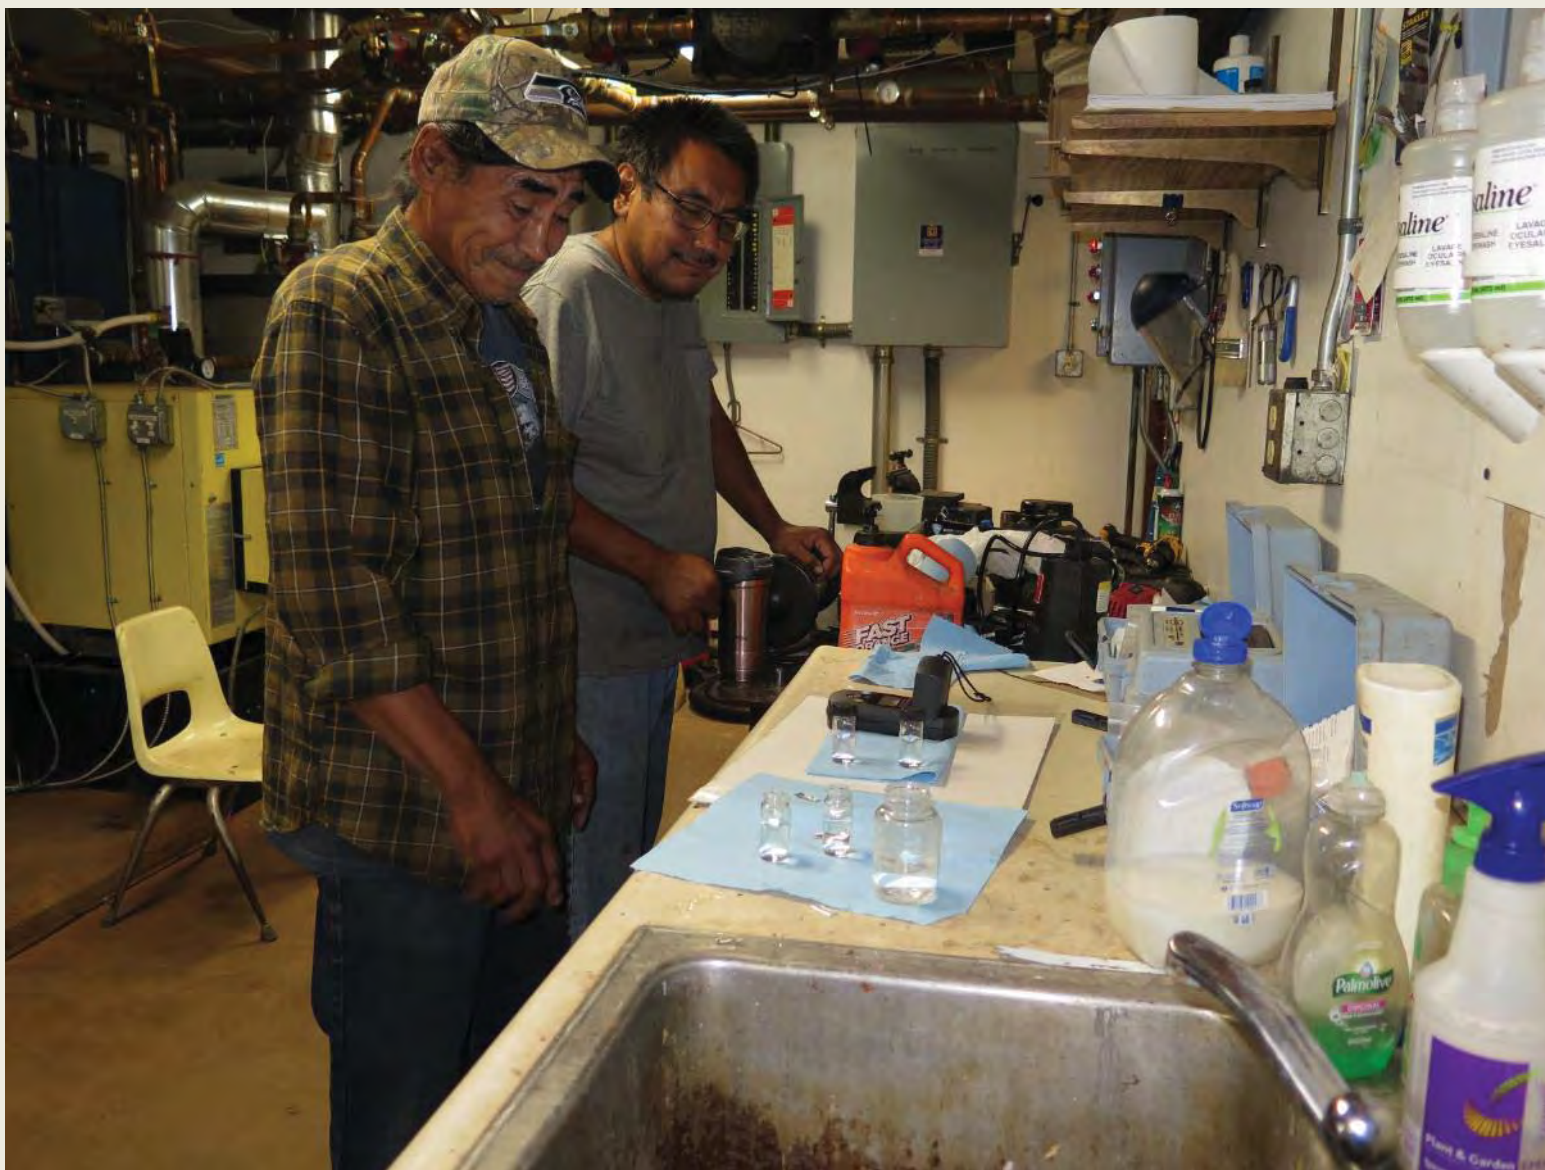
Photo 48: Primary operator Paul Petruska and backup Aaron Petruska demonstrate use of the Hach Pocket Colorimeters for chlorine, iron, and manganese.

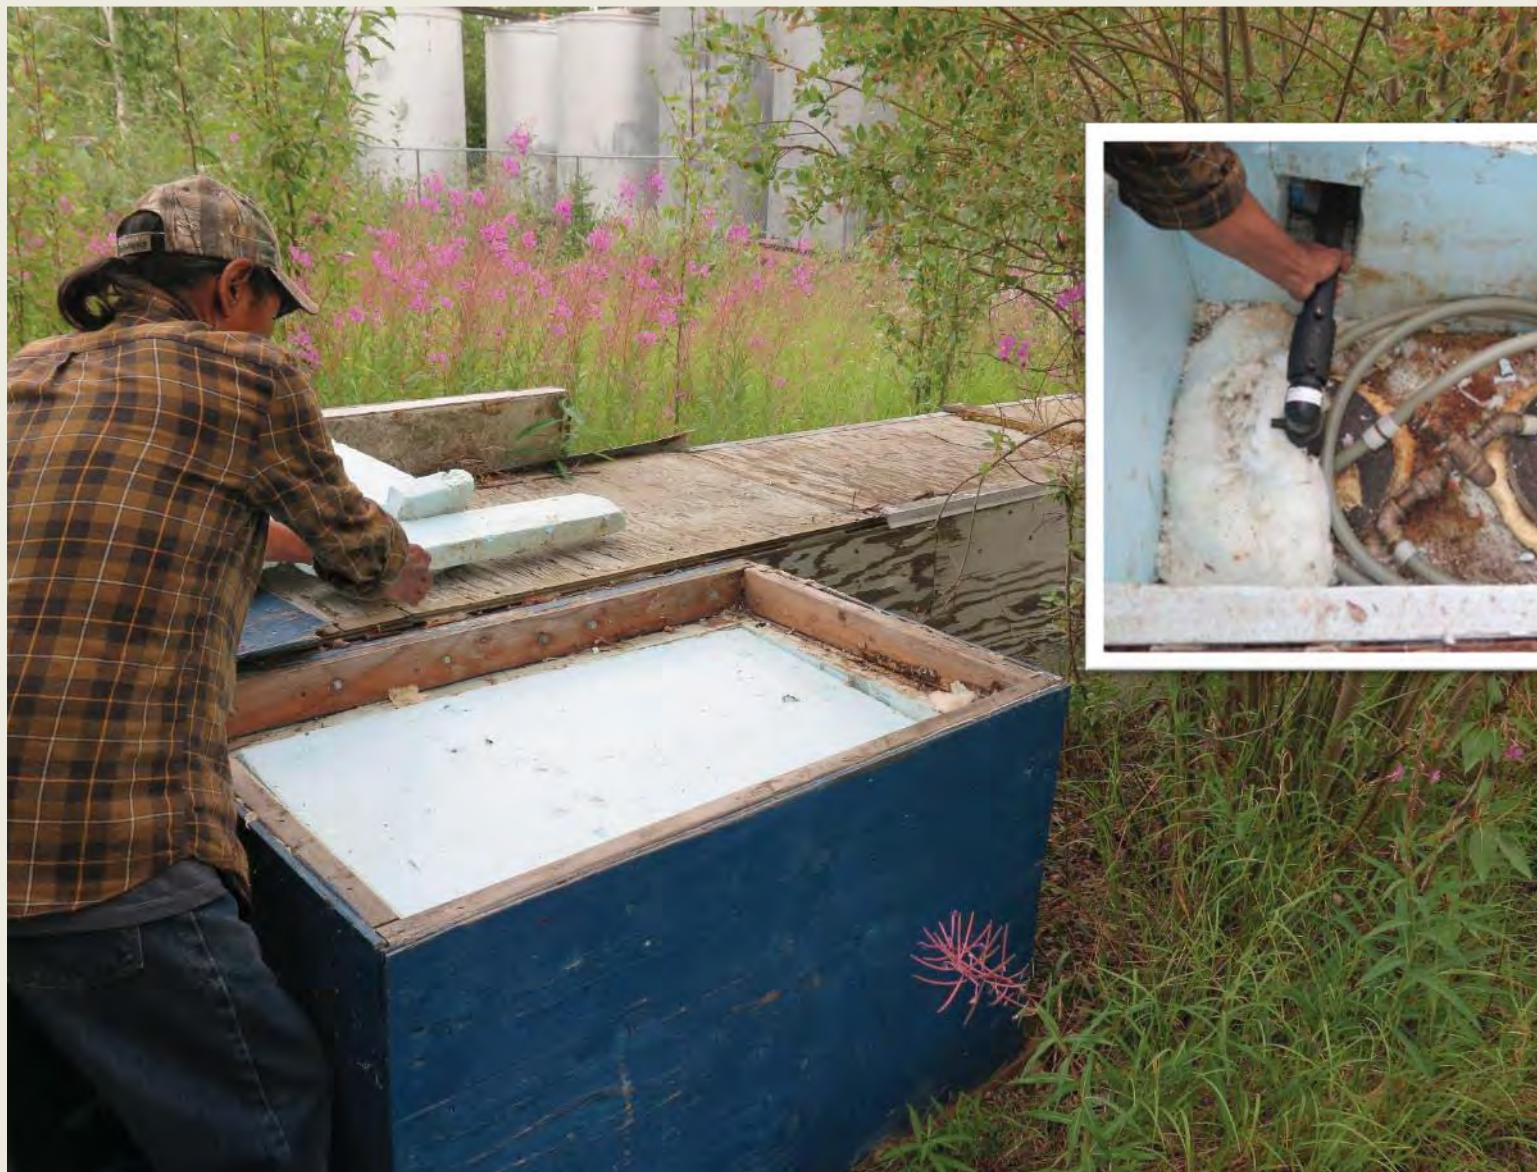
Photo 49: Point of connection to the old school utilitdor. Water main (left) and sewer force main in black HDPE; glycol heat trace piping shown coiled in box.

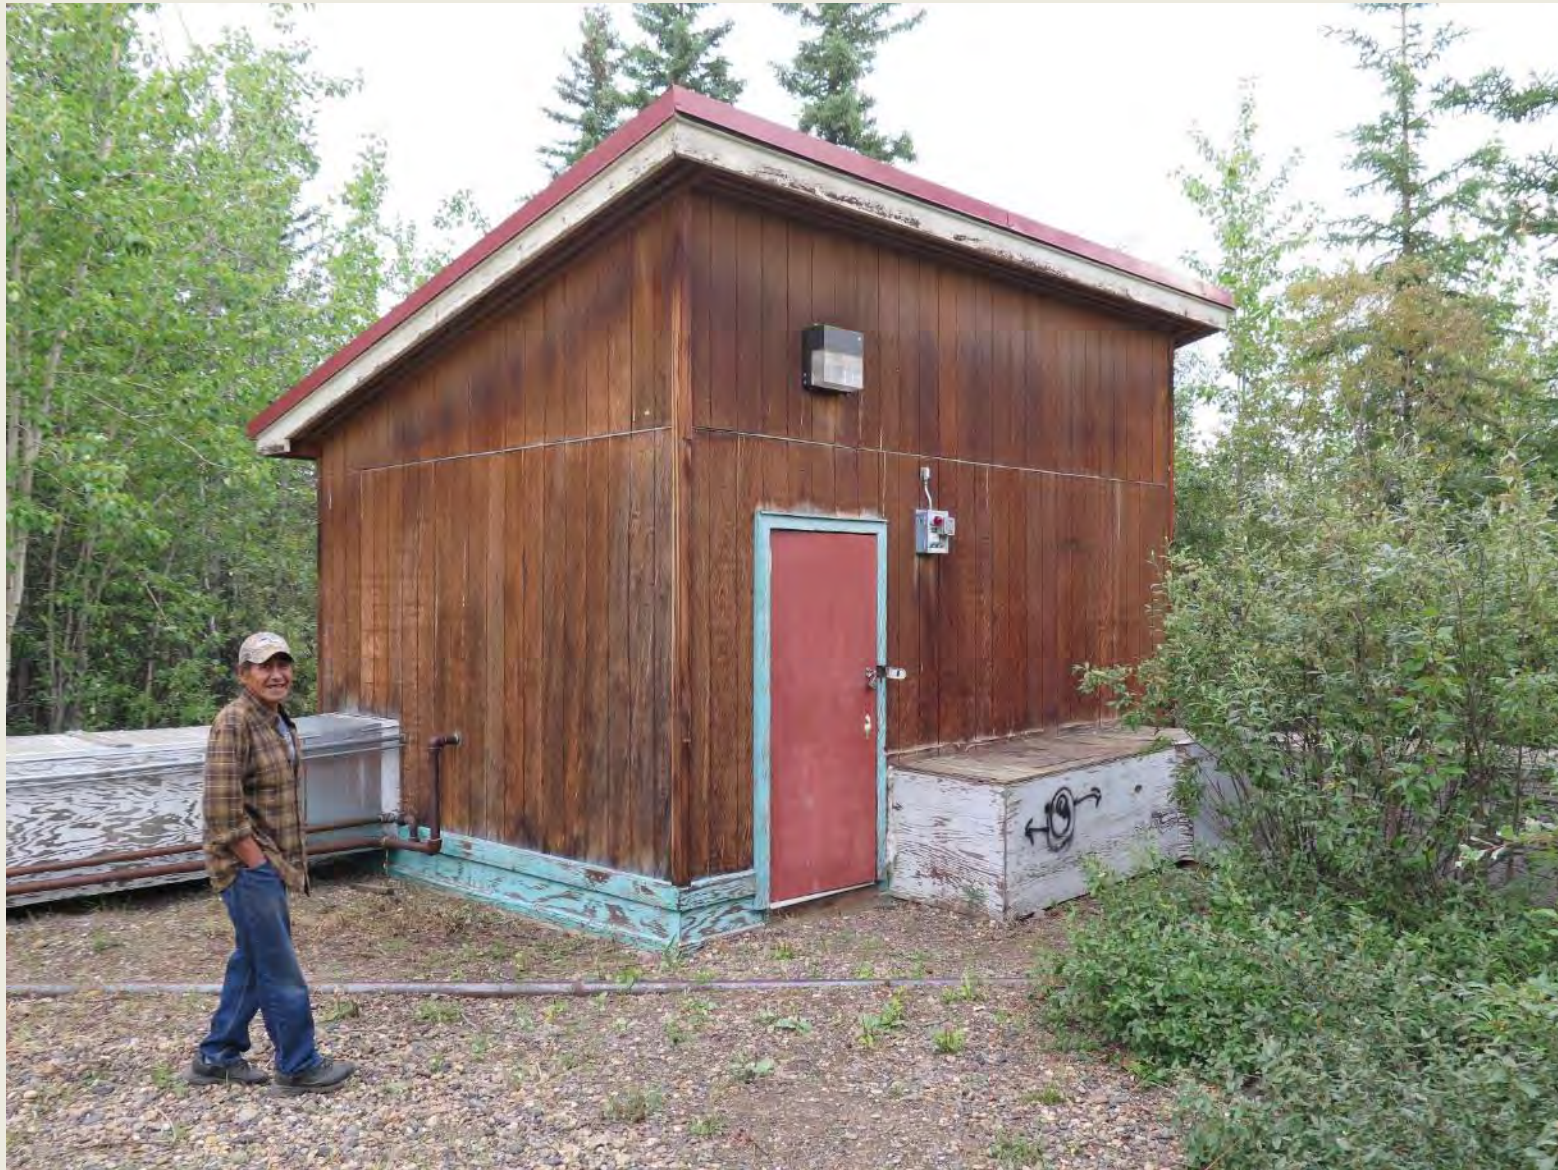
Photo 50: Point of connection to the old school utilitdor. Circulating water main in black HDPE; glycol heat trace piping shown coiled in box.

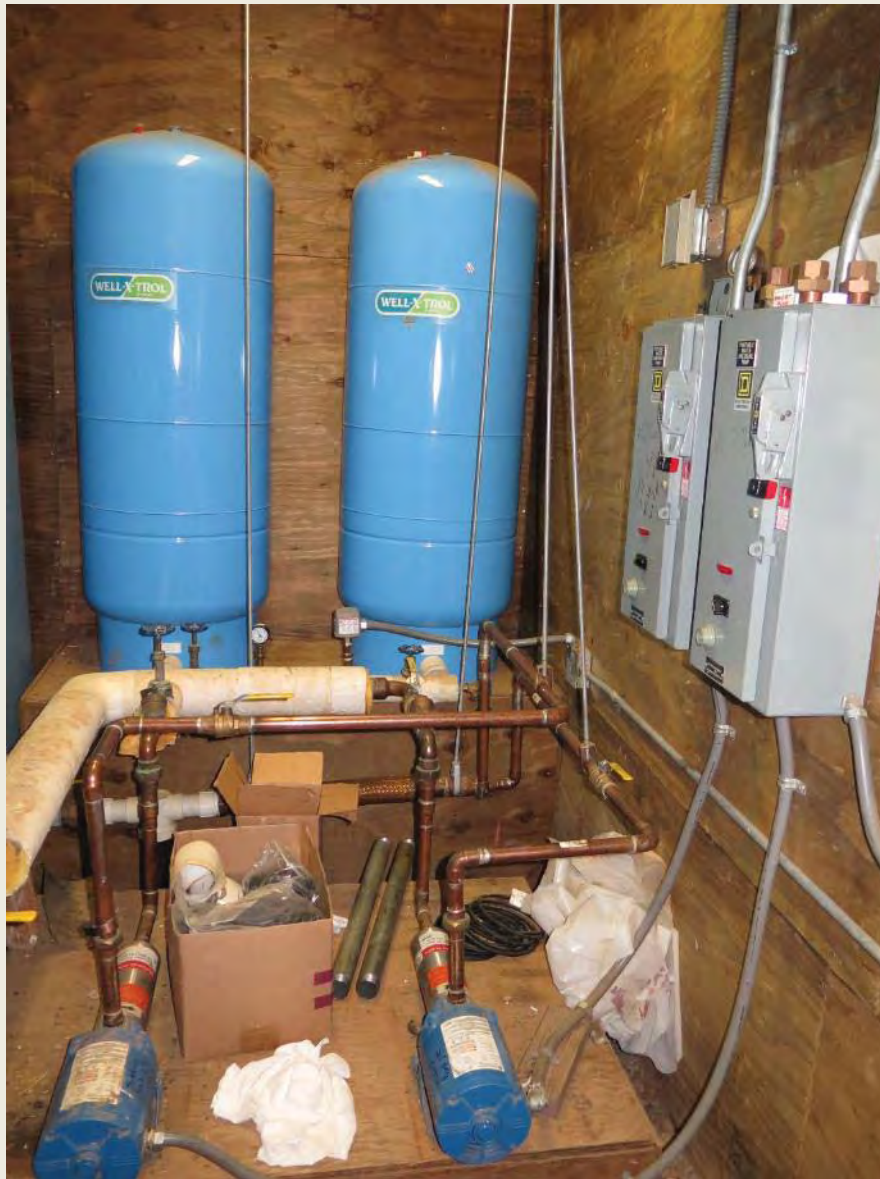
Photo 51: School's pressure pumps and pressure tanks, piped from indoor storage tank to school. This system is valved "off" but still hard-piped to the water distribution system.

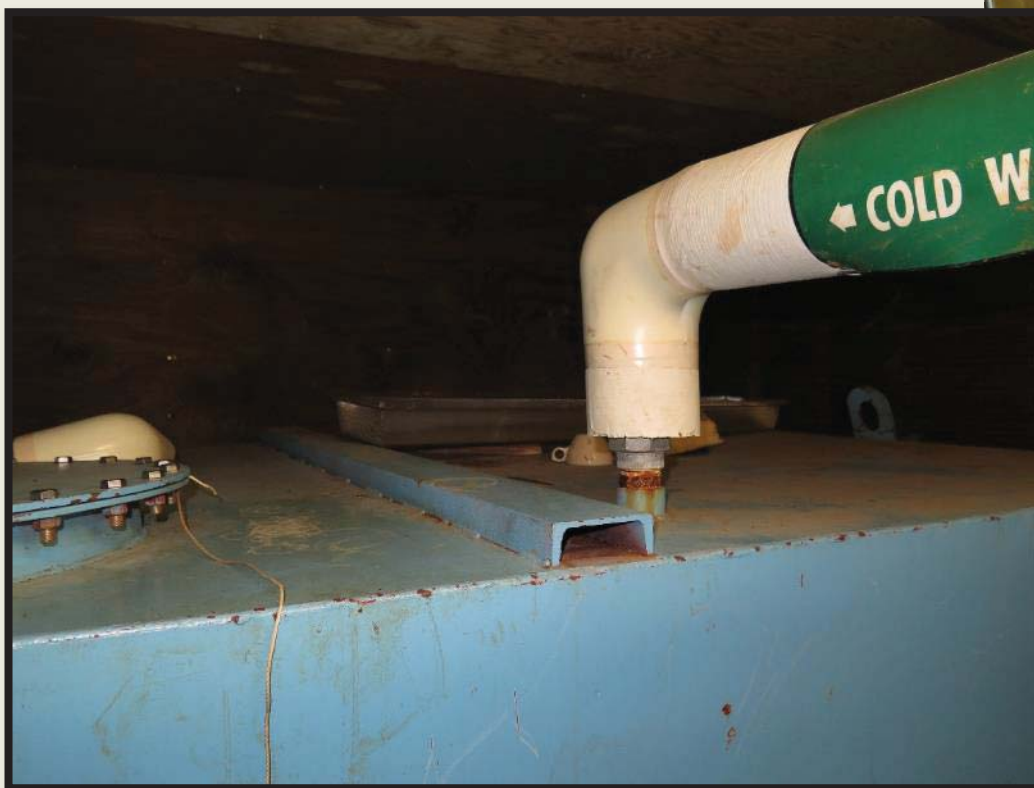
Photo 53: Top access hatch and water service entrance on the school's indoor storage tank, which is completely sealed. The tank is valved off from the distribution system on the inlet pipe.

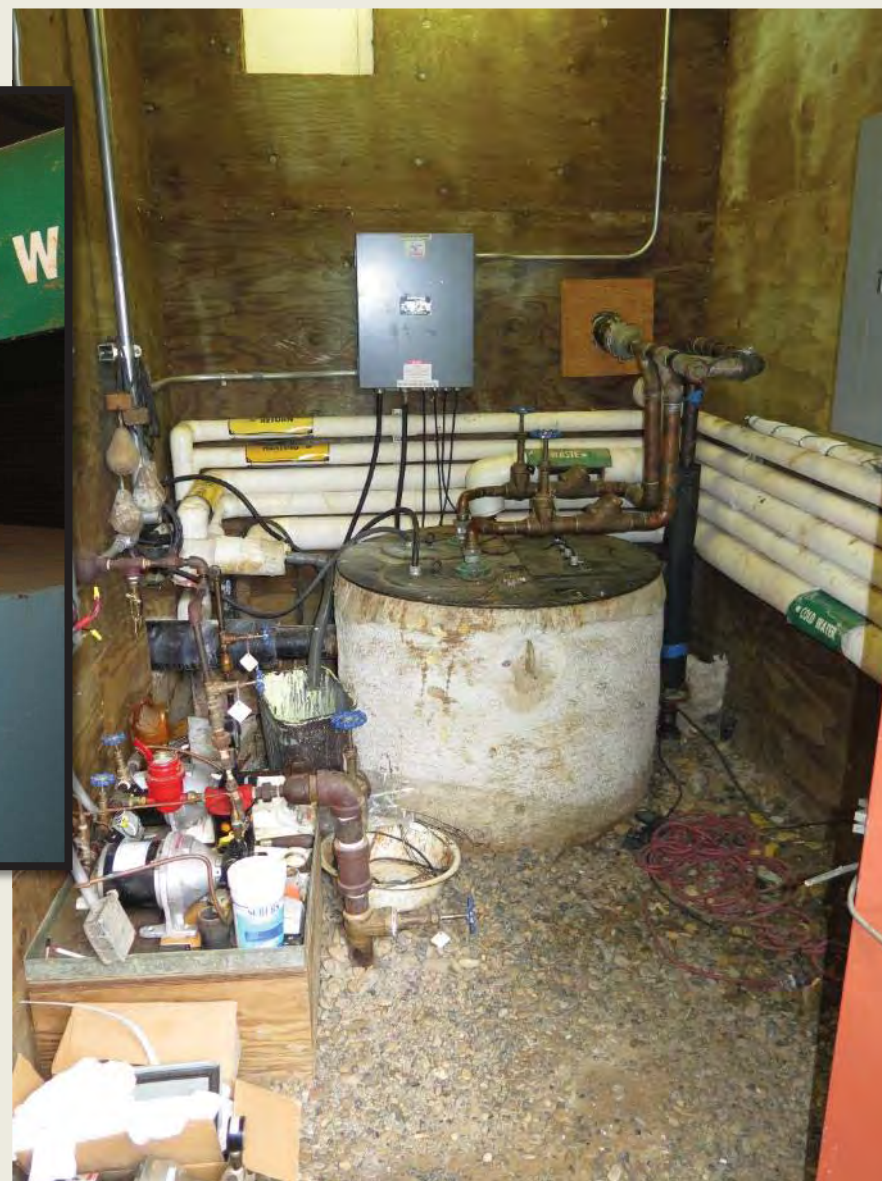
Photo 54: The school lift station, located in room adjacent to school water tank and pressure distribution pump system. The sewer main is located in the same utilidor as the water lines.
