# Washeteria Replacement

## Preliminary Engineering Report

### Beaver, Alaska

**FINAL REPORT**  
**May 21, 2019**

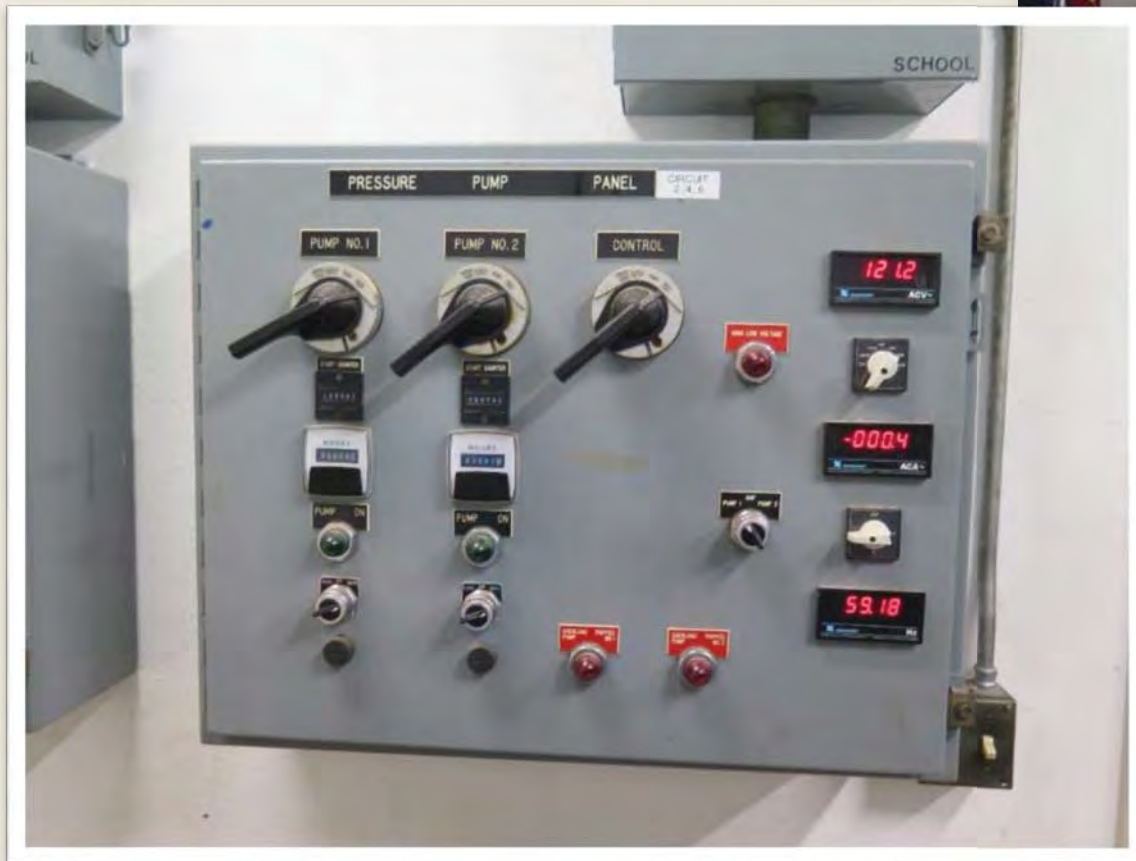
Photo 55: Pressure pump control panel.

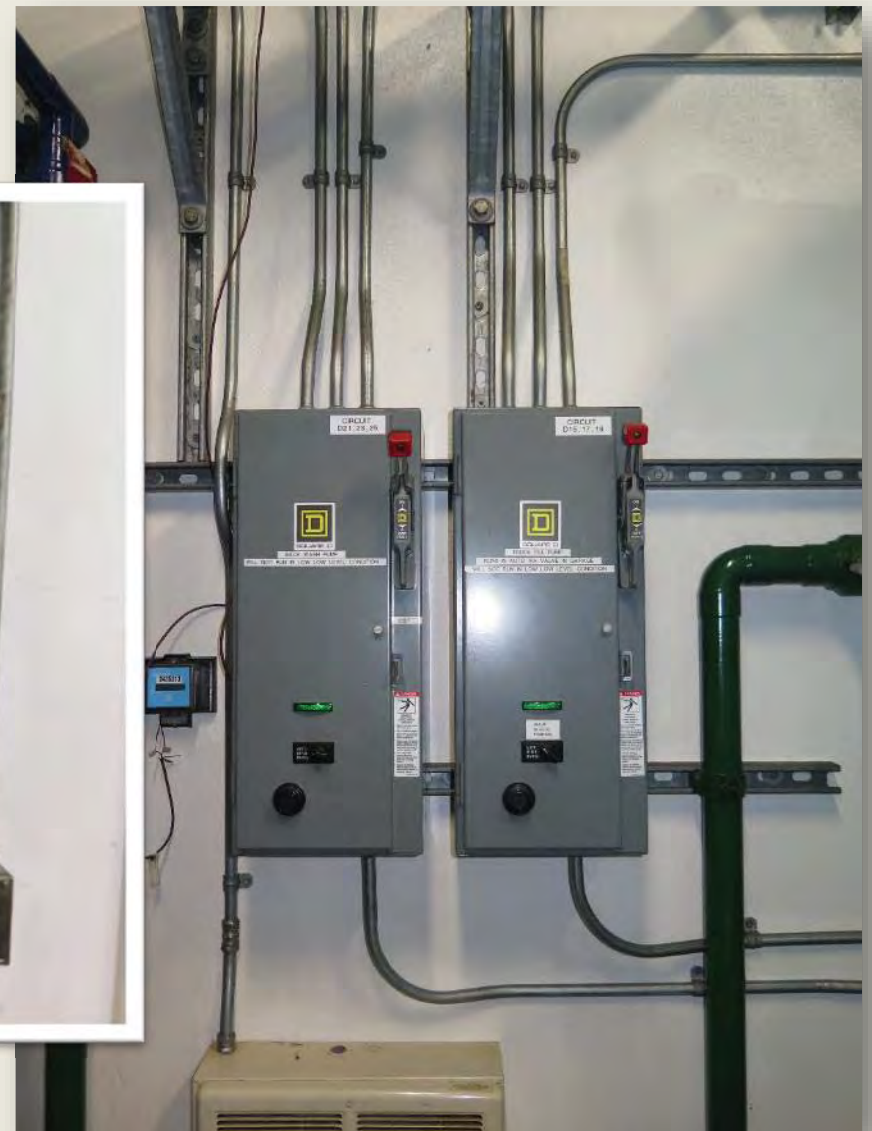
Photo 56: Backwash and Truck Fill pump control panels

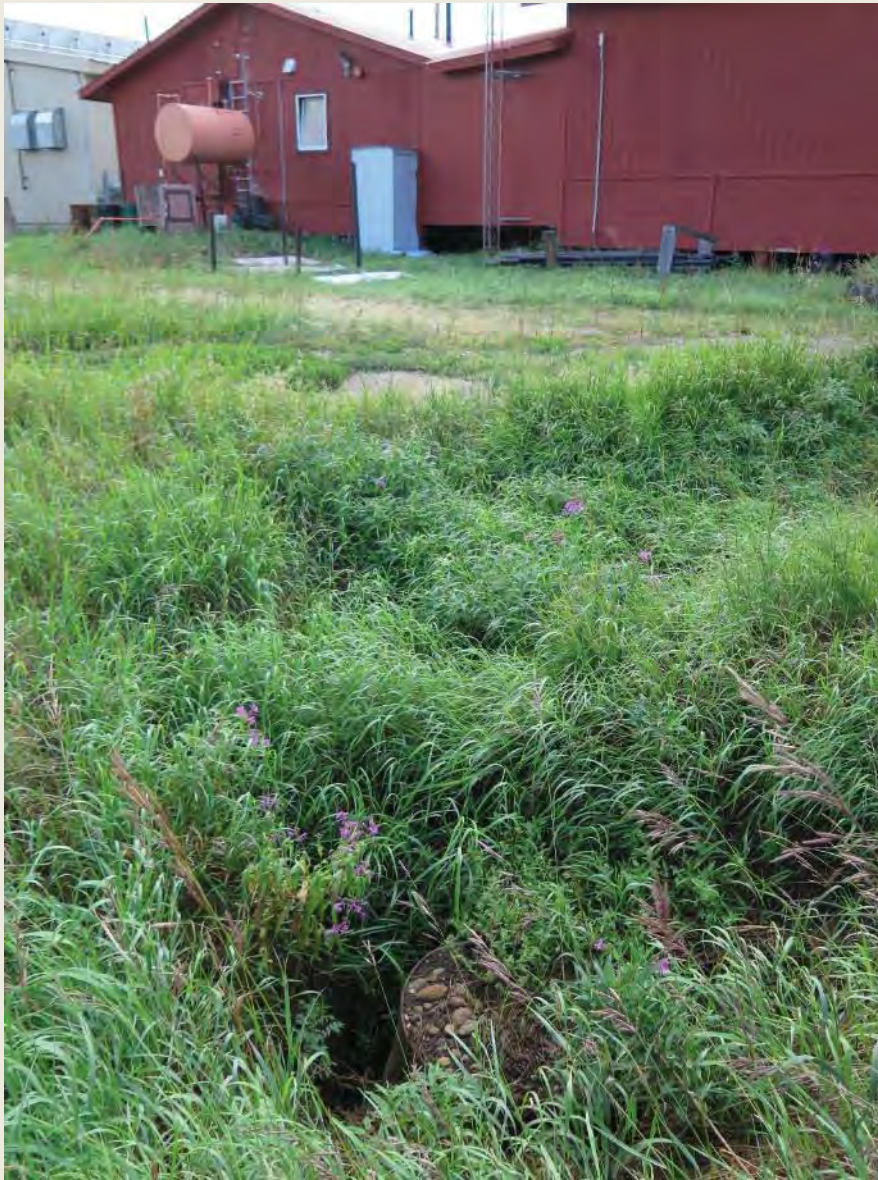
Photo 59: Another shot of the sinkhole(s) behind the washeteria, showing gravel-filled drum placed into center.

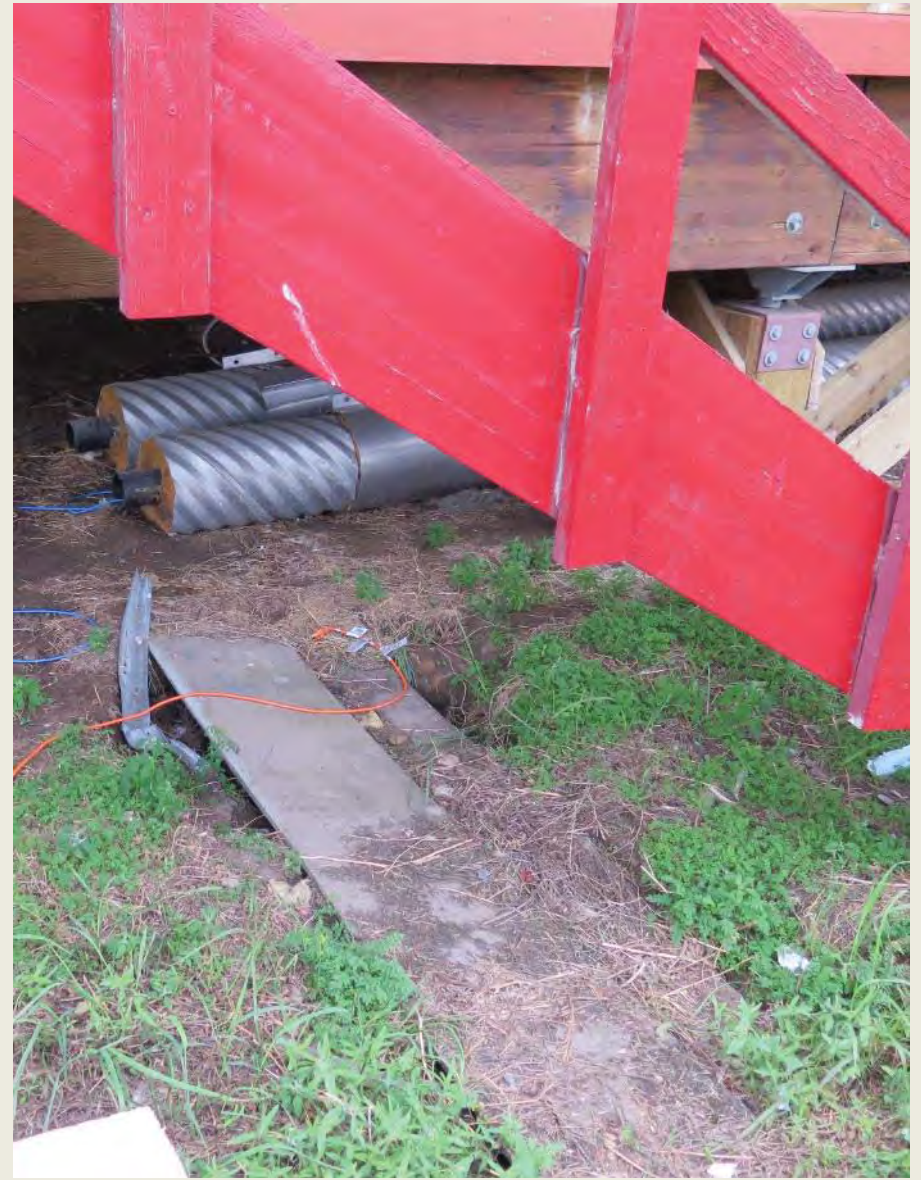
Photo 60: Another sinkhole which has appeared directly adjacent to the Beaver Multi-Purpose Building.

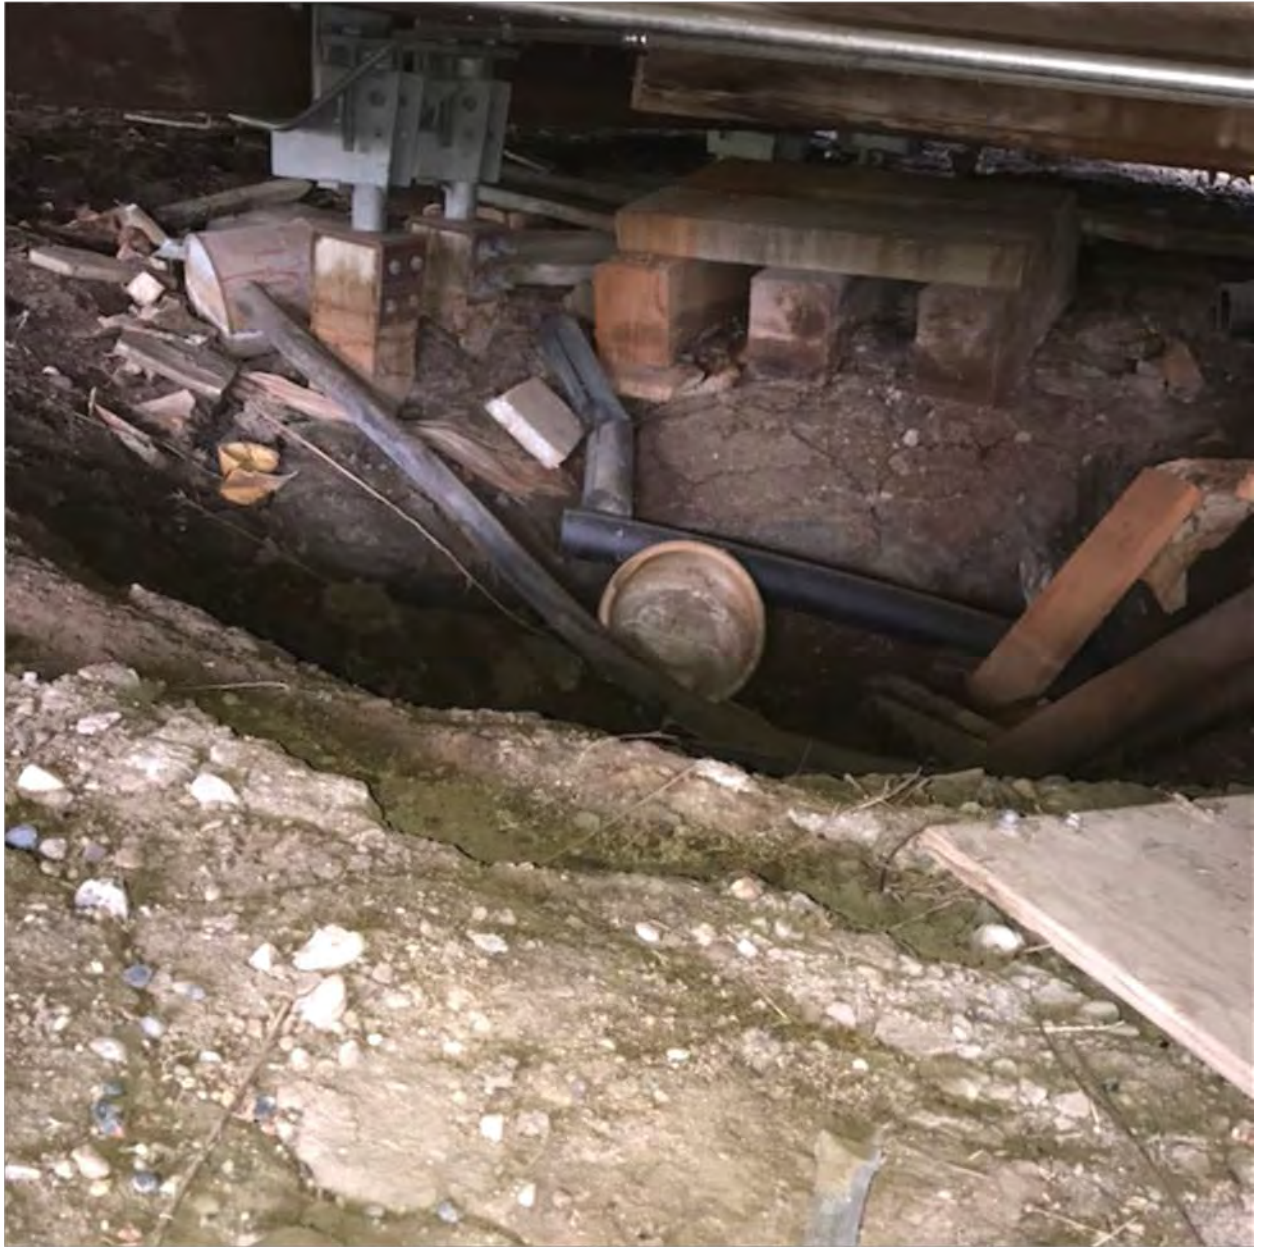
I dare not crawl any closer, right?

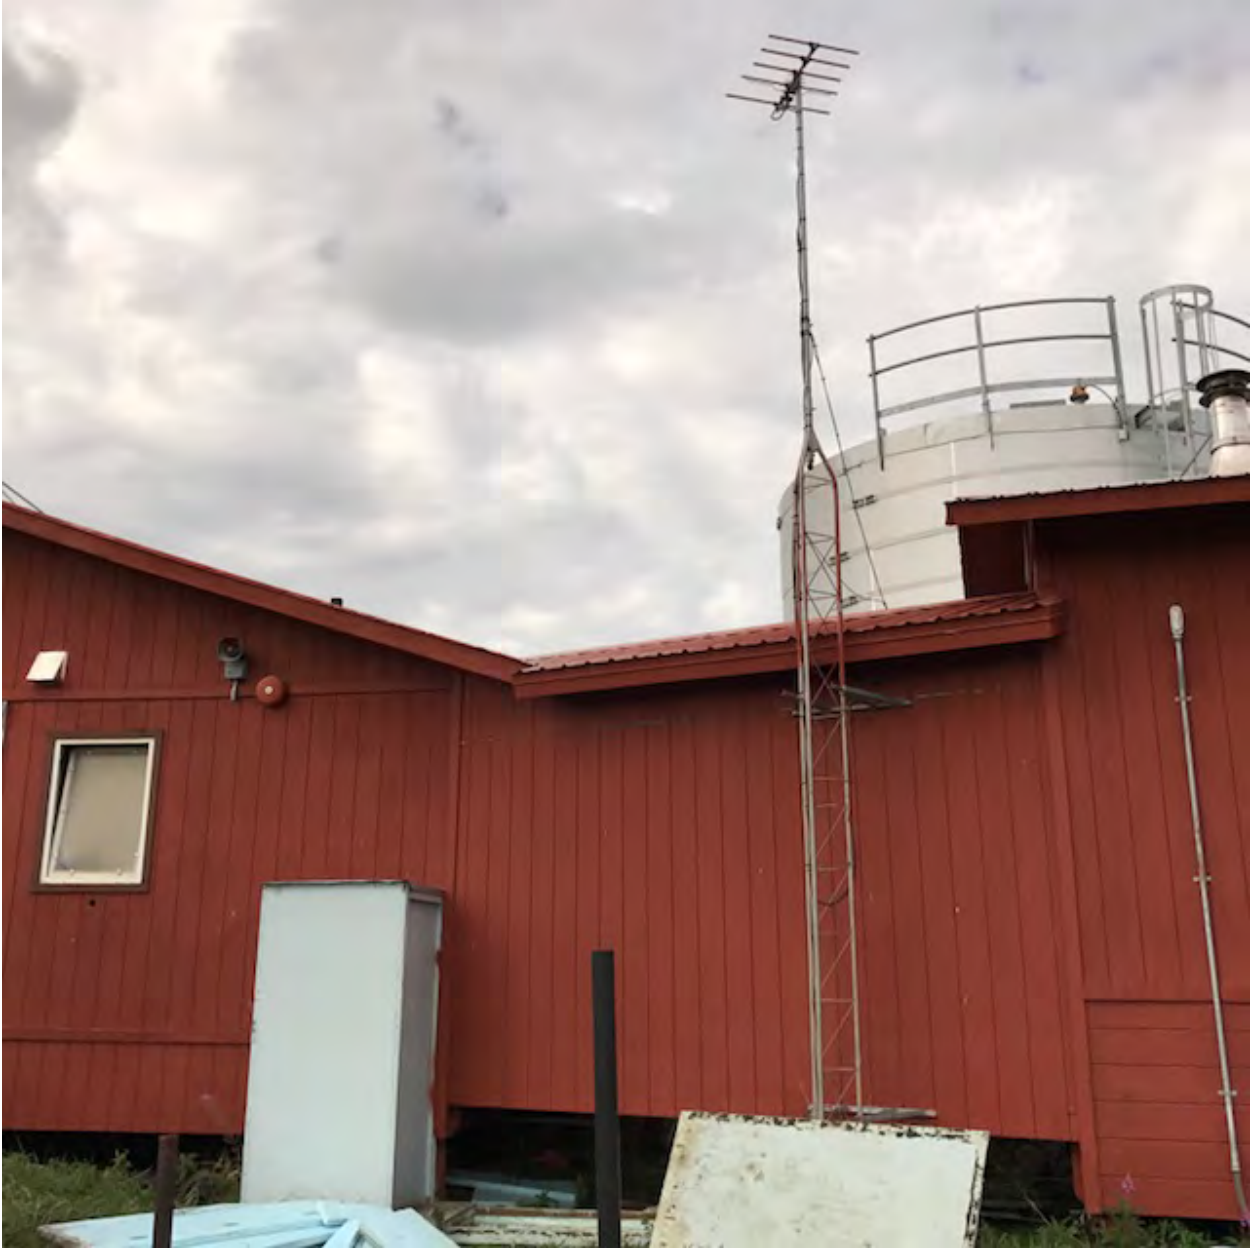
The sink hole is on the left hand side of the picture and is located under the building just below the opened window. The 60,000 plus gallon water storage tank is on the other side of the building in the background.

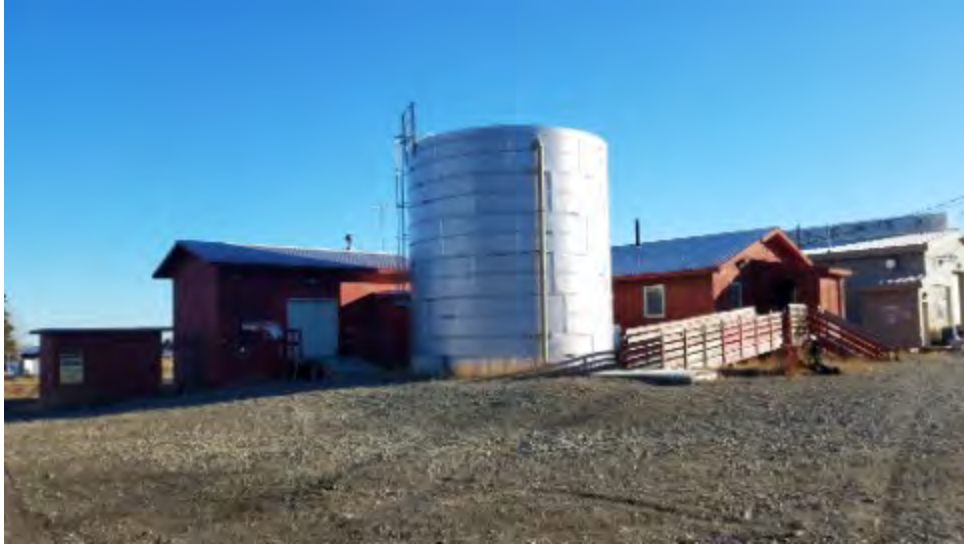
Figure 1: WTP, Storage Tank, Washeteria-North West Side

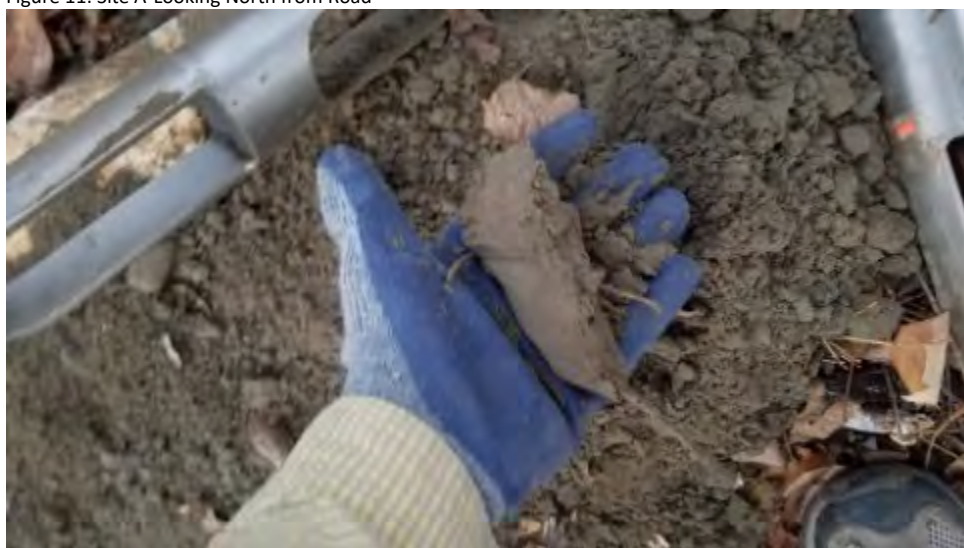
Figure 12: Sandy Silt from Hole A.

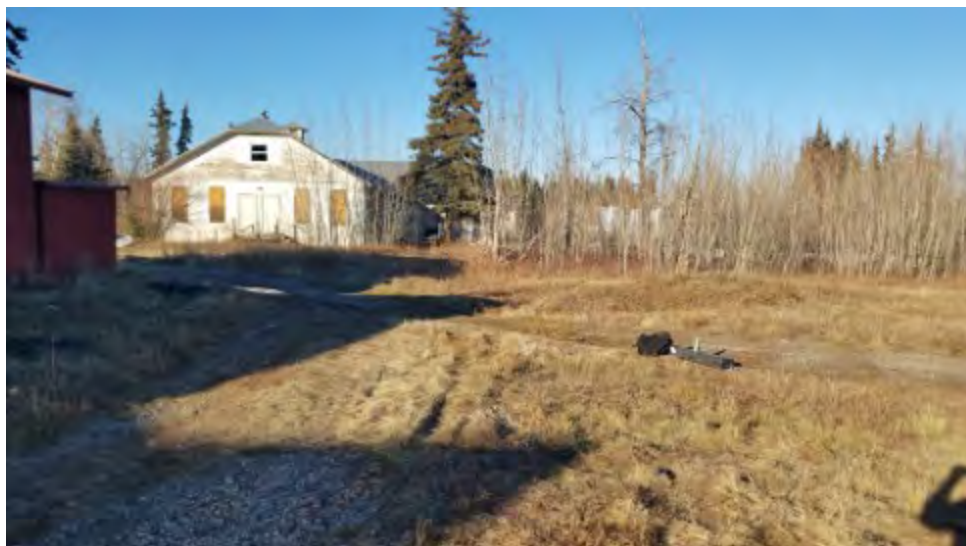
Figure 13: Site B-West of WTP, Looking North to Old School & Site A

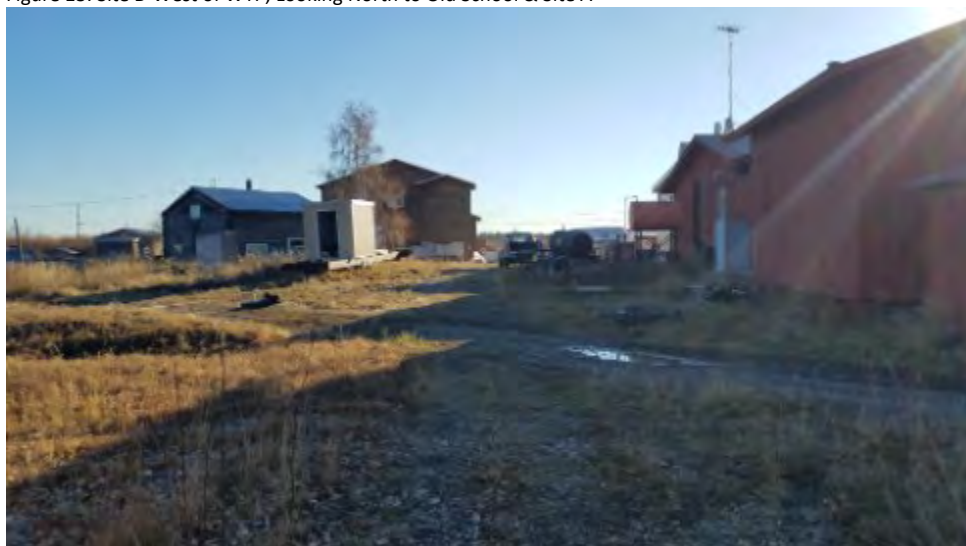
Figure 14: Site B-West of WTP, Looking South Towards Missionary Housing & Village Office

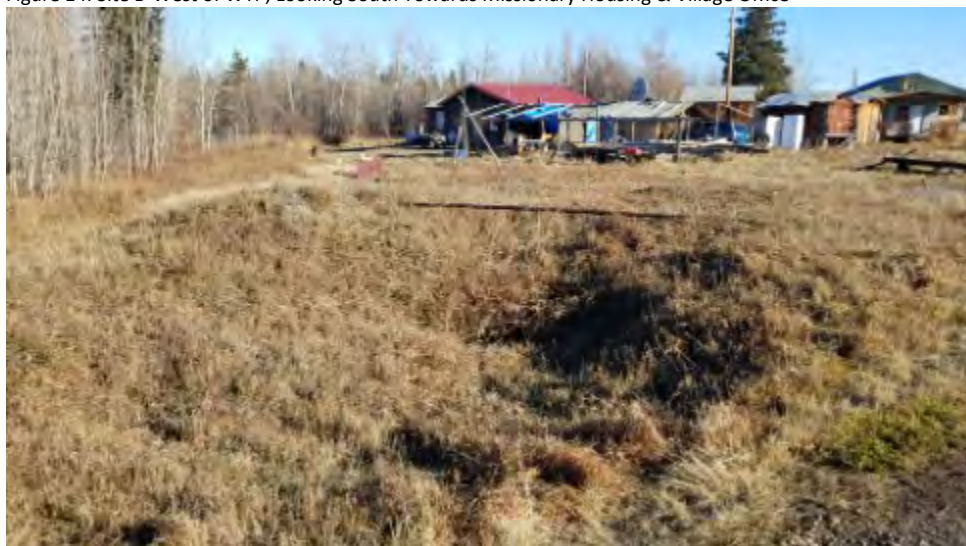
Figure 15: Depression-West of Site B, Looking East

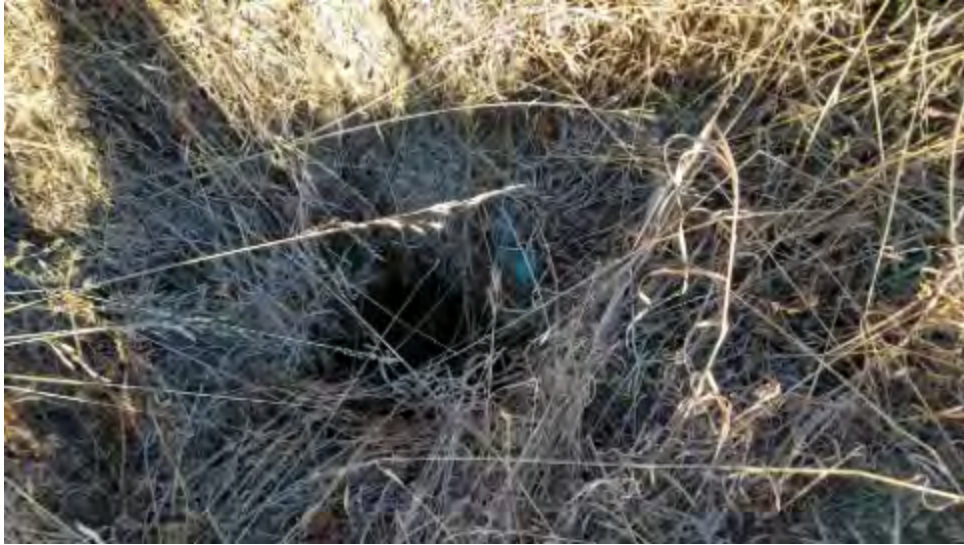
Figure 16: Depression, East Hole, Insulation Board Exposed

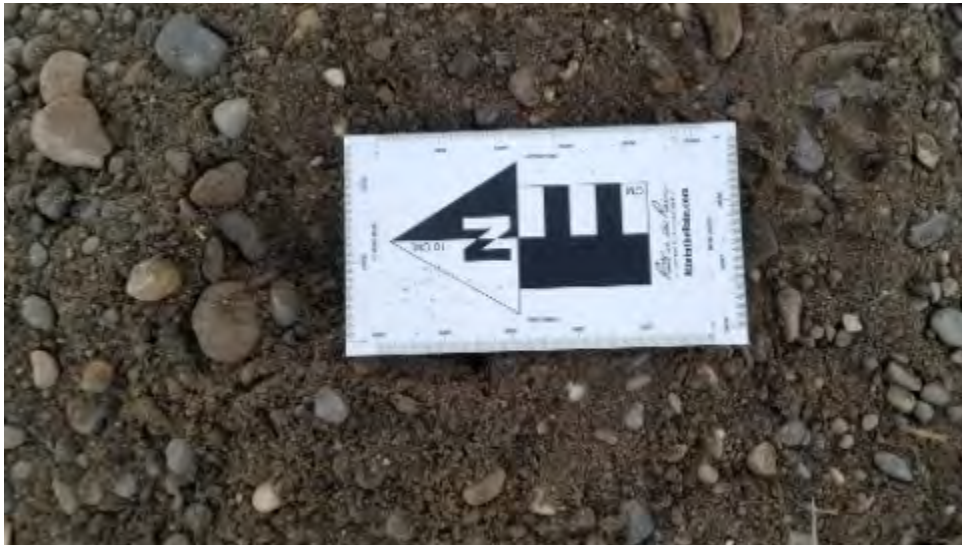
Figure 17: Gravel with Sand from Hole B.

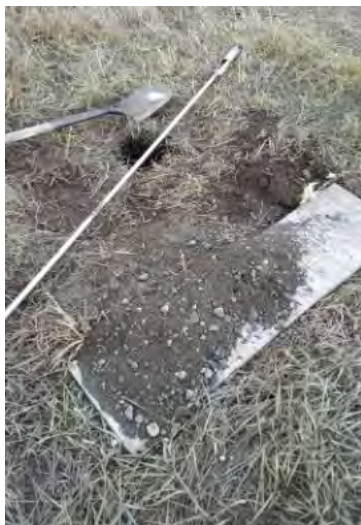
Figure 18: Hole B

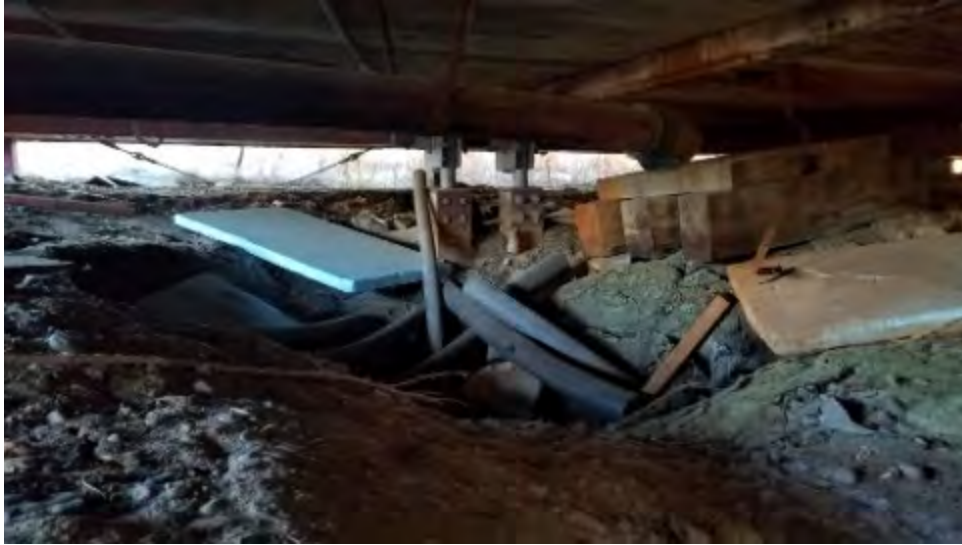
Figure 19: Depression Under Washeteria

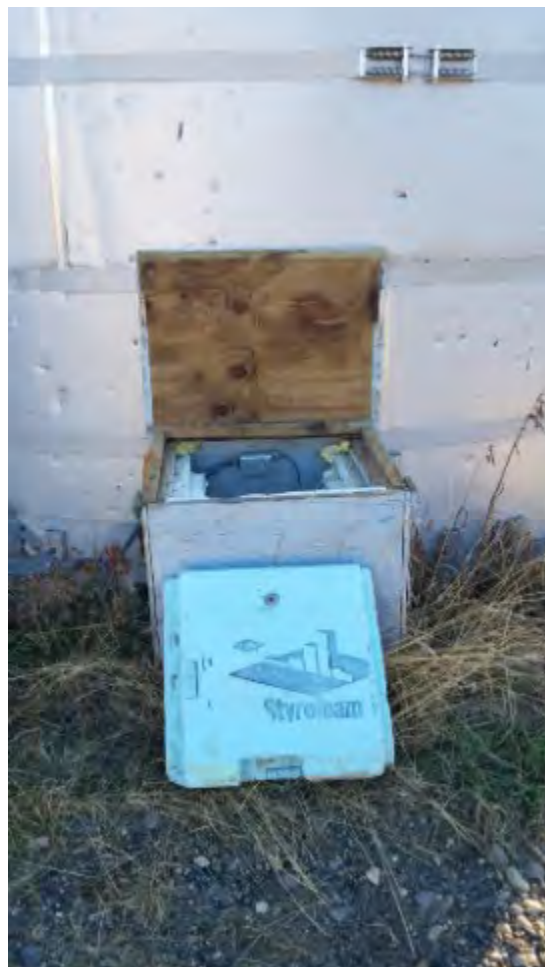
Figure 23: Typical Perimeter Pile, Beginning to Fail, Leans Towards Depression Figure 24: Water Storage Tank-Exterior Valve Box

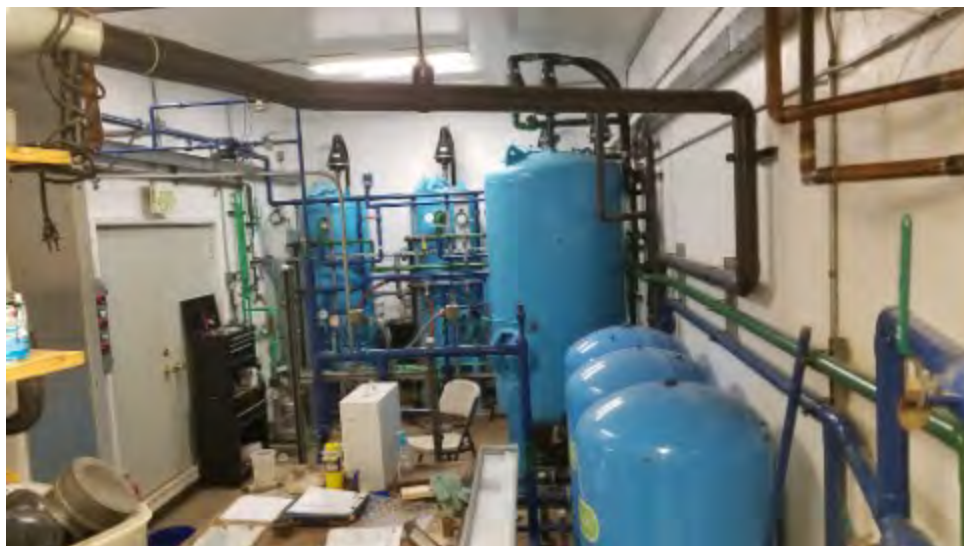
Figure 25: WTP Filters, Settling Tank, and Pressure Tanks

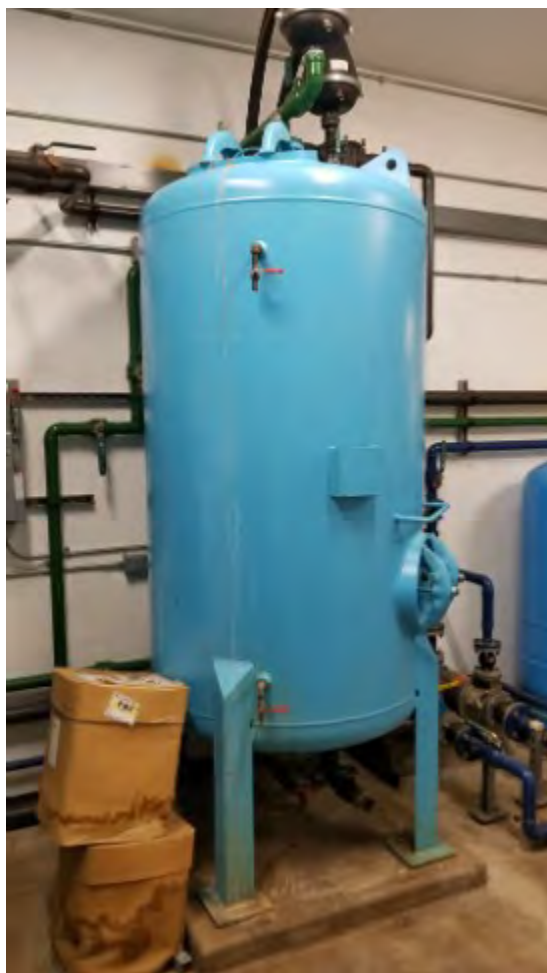
Figure 26: WTP-Settling Tank

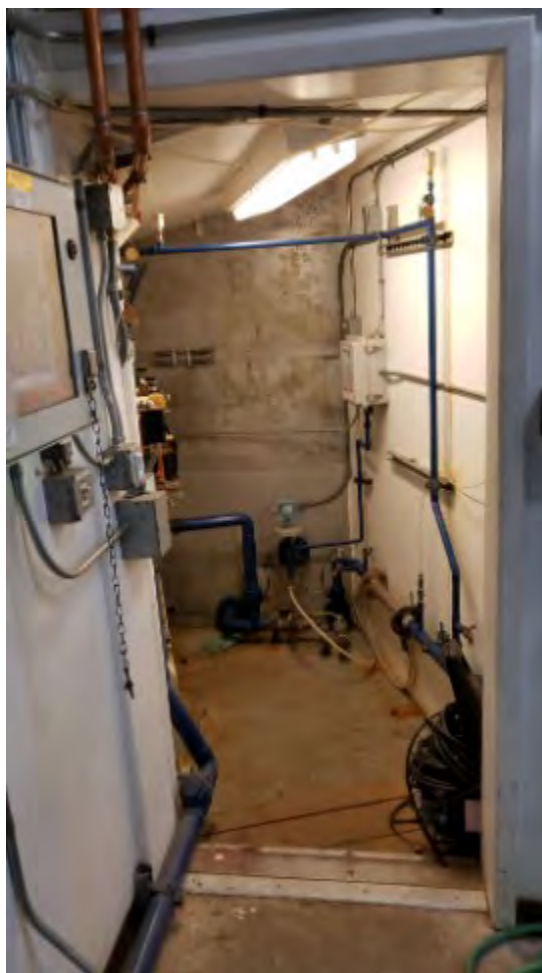
Figure 27: WTP-Water Storage Tank Valve Room

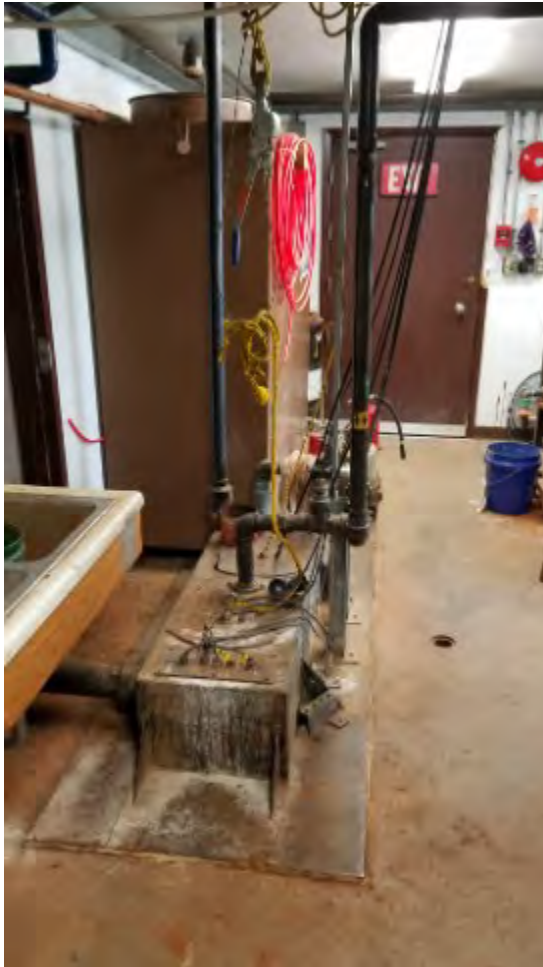
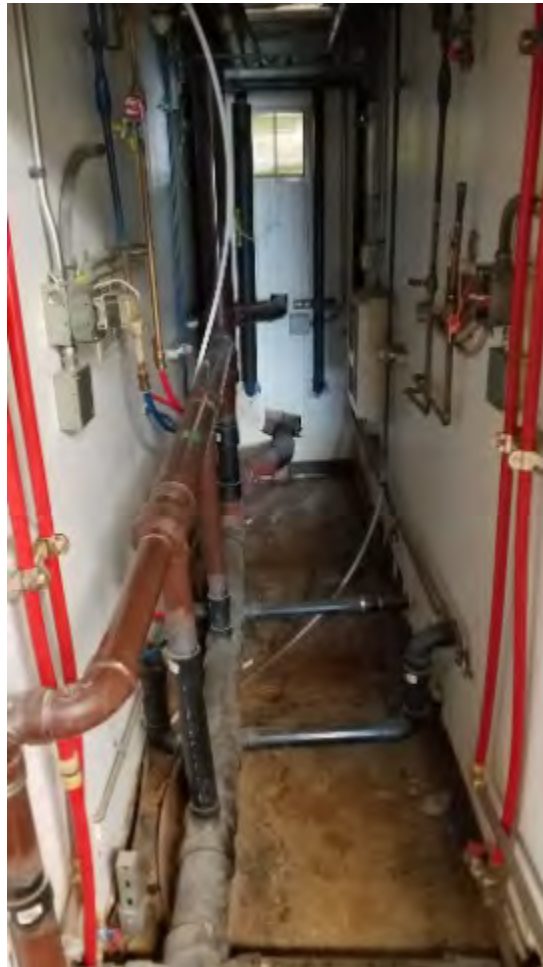
Figure 29: Boiler Room-Lift Station and Backwash Tank (Brown Tank) Figure 30: Washer Access Room

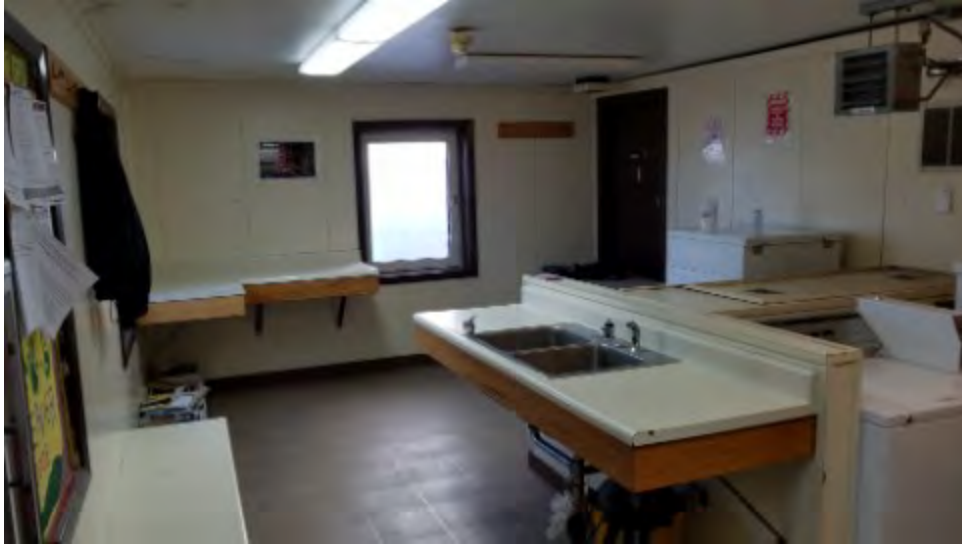
Figure 31: Laundry Room-East Side

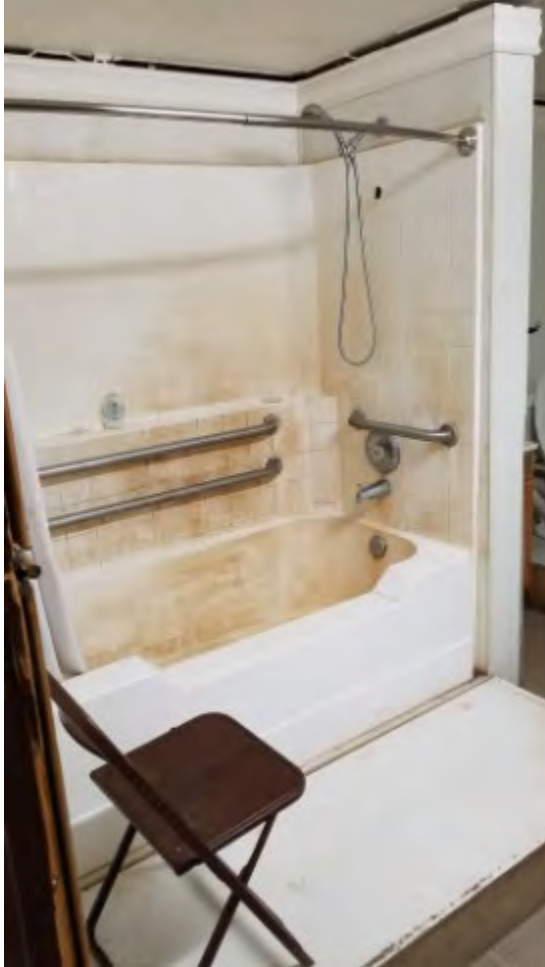
Figure 34: Bathroom-Bathtub

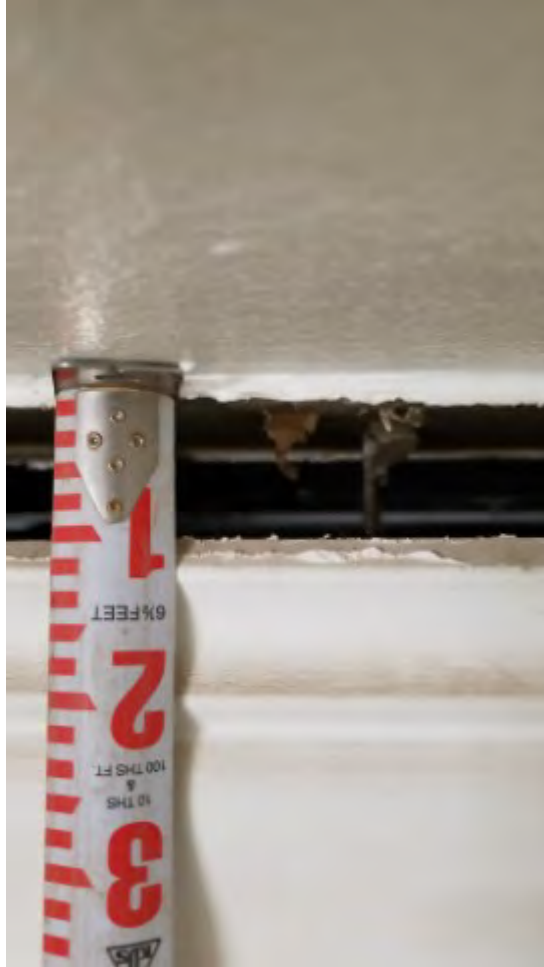
Figure 35: Bathroom-Wall and Ceiling Separation

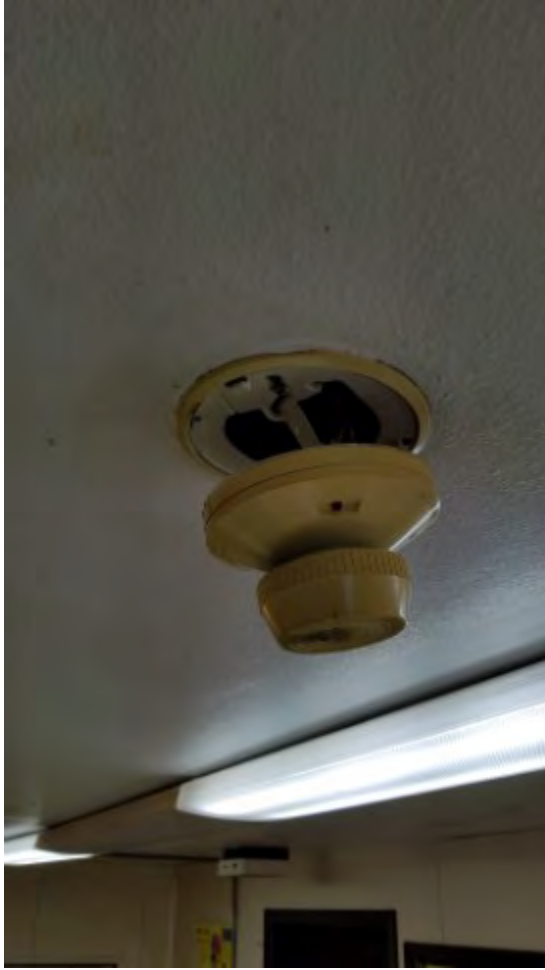
Figure 38: Laundry-Nonfunctioning Smoke Alarm
