Site Assessment Pitkas Point School Site Pitkas Point, Alaska ADEC File ID: 2444.57.001

January 2016

Alaska Department of Environmental Conservation
Spill Prevention and Response
555 Cordova Street
Anchorage, Alaska 99501

By: Shannon & Wilson, Inc. 5430 Fairbanks Street, Suite 3 Anchorage, Alaska 99518

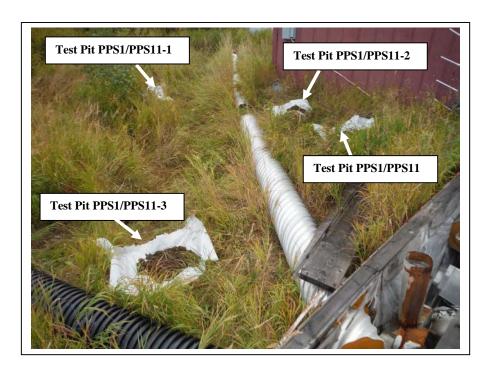
Photo 2: Looking east at the location of the PPS1/PPS11 sample area near the northwest corner of the Fire House. (September 16, 2015)

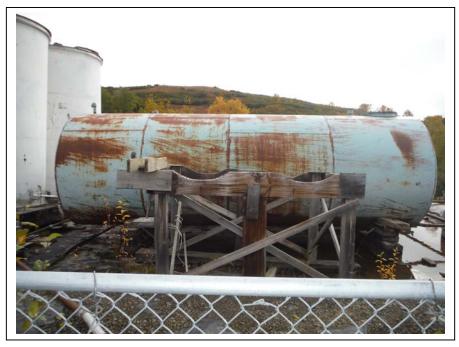
Photo 7: Looking east at Tank Farm wood support of former School ASTs. (September 16, 2015)

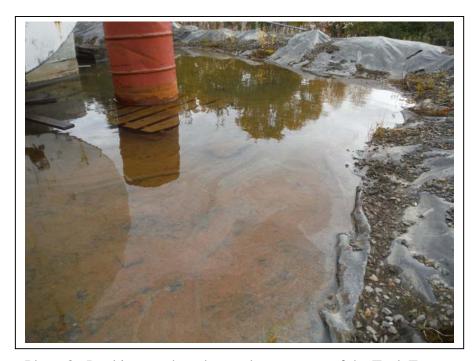
Photo 8: Looking south at the southeast corner of the Tank Farm. A sheen was present on the surface water ponded within the lined Tank Farm. (September 16, 2015)

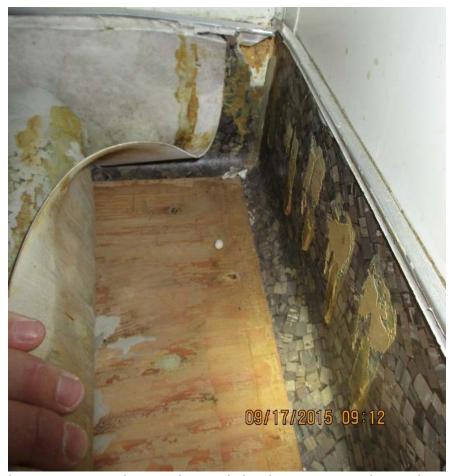
Example of asbestos-containing sheet vinyl concealed under newer non-asbestos sheet vinyl and plywood in the Boy's Bathroom in the Main School Building.

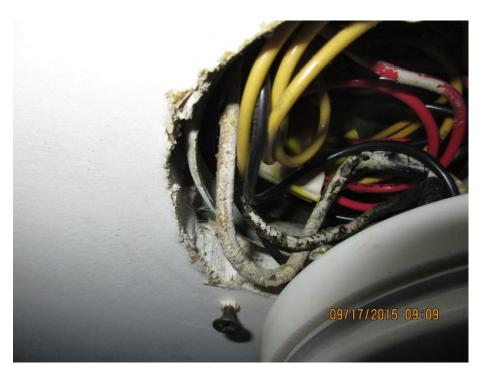
Example of asbestos-containing wire insulation at a heat detector in the Janitor's Closet in the Main School Building.

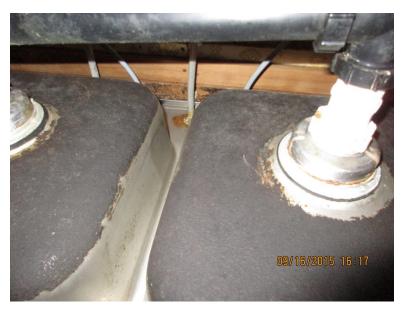
Asbestos-containing sink undercoating on Kitchen sink in Teacher Housing Unit 1. Teacher Housing Unit 2 similar.

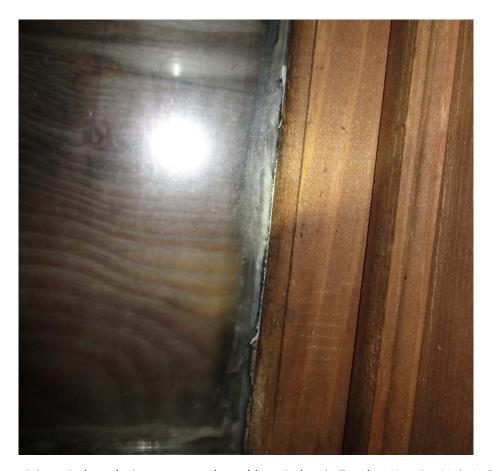
Asbestos-containing window glazing compound on older window in Teacher Housing Unit 1. Teacher Housing Unit 2 similar.

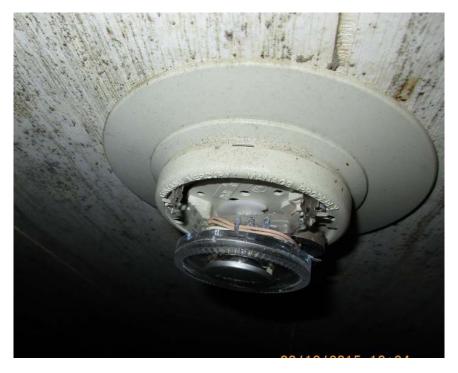
Thermostat with mercury filled ampule in Teacher Housing Unit 1. Note mold on wood wall finish.

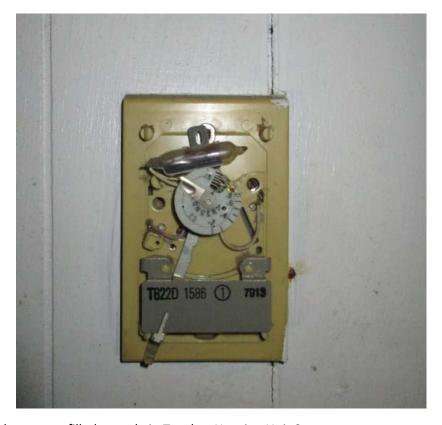
Thermostat with mercury filled ampule in Teacher Housing Unit 2.

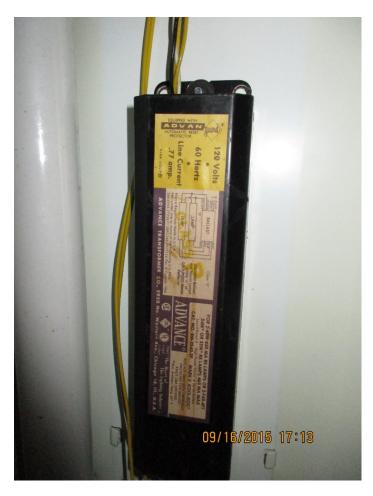
PCB containing ballast in a fluorescent light fixture in the Kitchen in Teacher Housing Unit 2.

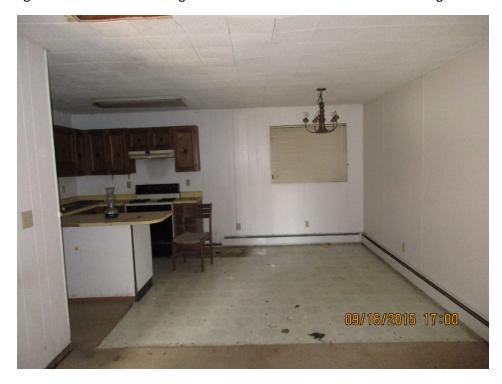
At first glance, Teacher Housing Unit 2 did not appear to have as extensive of a mold problem as Teacher Housing Unit 1. Closer examination revealed nearly the same level of fungal growth even though the ceiling tiles remained mostly intact.

- 1. Completely demolish the unit.
- 2. Completely renovate the unit which would include removal of all existing equipment, finishes, plywood subfloor, plywood ceiling, roofing, etc. After removal of all of these items the contractor would need to inspect for any other water damaged structure and replace items as necessary to complete renovation work.
- There were materials that were assumed to contain asbestos due to site conditions and the limited nature of this survey. Those materials should be investigated as part of a renovation or demolition design effort.

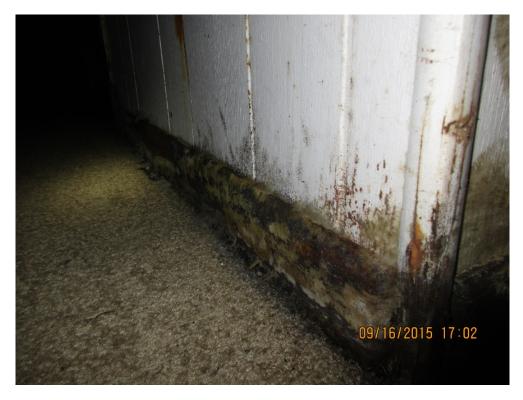
Fungal growth on carpet, base trim, and wood paneling of cabinetry near the Kitchen in Teacher Housing Unit 2.

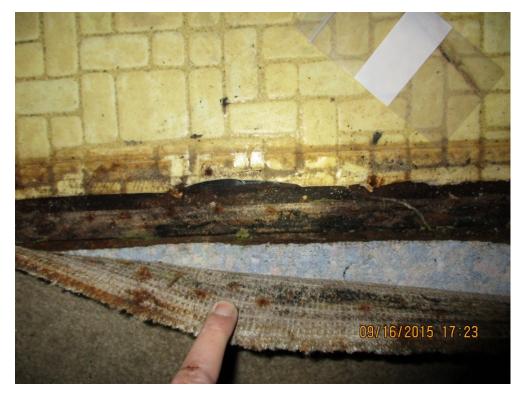
Fungal growth on plywood subfloor in Teacher Housing Unit 2. Note water saturated flooring materials and subfloor.

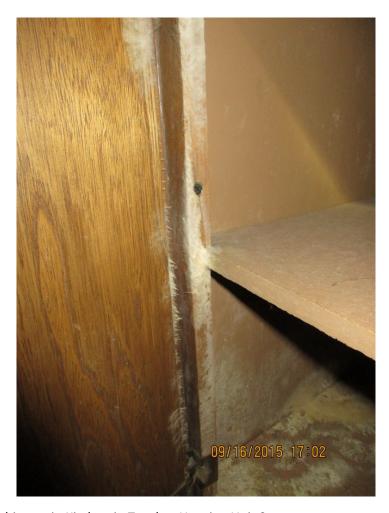
Fungal growth on cabinetry in Kitchen in Teacher Housing Unit 2.

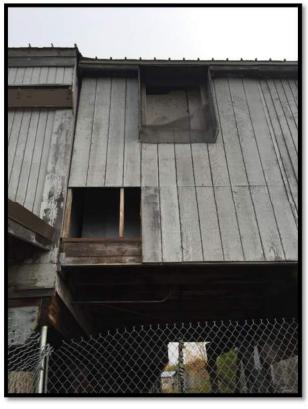
5. Cold Storage Room – Separation of Structure From Existing Building
