PROPERTY ASSESSMENT AND CLEANUP PLAN

COPPER VALLEY SCHOOL TAZLINA, ALASKA

Submitted to: Department of Environmental Conservation Reuse and Redevelopment Program

> By: Oasis Environmental, Inc. May 19, 2010

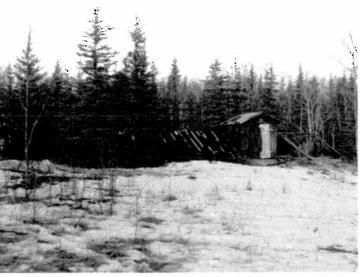
Buried Fuel Tank (about 10'x60') and bunker

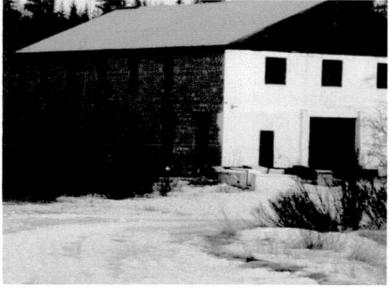
Out building – unknown use

Maintenance garage – fav kids hangout

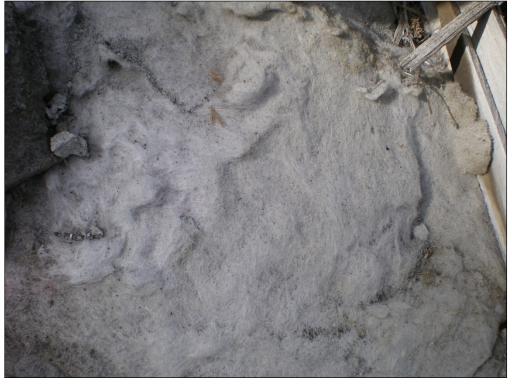
contained asbestos. The amount of debris in the kitchen wing made it difficult and unsafe to fully inspect the kitchen area (see Photographs 3 and 4, Appendix E).

PHOTOGRAPH 4: SUSPECT MATERIAL POTENTIALLY CONTAINING ASBESTOS IN THE KITCHEN

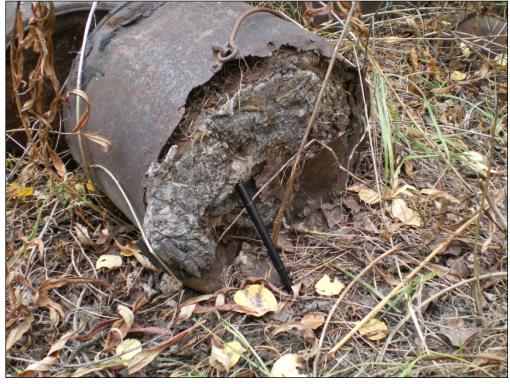
PHOTOGRAPH 8: CONTENTS OF A BUCKET

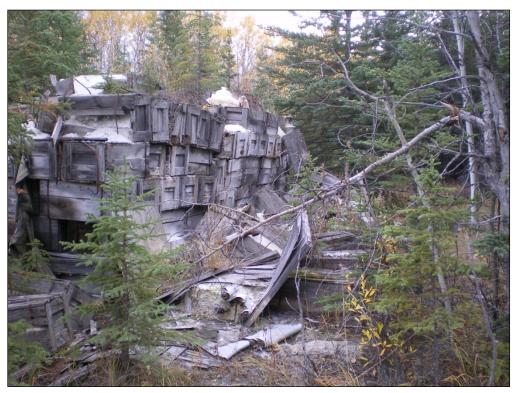
powder. Photographs 10 and 11 in Appendix

PHOTOGRAPH 10: CRATES CONTAINING WHITE POWDER, VIEW SOUTHWEST

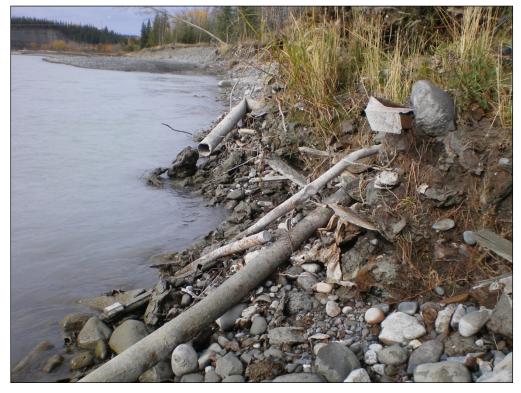
observations of the dumpsite. Photographs 12 and 13 in Appendix E show the eroding dumpsite.

PHOTOGRAPH 12: DUMPSITE ERODING INTO TAZLINA RIVER, VIEW WEST

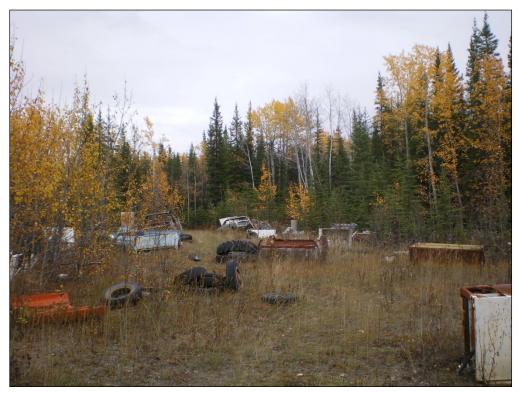
PHOTOGRAPH 16: DEBRIS IN AN ABOVEGROUND DUMPSITE, VIEW NORTHEAST

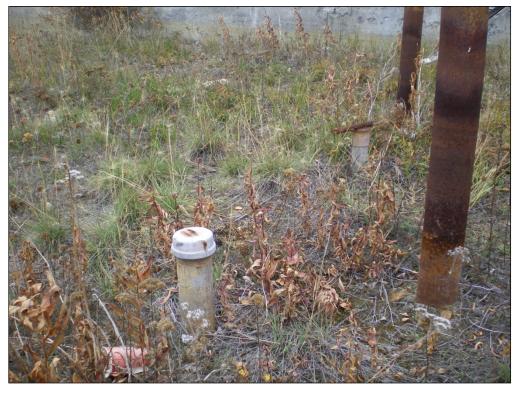
observed south of the former boiler room (see Photograph 18, Appendix E). It is unknown what the contents of the UST were and if any liquid remains in the tank. The size of the UST also is unknown; however, the tank is likely small, as the fill and vent pipes were approximately 3 feet apart. No stressed vegetation or staining was observed on the ground surface.

PHOTOGRAPH 18: FILL AND VENT PIPE OF UST, VIEW WEST

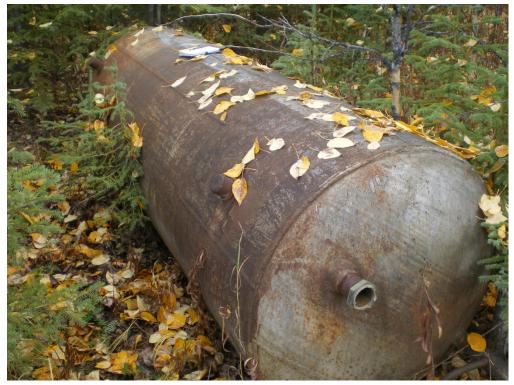
A tank was observed in the woods northeast of the shop building (Photograph 22, Appendix E). It appeared to have once been standing upright, but is now fallen over. A former student thought the tank container water. No leaks or staining was observed in the vicinity of the tank.

PHOTOGRAPH 22: TANK IN WOODS NEAR SHOP BUILDING, VIEW NORTHEAST

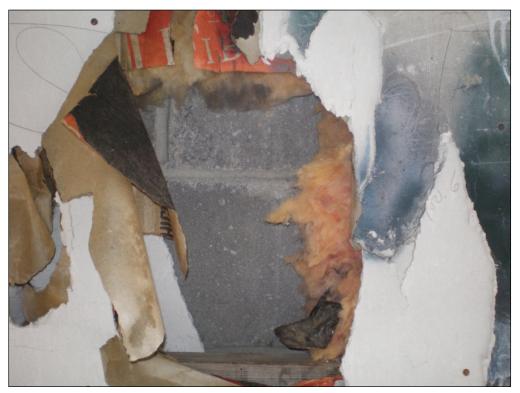
PHOTOGRAPH 26: INSULATION IN SHOP BUILDING, LIKELY FIBERGLASS, VIEW SOUTH-SOUTHWEST
